Habitat tree at 3457 Warburton Highway, Warburton

Background

Condition of the tree

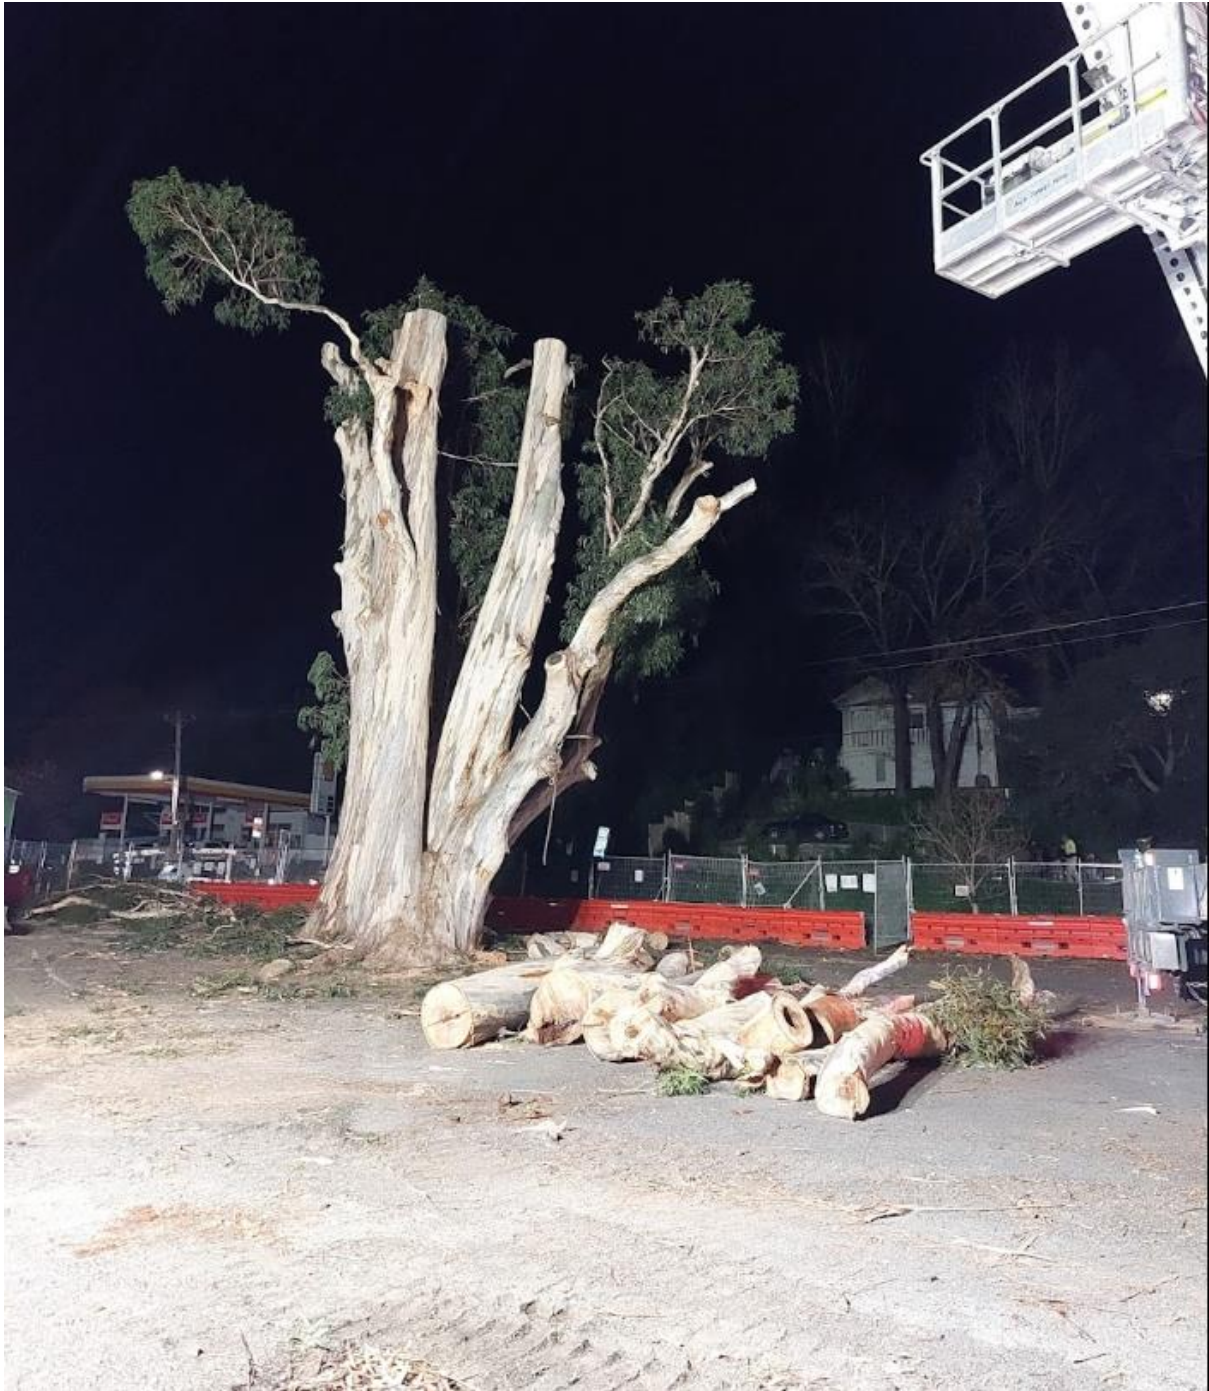
Photo 1

The tree has now been cut to 10m (see photo 1 below) and this report assesses the residual risk.

The tree was cut to 10m on 1 June. A cable at 8m is still in the tree and is not under tension, indicating that removing the crown of the tree has reduced the load on the base of the trunk.

There is only a small amount of leaf canopy left, which means that sugar production is limited. In response to this the tree may produce epicormic shoots (regrowth to replace the foliage lost), or very limited regrowth, or die. It is not possible to gauge the response accurately at this time.

As well as undertaking the risk assessment in three years' time as mentioned above, the tree will also need to be assessed annually to monitor the regrowth. Large epicormic shoots may need to be pruned as they can become large, but are not well attached, with failure possible.

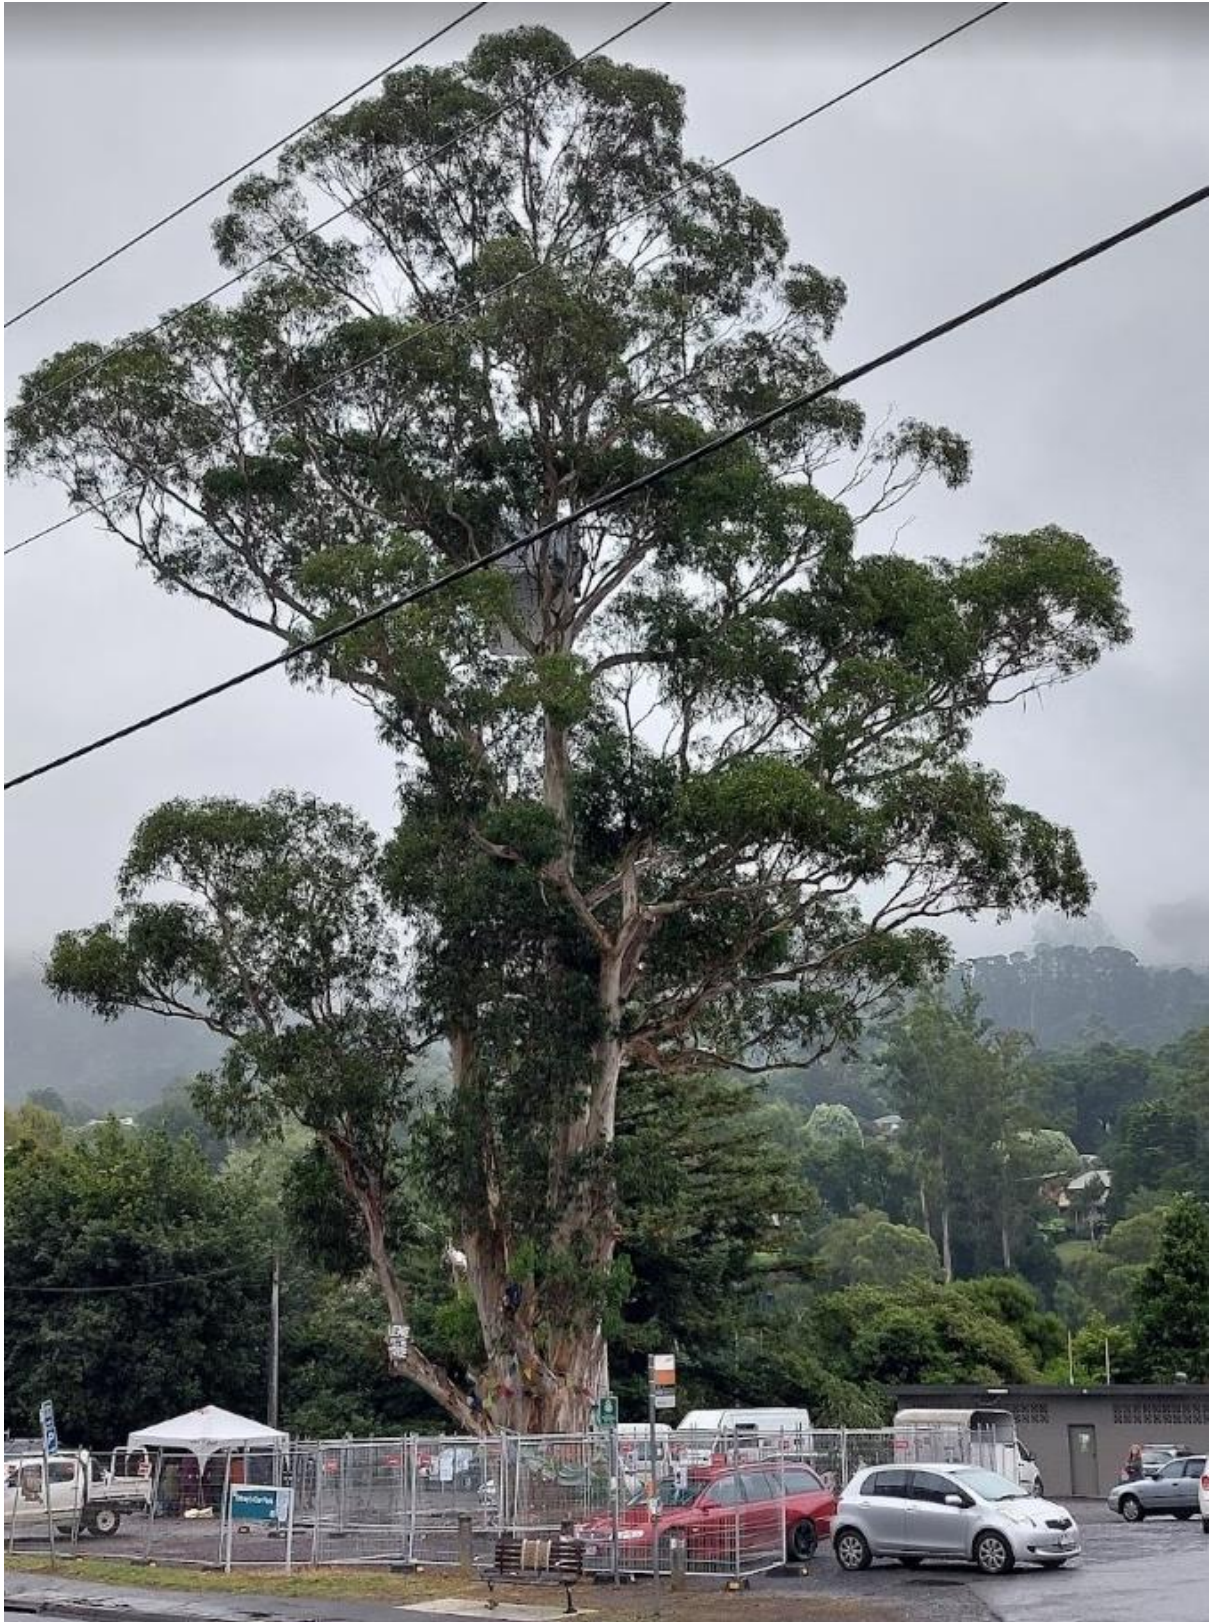
Photo 2

Council has managed a large tree at 3457 Warburton Highway, Warburton for many years. The tree is a large *Eucalyptus cypellocarpa* (Mountain Grey Gum) and has been cabled due to faults at the base (see photo 2 below).

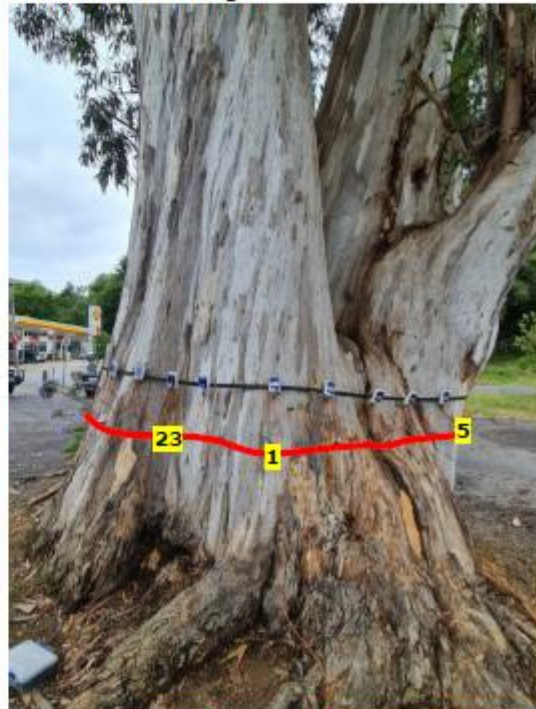
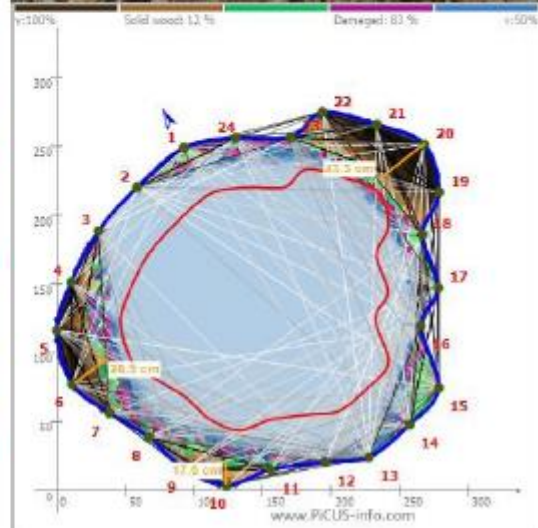
Figure 1

In late 2022 a qualified arborist recommended that the tree be removed. A tomography test in 2023 confirmed that there was extensive decay at the base and that there was a crack from the stem union to the ground (see figures 1 and 2 below).

The Sonic Tomograph test result indicates the percentage of the test area that is sound (high density) wood, incipient wood (wood being altered by the fungus) or active fungus and decayed (low density) wood. The tree was previously tested at approximately the same height in June 2016 and the results of that test, and the recent test are:

2016	2023
Sound wood	22%	12%
Incipient wood	9%	5%
Active fungus & decayed wood	69%	83%

The circumference of the trunk at the test height has increased by approximately 43 cm since the 2016 test, and it is acknowledged erosion of the soil at the base of the tree has lowered the ground level in the years between tests. Therefore, the current test height is lower on the trunk than the 2016 test.

Notwithstanding the change in test heights, comparing the two test results shows that the percentage of sound wood has decreased, and the percentage of active fungus and decayed wood has increased over the 6½ years since the last test in 2016.

The active fungus progressed further through the heartwood since the 2016 test causing extensive degradation to the structural integrity of the trunk at the test point. Additionally, the test result shows that the tension wood in the split primary union of the co-dominant trunks that traverses the test height from sensors 2-3 through to sensors 13-14 is totally dysfunctional.

The test result shows that there is some structural compression wood at the test height. At the test height, the test result shows at sensor 6 there is 28 cm of sound wood; at sensor 10 there is 17 cm of sound wood; and at sensor 20 there is 43 cm of sound wood. Furthermore, it is observed that new wood growth increments are occurring in the compression wood at sensors 5, 6, 19, 20, 21 and 22.

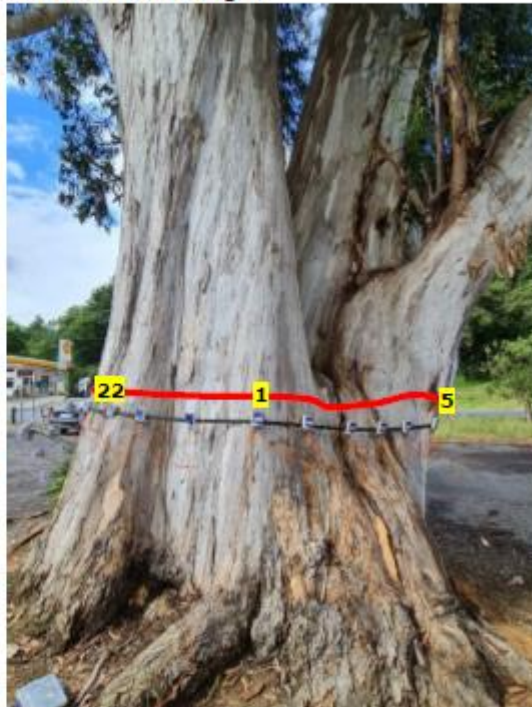
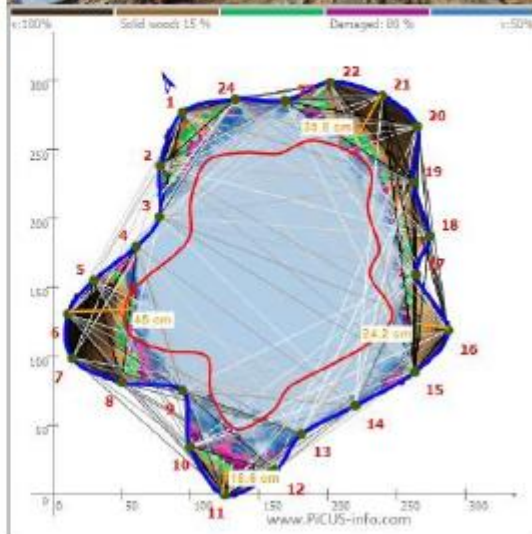
Figure 2

The Sonic Tomograph test result indicates 15% of the test area is sound (high density) wood. There is 5% of incipient wood (wood being altered by the fungus). The remaining 80% is active fungus and decayed (low density) wood.

The fungus in the test result is associated with the degradation seen in the lower test point. The split primary union of the co-dominant trunks traverses the test height from sensors 3-4 through to sensor 14-15.

The active fungus has spread through the heartwood reaching the outer trunk between sensors 2 and 4; between sensors 8 and 10; between sensors 12 and 15; and between sensors 23 and 24. The test result shows that the fungus has caused significant degradation to the structural integrity of the trunk and primary union of the tree.

The progression of the fungus at the test point has confined the structural wood is to the compression wood of the co-dominant trunks and primary union. At the test height, the test result shows at sensor 6 there is 45 cm of sound wood; at sensor 11 there is 18 cm of sound wood; at sensor 16 there is 24 cm of sound wood; and at sensor 21 there is 35 cm of sound wood. Furthermore, it is observed that new wood growth increments are occurring in the compression wood at sensors 6, 7, 11, 20 and 21.
