Arboricultural Construction Impact Assessment

**5 Seymour Street,
Seville**

Location: 5 Seymour Street, Seville

Date: 13th March 2023

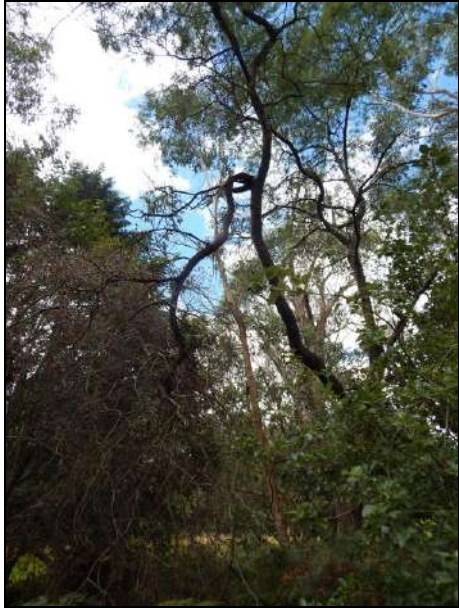
Tree 177

Tree 177: Construction works will enter more than 10% of the TPZ but does not enter the SRZ. Therefore, it is recommended that where the proposed driveway enters the TPZ of this tree that it is constructed using alternative construction methods. It must be constructed above existing grade level. There must be no grade changes within the TPZ (no excavations and no soil fill) and no roots are to be cut or damaged during any part of the construction process. However, if excavations or soil fill are required for the driveway, then root investigation will be required to establish if any significant roots will be damaged by the proposed earth works. If significant roots or a large percentage of fine fibrous roots are discovered then proposed driveway must be redesigned around these roots.

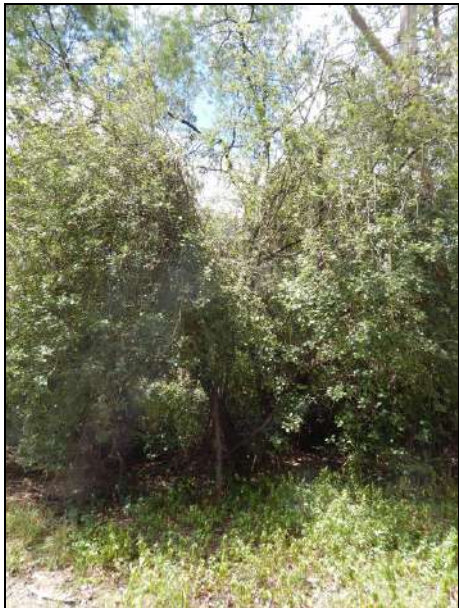
Tree 179

179	<i>Malus speciosa</i> Fruit Tree	Exotic	4.5	6	40	4.8	40	2.24	126	Mature	6yrs	Tree located on mature strip	High	Good	Fair	Tree is located on nature strip on Howard Street. It is located 6.6m from the western boundary and 78.6m from the southern boundary. Proposed driveway for Lot 6 will require the removal of this tree. This tree is recommended for removal so the proposed driveway does not impact Tree 170 a <i>Eucalyptus speciosa</i> . The location of the driveway has taken into consideration significant canopy trees and the flood zone. It is not possible to locate the driveway between this tree and tree 170 and not enter a SRZ. Due to the natural slope of the land alternative construction methods for the cross over are not possible, so the proposed driveway must not enter the SRZ of any tree. Therefore, the removal of this tree is required to allow for the construction of the driveway.	Tree removal required to facilitate proposed construction works.	Yes
