TREE INSPECTION REPORT

Report number: 32691	Site address of tree: 8 Kingswood Drive, Chirnside Park	
Date of inspection: 22/01/2023	Melway: 37 K4	
Name: [REDACTED]	Address: [REDACTED]	Phone: [REDACTED]
Recommended action: No works		
Reasons for recommended action: The tree is a mature specimen with good health and structure. The trunk is single and straight, the roots appear sound. Branch attachments are good and there is a low likelihood for major failure. The complainant's house is ~20-25m away.		
Risk & works priority: Low		Site conditions & equipment required:

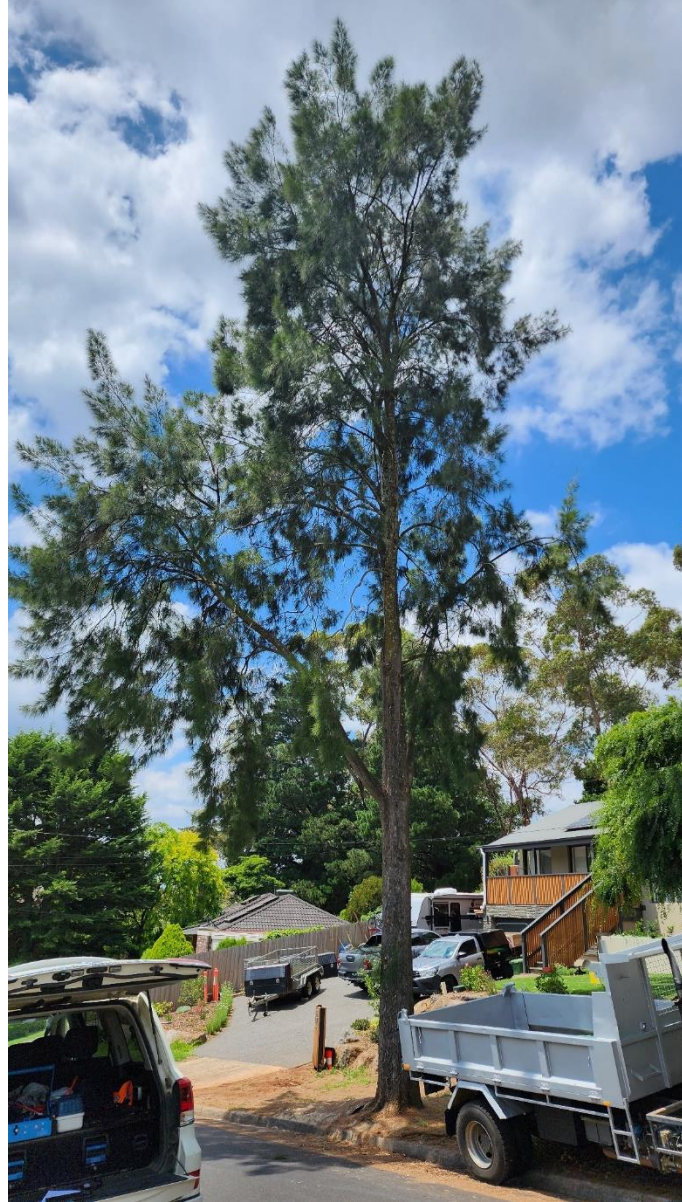
Photo 1

Age: Mature		Common name: River She Oak		Botanical name: <i>Casuarina cunninghamiana</i>	
Tree No. 1	Height (m) 17	Spread (m) 7	DBH (mm) 550		
Roots condition: Not observed			Trunk condition: Good		
Limbs condition: Good			Foliage condition: Good		
Amenity value: High			Habitat: <i>Part of habitat corridor:</i> No <i>Hollow bearing:</i> No <i>Native Fauna Use:</i> No		
Distance to building (m): ~13		Do branches overhang buildings? No		Targets Road	
Company: Ryder Consulting		Name: [REDACTED]		Date report written up: 22/01/2023
