ARBORICULTURAL IMPACT ASSESSMENT

SITE 340074
CHIRNSIDE PARK NORTHEAST

8 MEADOW FAIR WAY
CHIRNSIDE PARK
VIC 3116

28 NOVEMBER 2023

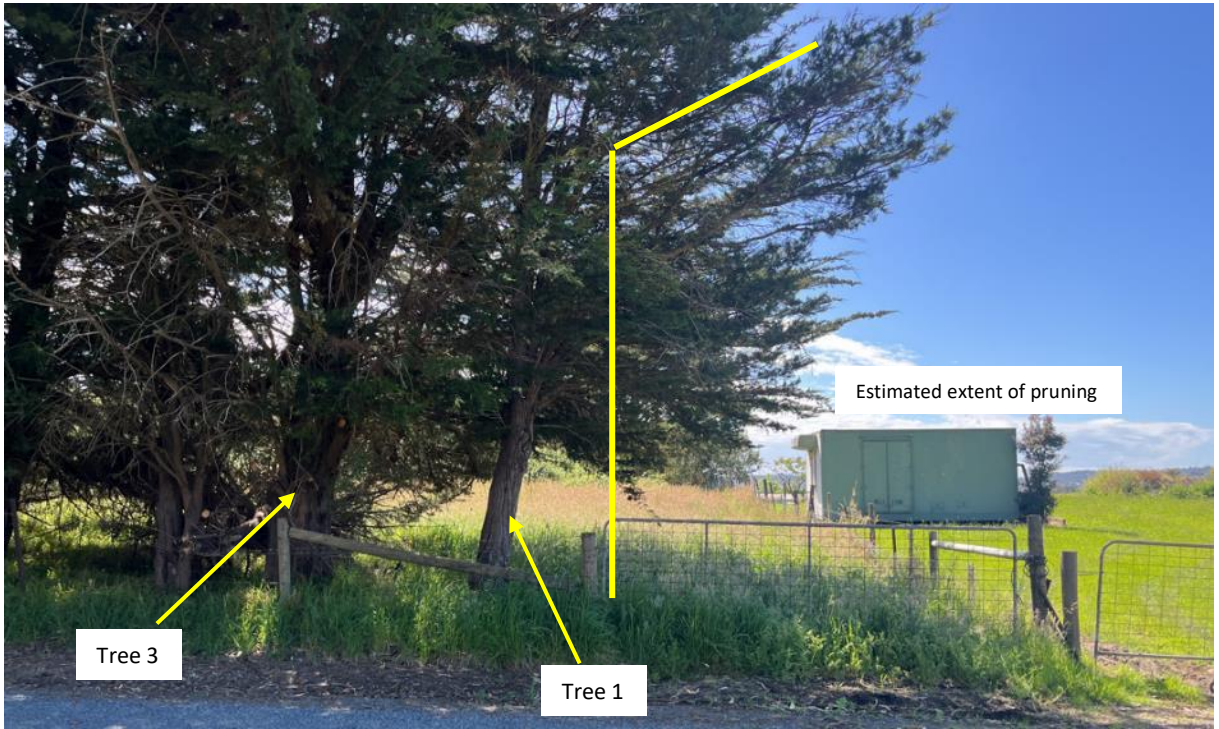
Figure 3: Viewing east toward Trees 1, 2 & access track entry gate

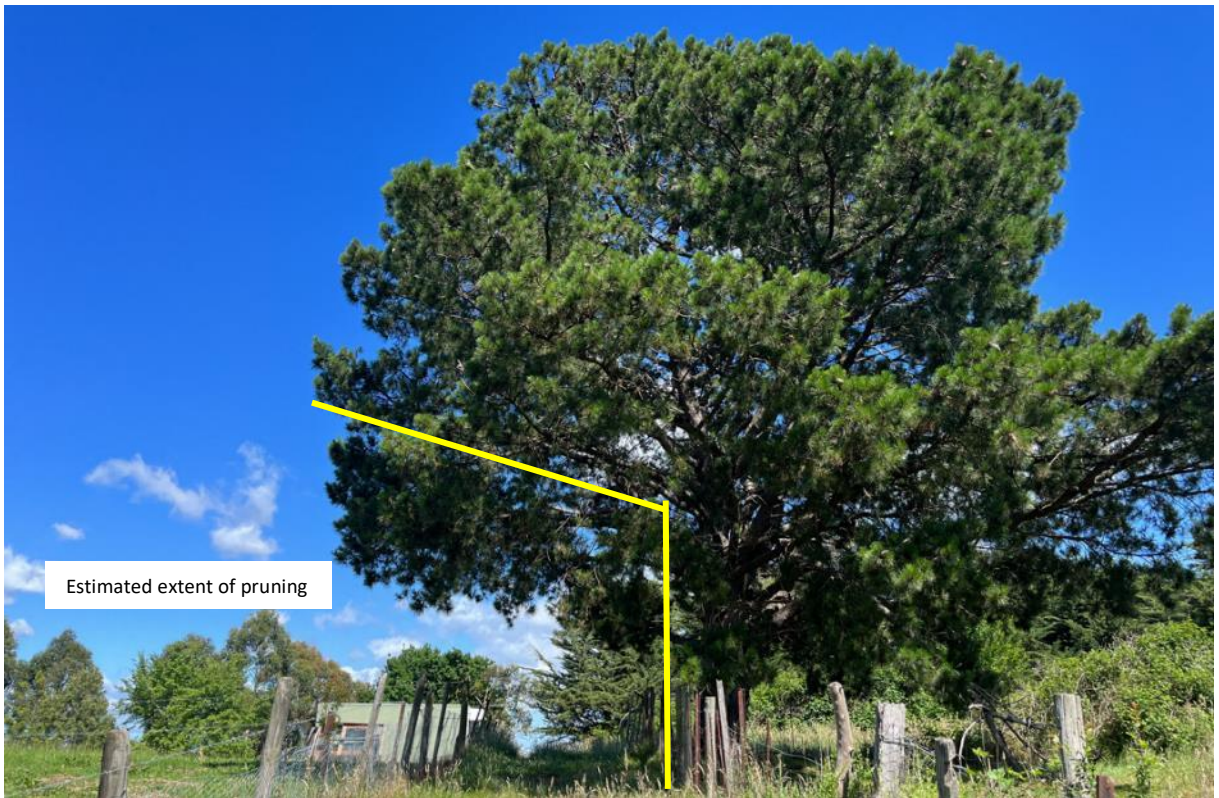
Figure 4: Viewing west toward Tree 3

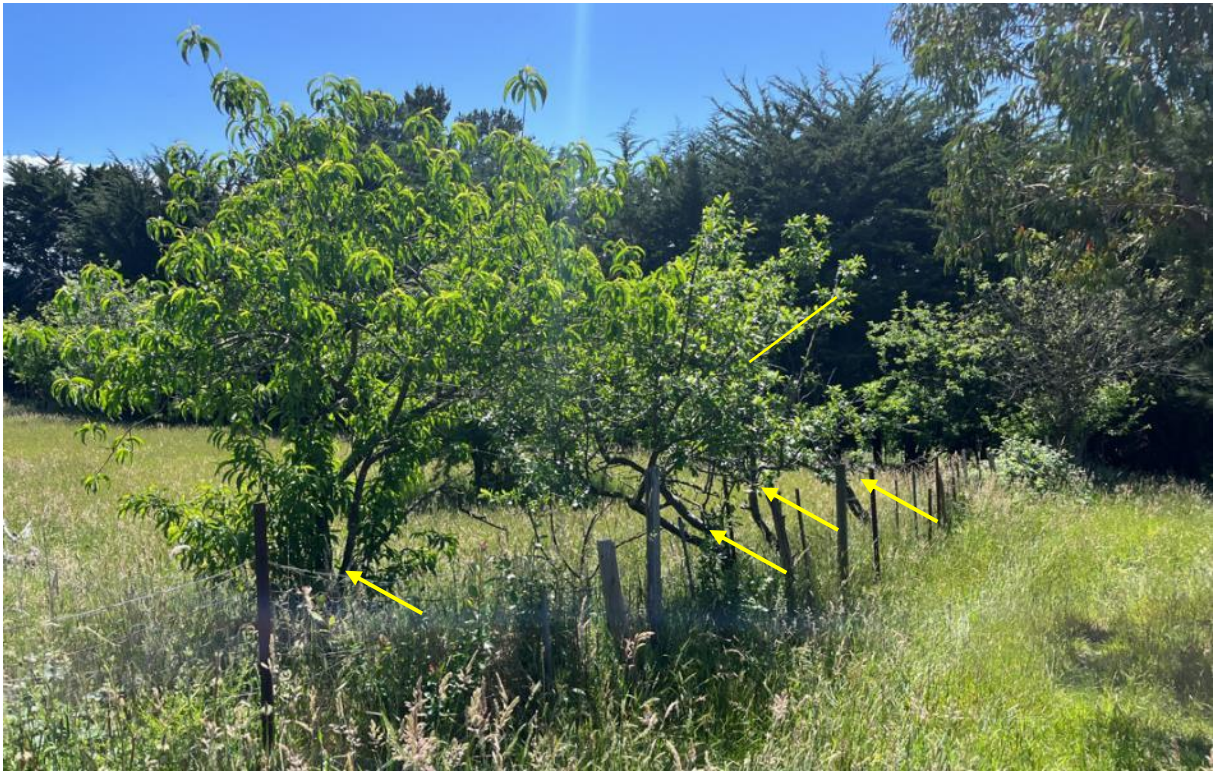
Figure 5: Viewing east toward Group 4

- 7.1.1 Undertake the removal of Groups 4, 7, 8 and Tree 15 to accommodate construction of the 4WD access track.
- 7.1.2 Prior to construction of the 4WD, a site meeting between the site manager, Project Arborist and arboricultural contractor must take place to discuss the extent of pruning works (as specified in Table 1) to accommodate construction of the access track and plant access.

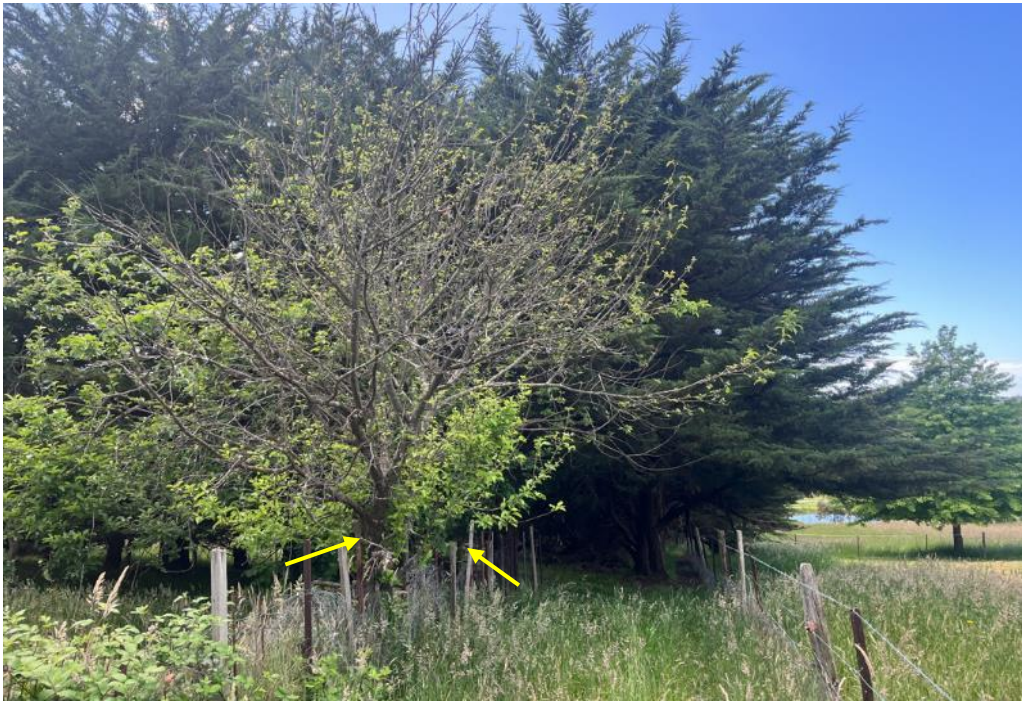
Figure 7: Viewing east toward Group 7

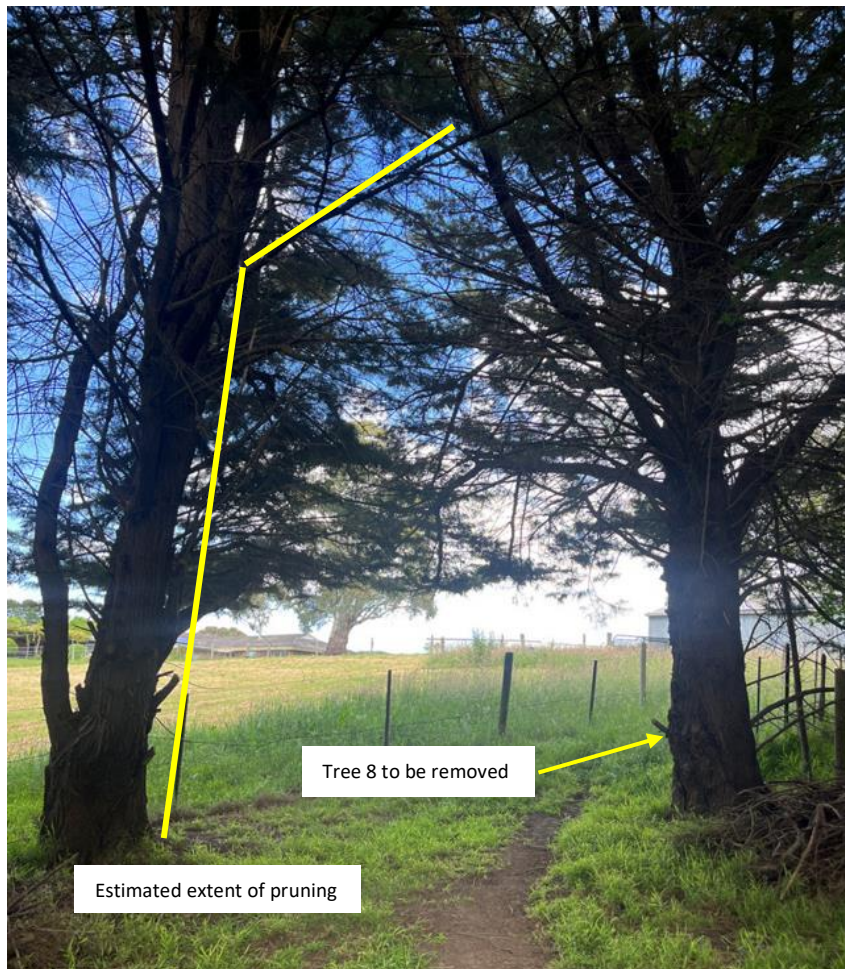
Figure 8: Viewing south-west toward the access route adjacent to Trees 8 & 11

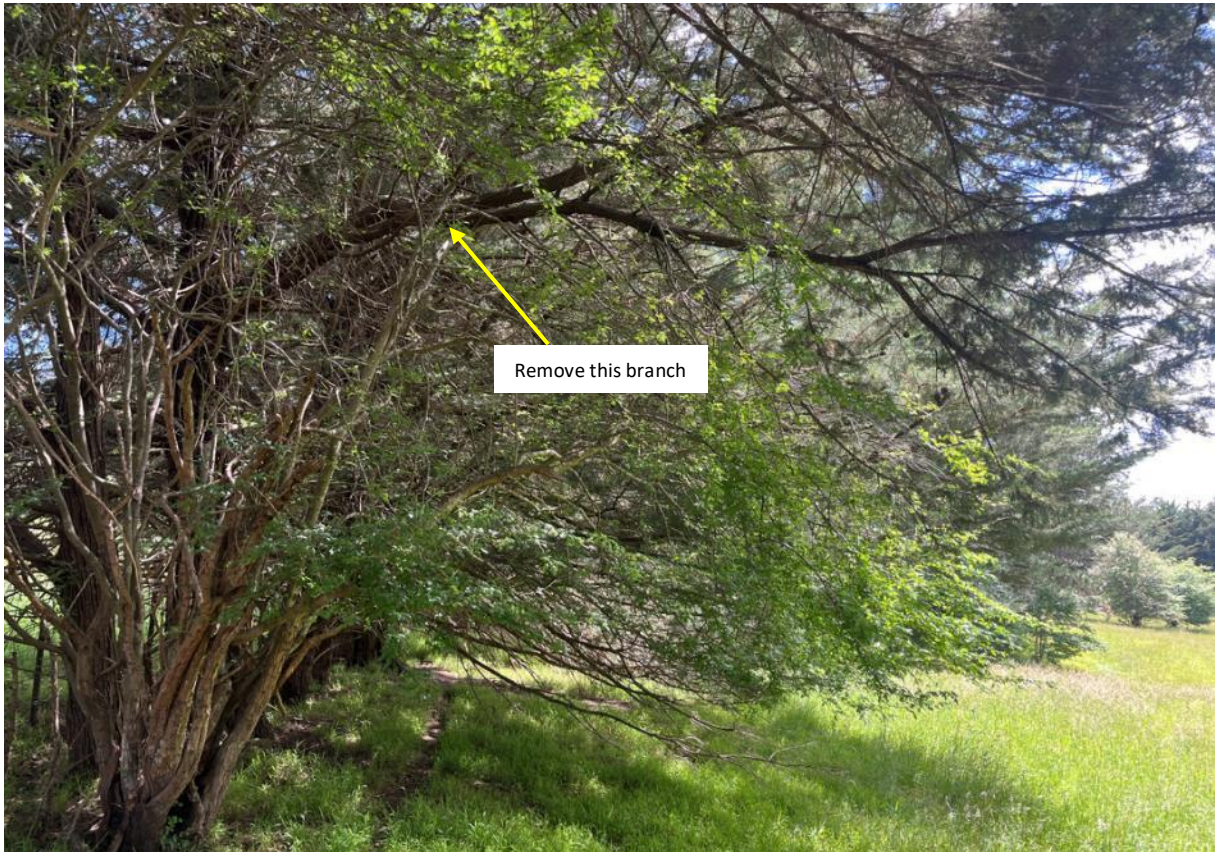
9	<i>Hesperocyparis macrocarpa</i>	10	3	Minor – Access track	Dominated by adjacent larger specimens	- Remove lowest scaffold branch
10	<i>Hesperocyparis macrocarpa</i>	18	7	Major – Access track	No pruning required.	- Above grade track construction within TPZ
11	<i>Hesperocyparis macrocarpa</i>	11	7	Major – Access track and fibre route	Scaffold extending into adjoining property may need to be removed depending upon direction of access.	- Directional boring within TPZ - Above grade track construction within TPZ - Removal of lower secondary stem to accommodate plant. - Minor lower canopy to be reduced
12	<i>Hesperocyparis macrocarpa</i>	9	9	Major – Access track and fibre route	Suppressed form from T11 with severe leaning stem toward track location	- Directional boring within TPZ - Above grade track construction within TPZ - Remove low leaning stem
G13	<i>Pinus radiata</i>	20	9	Minor – access track	Circular cluster with 3 specimens closest to access track.	- Above grade track construction within TPZ - Uplift lower canopies to accommodate plant movement

Figure 9: Viewing north toward Trees 9 & 10

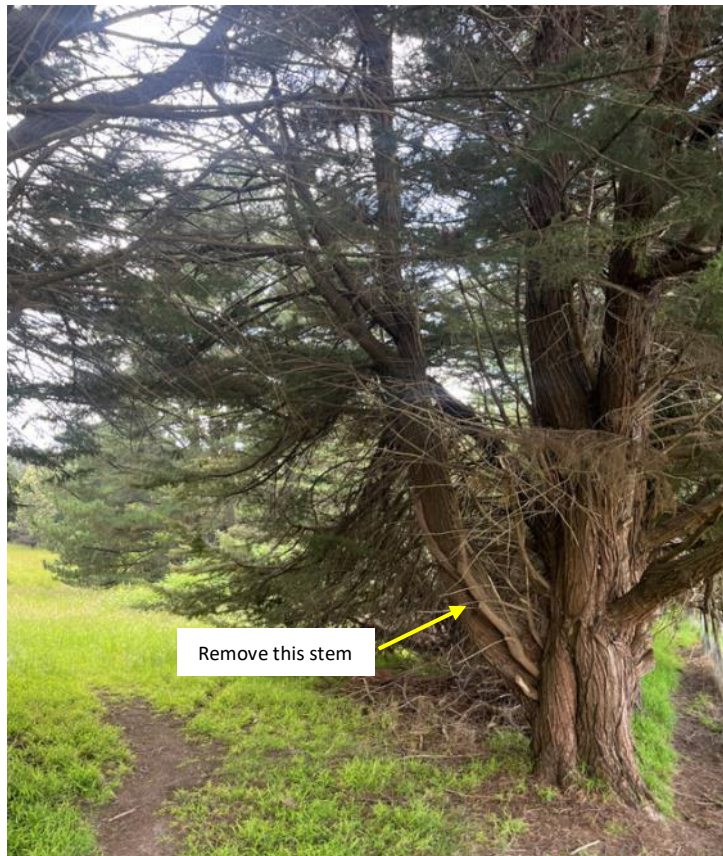
Figure 10: Viewing east toward Tree 11

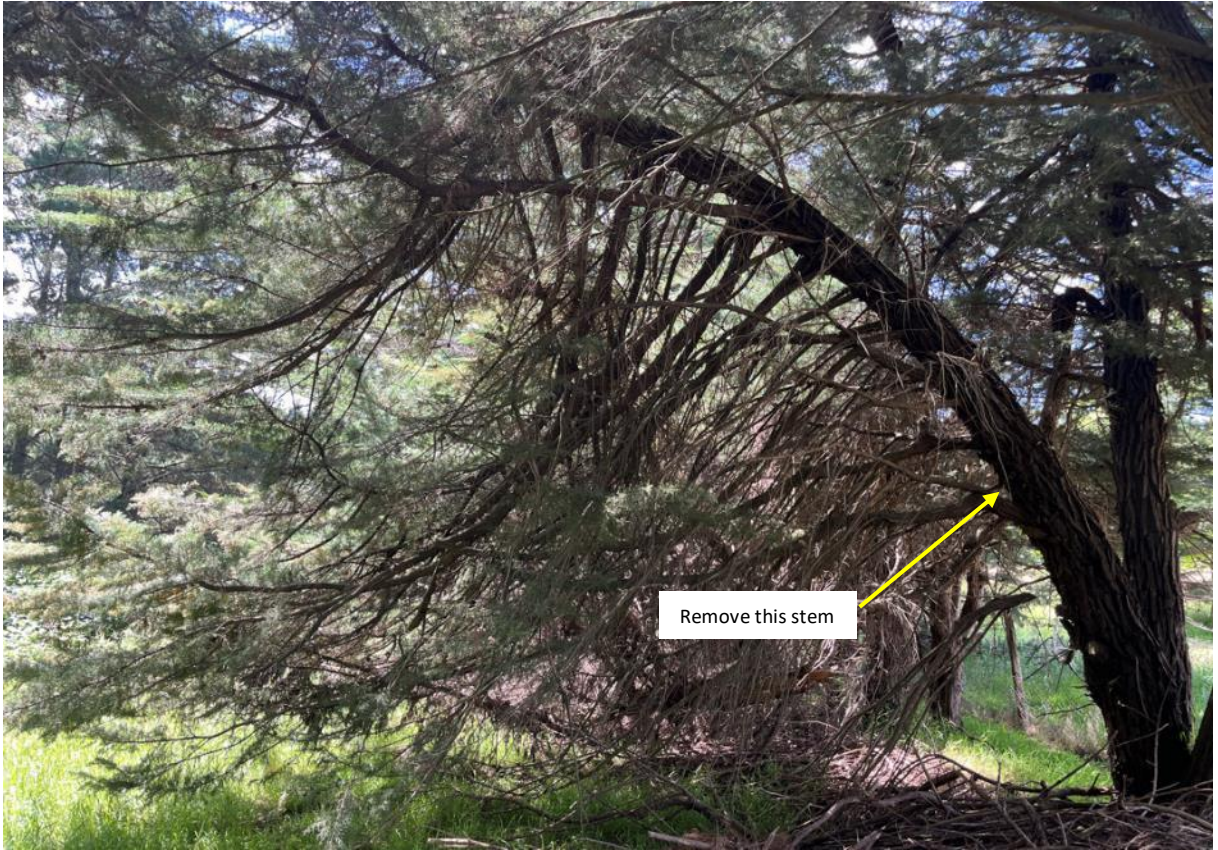
Figure 11: Viewing east toward Tree 12

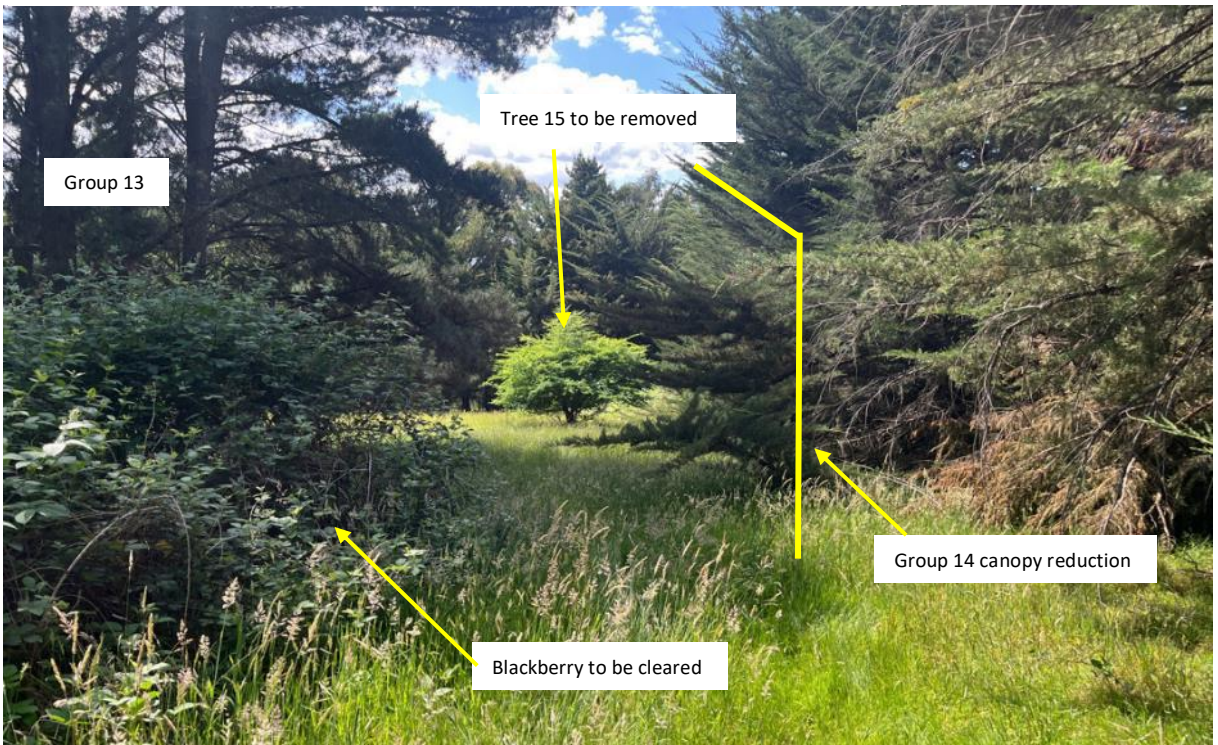
G14	<i>Hesperocyparis macrocarpa</i>	11	10	Major – fibre route	Lower branches to be pruned back to accommodate access track - very minor impact	- Directional boring within TPZ - Above grade track construction within TPZ - Uplift lower canopies to accommodate plant movement
15	<i>Crataegus monogyna</i>	4	5	Major – removal required	Positioned 14m from side boundary	- Low value weed species – removal required to accommodate access track

Figure 12: Viewing east toward Groups 13, 14 & Tree 15

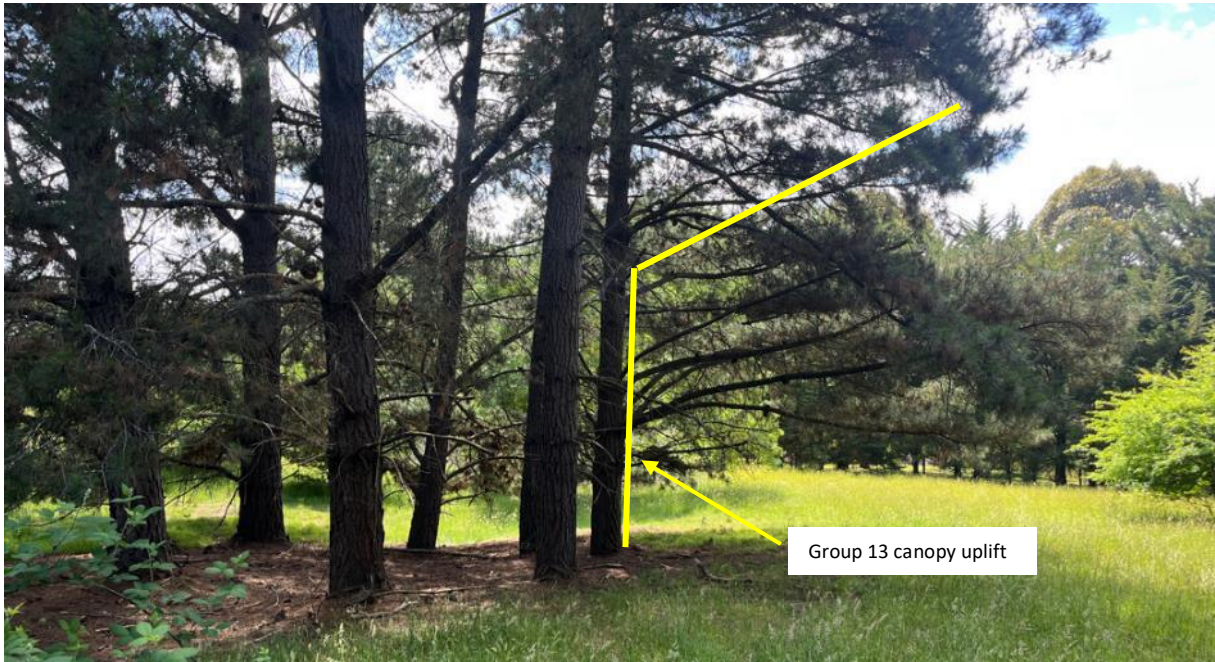
Figure 13: Viewing east toward Groups 13

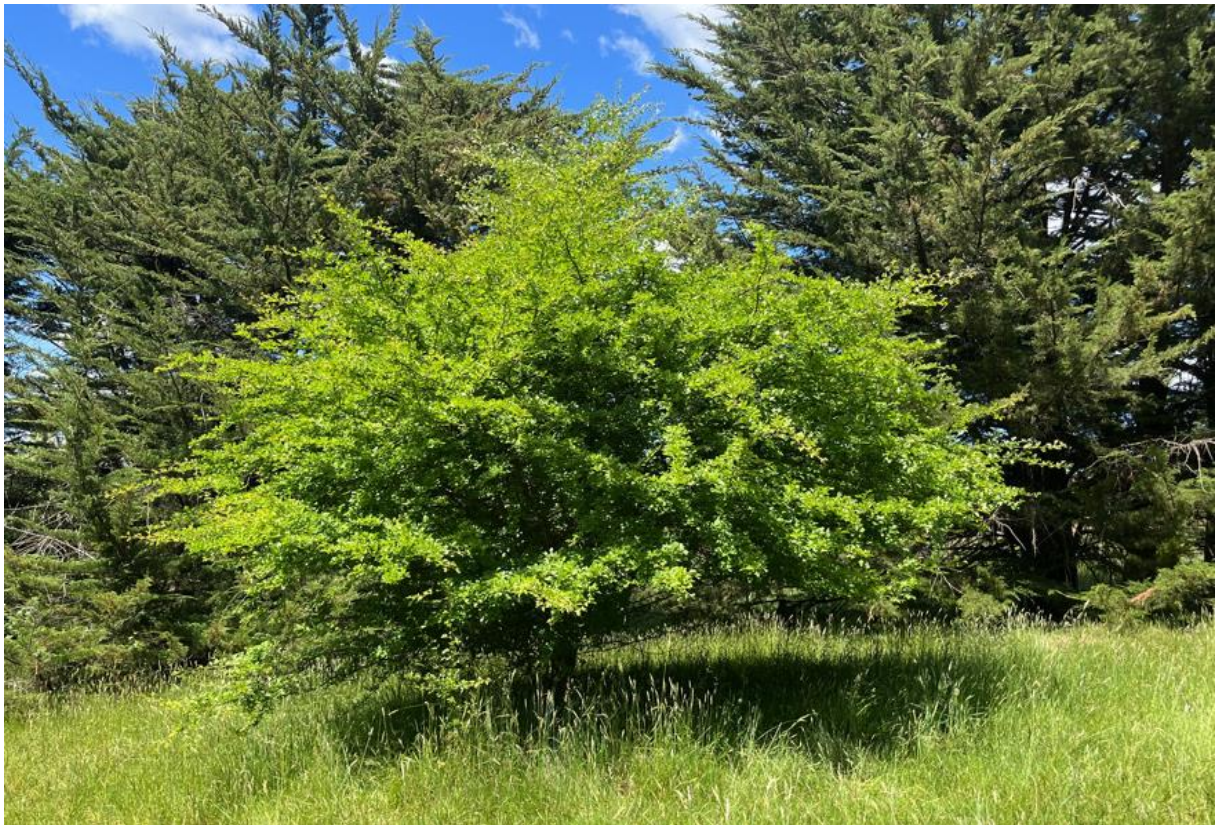
Figure 14: Viewing south toward Tree 15 - to be removed

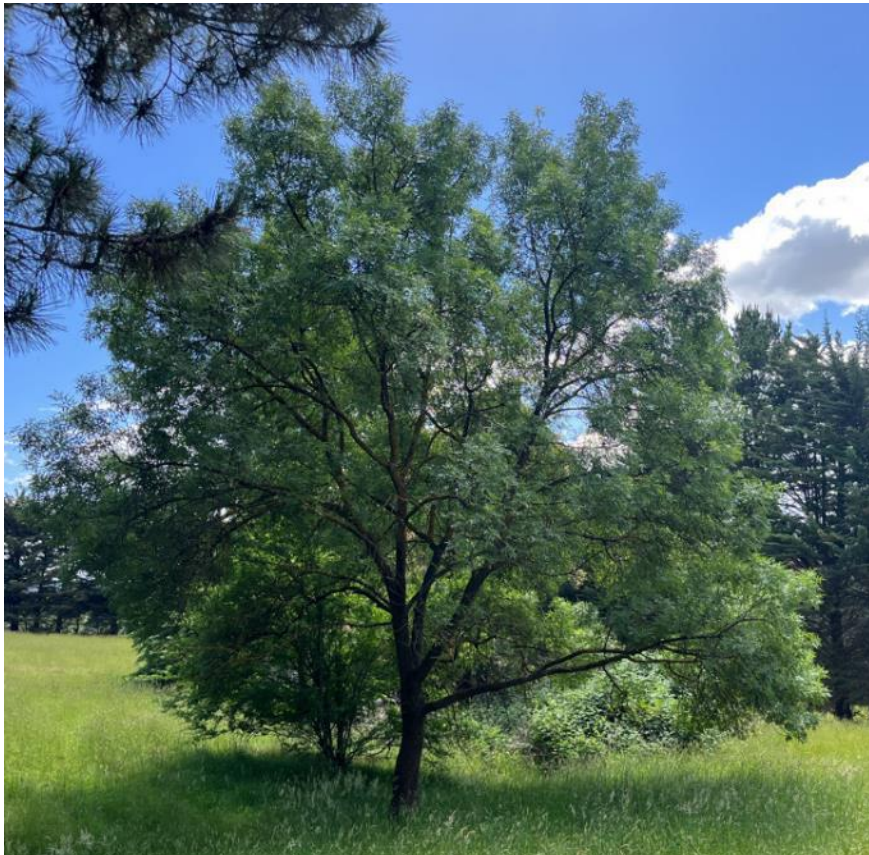
Tree	Taxon	Height (m)	Width (m)	Encroachment Major/Minor	Notes	Recommendations
16	<i>Fraxinus angustifolia</i> 'Raywood'	12	10	None	Positioned 15.5m from nearest compound corner	No action required
G17	<i>Hesperocyparis macrocarpa</i>	15	12	Minor		Canopy to be uplifted 3m for a 1m clearance from compound fence

Figure 15: Viewing north toward Tree 16

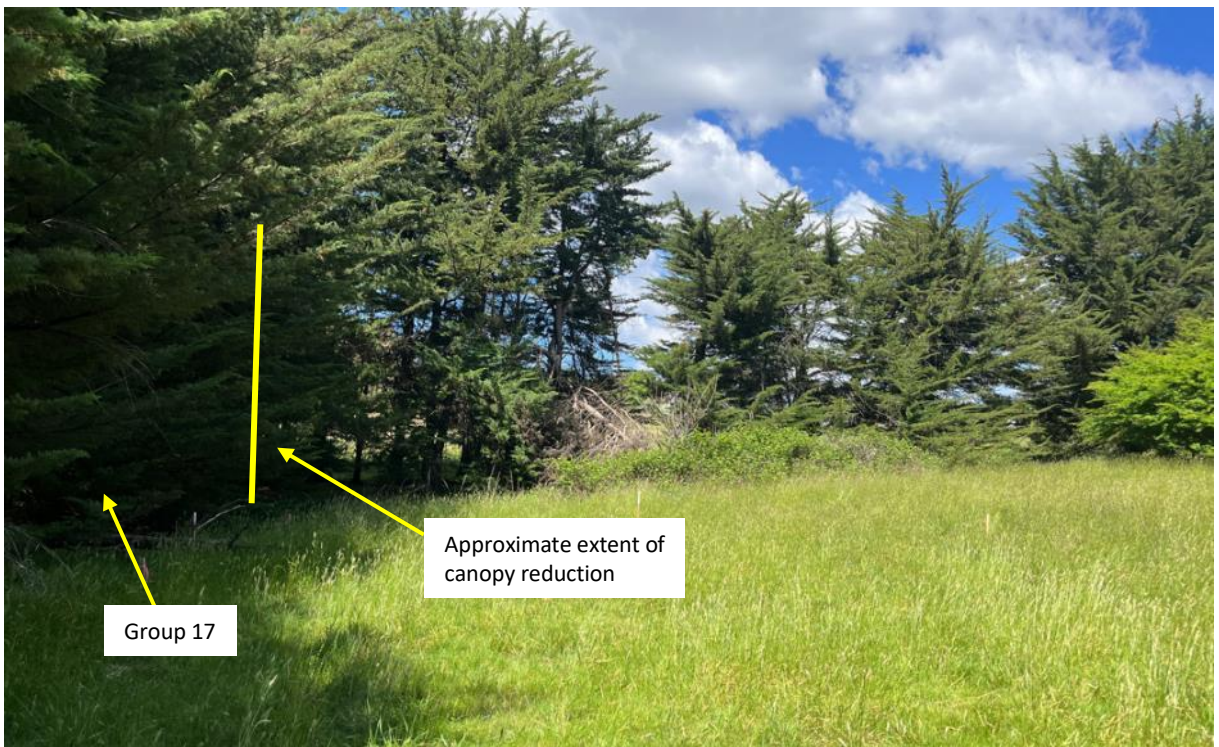
- The lease area and EWP locations do not encroach the TPZ of the adjacent Group 17 however, minor pruning of the lower canopy is required to accommodate the compound fencing.
- The removal of Groups 4, 7, 8 and Trees 15 will be required to accommodate the construction of the 4WD access track. Although Tree 8 is a medium value tree, its removal will be visually obscured in part, by Tree 11.
- Groups 4, 7 and Trees 15 are low value specimens which make an insignificant contribution to the site's landscape amenity.
- The 4WD access track makes a major/significant encroachment upon the TPZ of Trees 1, 2, 3, 5, 6, 10, 11, 12 and Group 14.
- The fibre route makes a major/significant encroachment upon the TPZ of Trees 3, 5, 6, 11, 12 and Group 14.
- The canopies of Trees 1, 2, 3, 6, 9, 11, 12 and Groups 13, 14 and 17.

Figure 16: Viewing south toward lease area and Group 17
