## Arboricultural Assessment and Report

375 Swansea Rd, Lilydale

Prepared for      Lilydale Development Pty.  
Ltd

29 August 2022

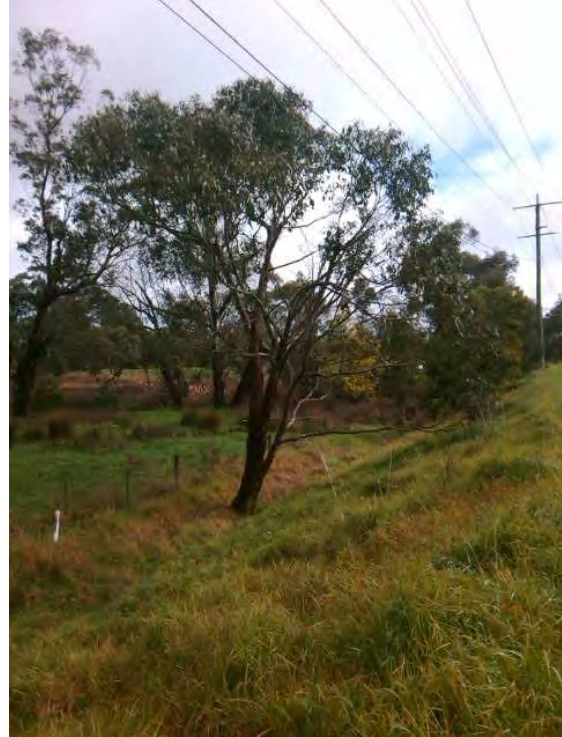
Tree id: 1. *Eucalyptus ovata* (Swamp Gum)  
 Semi-mature, Indigenous Arb rating. Mod.C  
 DBH: 26,24,22,18 (est.) cm TPZ: 5.4 m rad. Comments:  
 Included bark forks, multi-stemmed, past powerline  
 clearance.  
 Impact: None. TPZ encroachment 0.0%

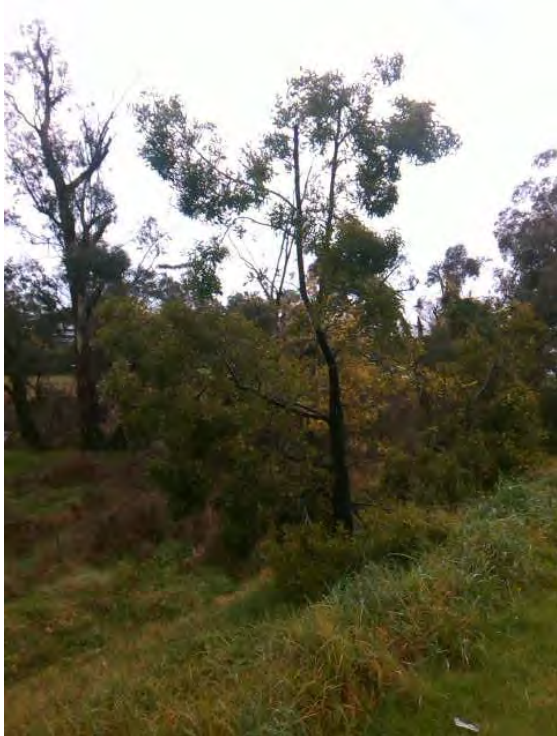
Tree id: 3. *Eucalyptus ovata* (Swamp Gum)  
 Early-mature, Indigenous Arb rating. Mod.B  
 DBH: 38,16 cm TPZ: 4.9 m rad. Comments: Acute forks,  
 past powerline clearance. Pruned for wire clearance

Impact: TPZ. TPZ encroachment 10.4%

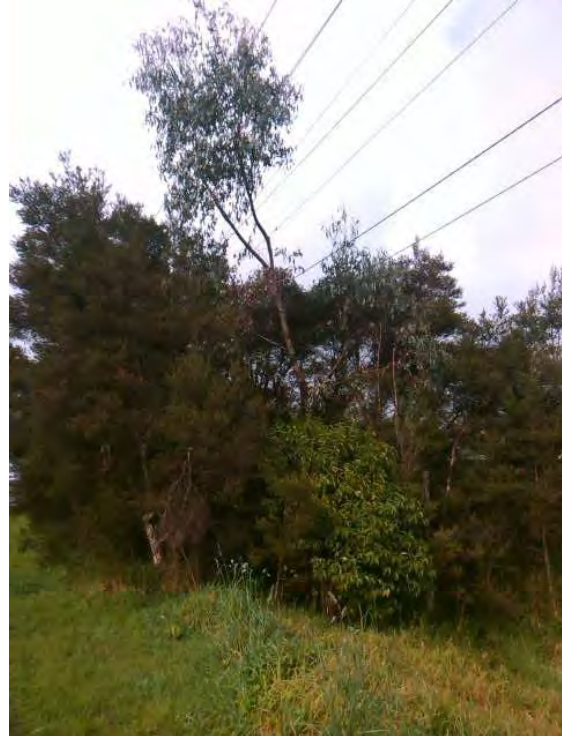
Tree id: 2. *Acacia melanoxylon* (Blackwood)  
 Early-mature, Indigenous Arb rating. Mod.C  
 DBH: 16 cm TPZ: 2 m rad. Comments: Past powerline  
 clearance. X2 trees.  
 Impact: None. TPZ encroachment 0.0%

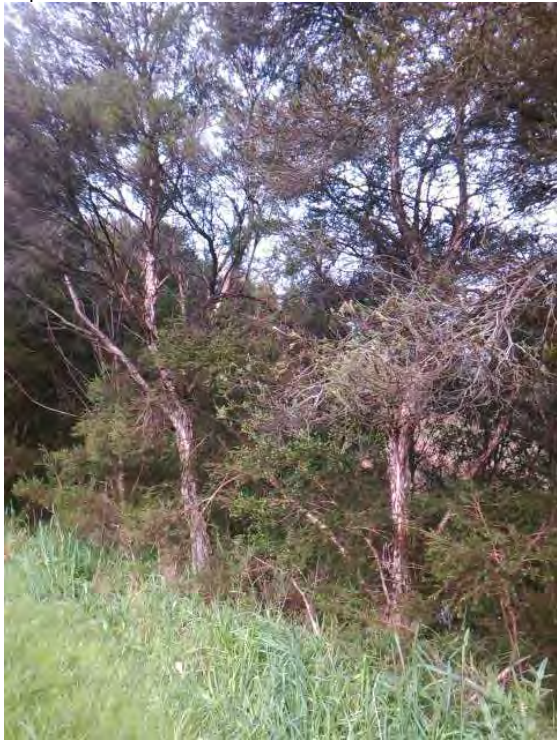
Tree id: 4. *Eucalyptus ovata* (Swamp Gum)  
 Semi-mature, Indigenous Arb rating. Mod.C  
 DBH: 20 (est.) cm TPZ: 2.4 m rad. Comments: Past  
 powerline clearance, street tree, weed infested.  
 Impact: None. TPZ encroachment 0.0%

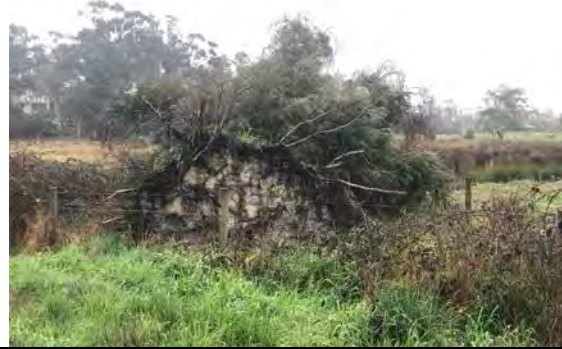
Tree id: 5. *Melaleuca ericifolia* (Swamp Paperbark)  
 Maturing, Indigenous Arb rating. Low  
 DBH: 18 cm) TPZ: 2.2 m rad. Comments: Suckering.  
 Impact: None. TPZ encroachment 0.0%

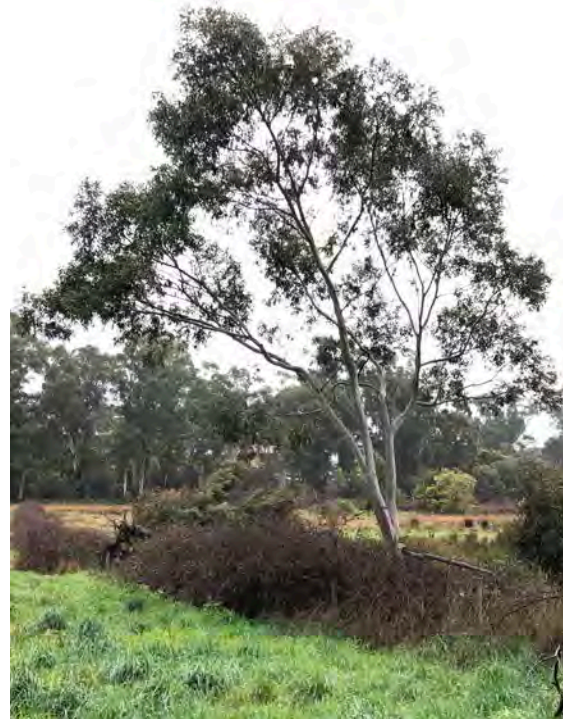
Tree id: 7. *Eucalyptus mannifera* (Brittle Gum)  
 Maturing, Australian native Arb rating. Very Low  
 DBH: 40 cm) TPZ: 4.8 m rad. Comments: Collapsed, stump  
 re-sprout.  
 Impact: Within. TPZ encroachment 100.0%

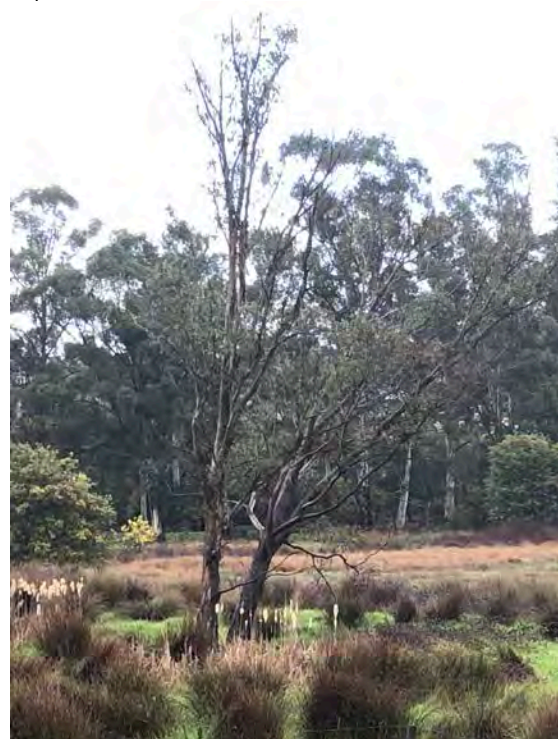
Tree id: 9. *Eucalyptus mannifera* (Brittle Gum)  
 Maturing, Australian native Arb rating. Very Low  
 DBH: 30 cm) TPZ: 3.6 m rad. Comments: Collapsed, stump  
 re-sprout.  
 Impact: Within. TPZ encroachment 100.0%

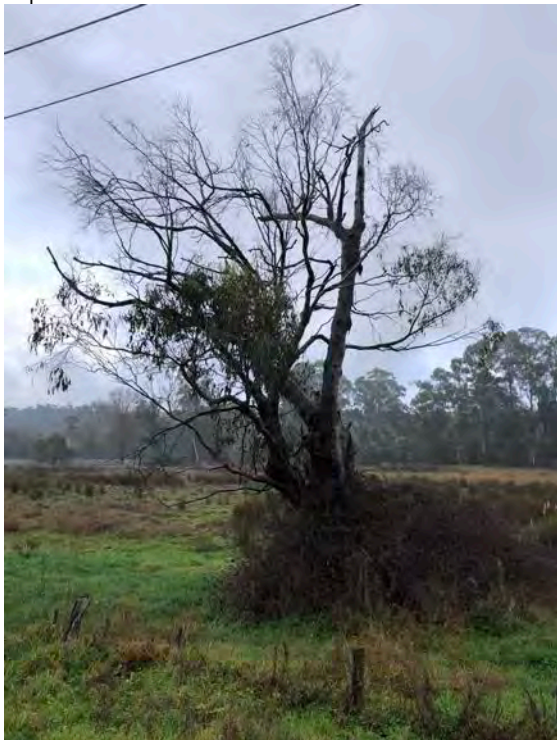
Tree id: 11. *Eucalyptus ovata* (Swamp Gum)  
 Maturing, Indigenous Arb rating. Mod.B  
 DBH: 46 cm) TPZ: 5.5 m rad. Comments: Partly suppressed  
 - crown bias nw, On lean, included union at ~3m.  
 Impact: Within. TPZ encroachment 100.0%

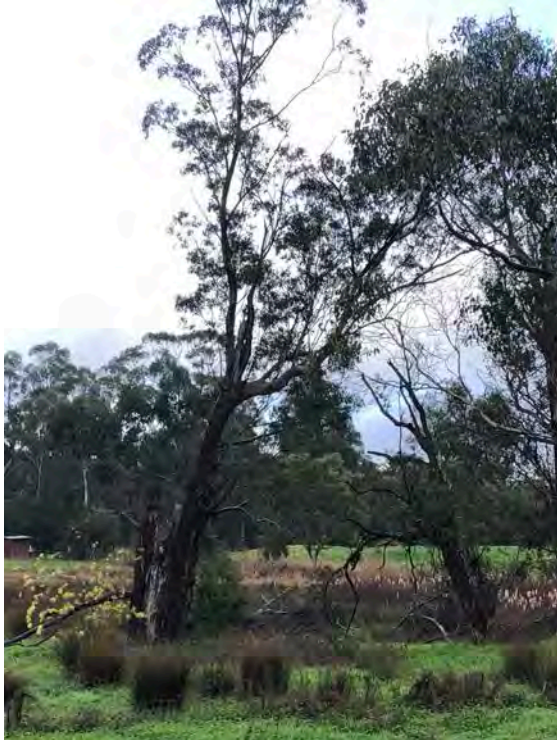
Tree id: 12. *Eucalyptus ovata* (Swamp Gum)  
 Maturing, Indigenous Arb rating. Mod.C  
 DBH: 46 cm) TPZ: 5.5 m rad. Comments: Minor dieback.  
 Suppressed, bifurcated with included unions.  
 Impact: Within. TPZ encroachment 100.0%

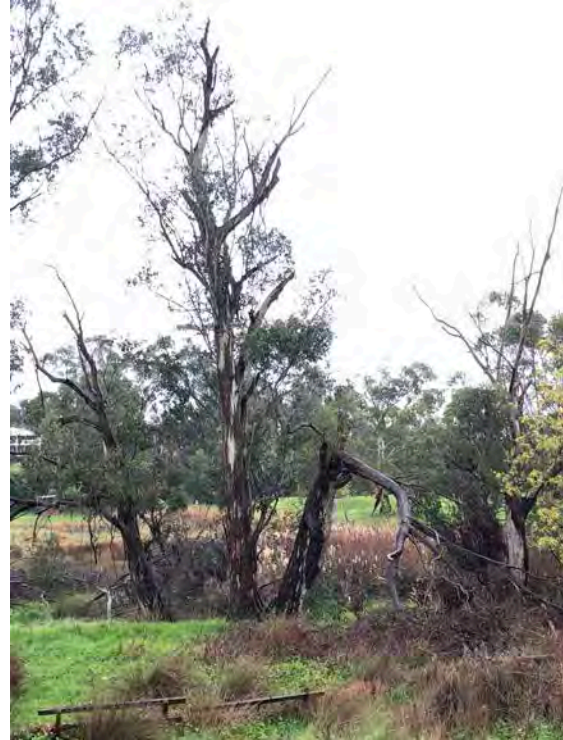
Tree id: 13. *Eucalyptus ovata* (Swamp Gum)  
 Over-mature, Indigenous Arb rating. Low  
 DBH: 163 cm TPZ: 15 m rad. Comments: Cavity, over-extended limbs, past stem failure, trunk decay. Dieback, bifurcated at 1.6m, previous failures.  
 Impact: Within. TPZ encroachment 100.0%

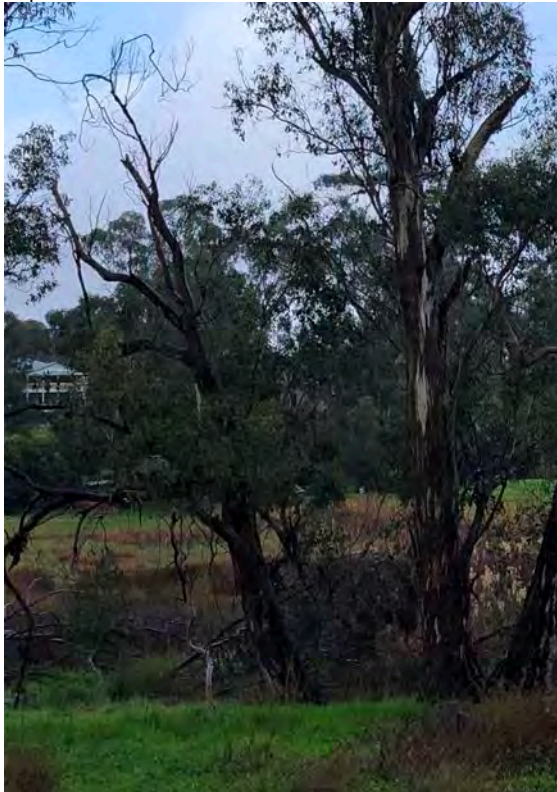
Tree id: 15. *Eucalyptus ovata* (Swamp Gum)  
 Over-mature, Indigenous Arb rating. Low  
 DBH: 90,94 (est.) cm TPZ: 15 m rad. Comments: Decay, main leader dead, past limb failure, past stem failure. Large stem tear, fungal fruiting bodies, in decline, habitat hollows.  
 Impact: Within. TPZ encroachment 100.0%

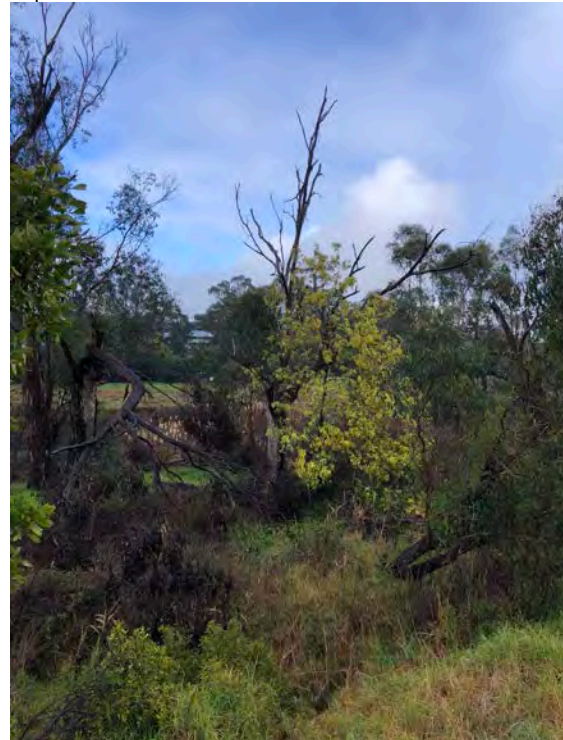
Tree id: 14. *Eucalyptus ovata* (Swamp Gum)  
 Over-mature, Indigenous Arb rating. Low  
 DBH: 72 cm TPZ: 8.6 m rad. Comments: Decay, declining, main leader dead. Almost dead, hollows in trunk.  
 Impact: Within. TPZ encroachment 98.3%

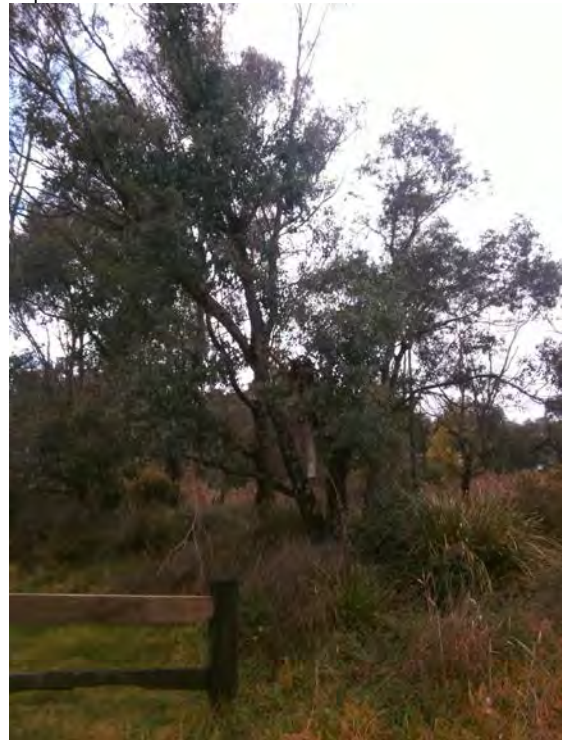
Tree id: 48. *Eucalyptus ovata* (Swamp Gum)  
 Early-mature, Indigenous Arb rating. Mod.B  
 DBH: 34 (est.) cm) TPZ: 4.1 m rad. Comments: Acute forks.  
 Bifurcated at 1.5m  
 Impact: TPZ. TPZ encroachment 2.0%

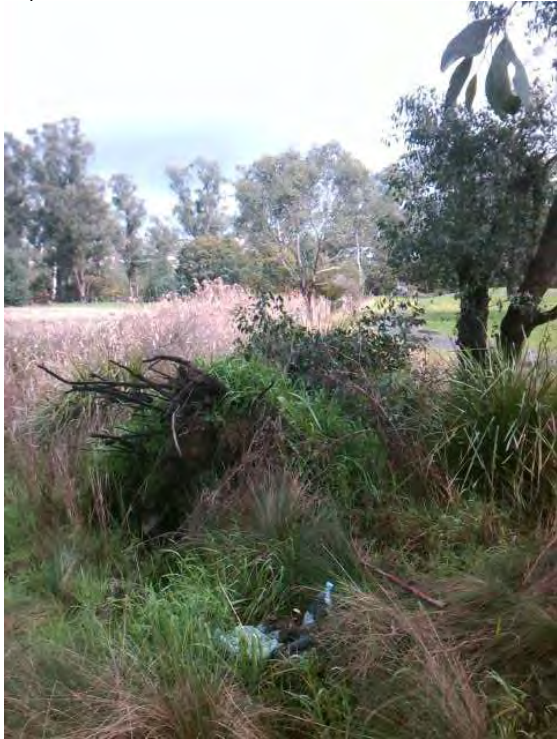
Tree id: 50. *Eucalyptus yarraensis* (Yarra Gum)  
 Semi-mature, Indigenous Arb rating. Mod.C  
 DBH: 26,23 cm) TPZ: 4.2 m rad. Comments: Hangers, minor  
 dieback, past stem failure.  
 Impact: None. TPZ encroachment 0.0%

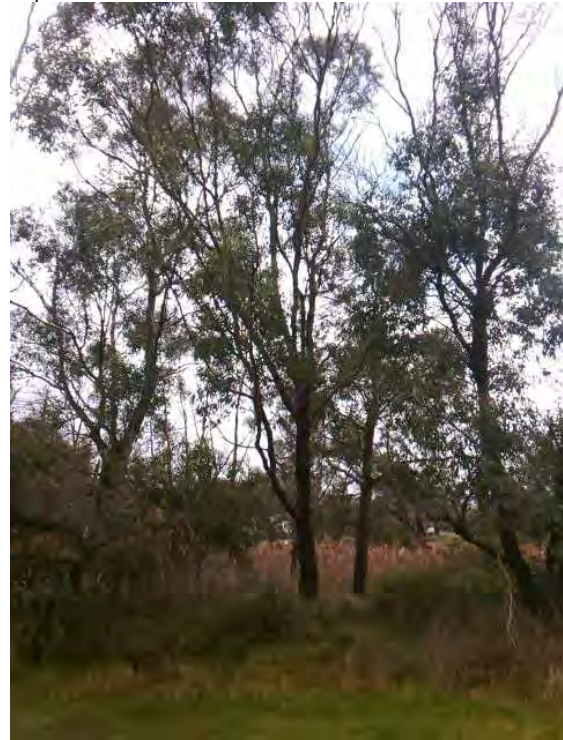
Tree id: 51. *Eucalyptus yarraensis* (Yarra Gum)  
 Early-mature, Indigenous Arb rating. Mod.B  
 DBH: 37 cm) TPZ: 1 m rad. Comments: Collapsed, stump re-sprout.  
 Impact: None. TPZ encroachment 0.0%

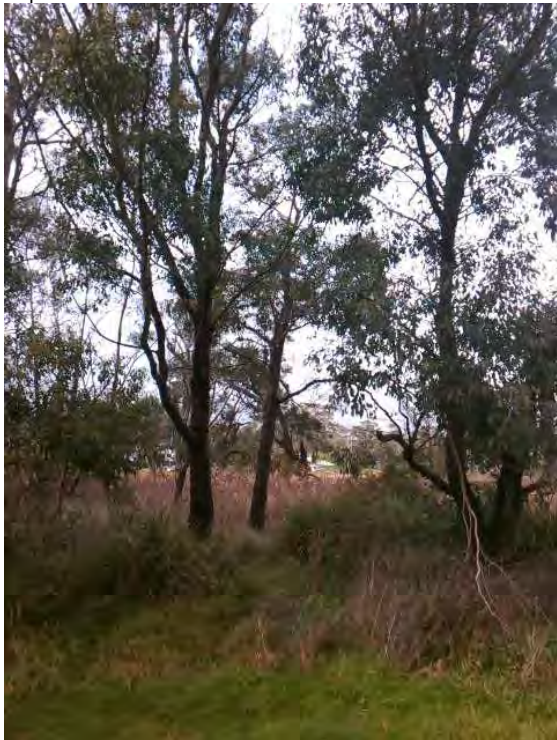
Tree id: 53. *Eucalyptus yarraensis* (Yarra Gum)  
 Early-mature, Indigenous Arb rating. Mod.B  
 DBH: 30 cm) TPZ: 3.6 m rad. Comments:  
 Impact: None. TPZ encroachment 0.0%

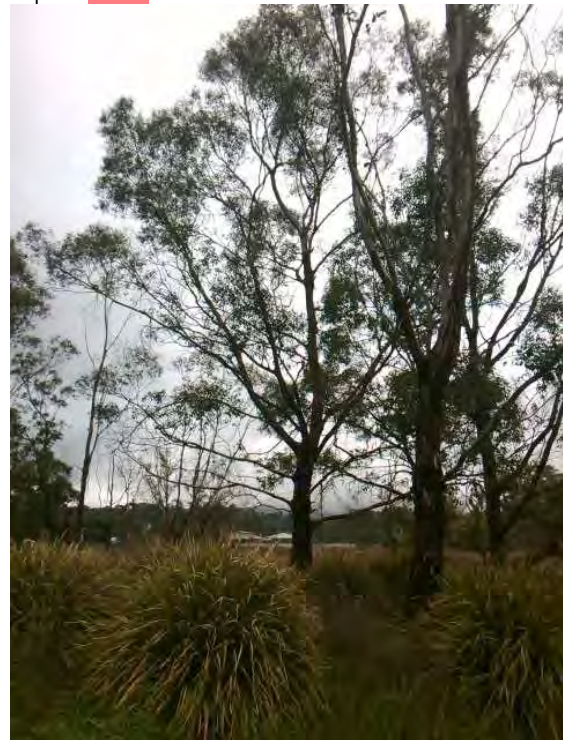
Tree id: 52. *Eucalyptus yarraensis* (Yarra Gum)  
 Early-mature, Indigenous Arb rating. Mod.B  
 DBH: 24 cm) TPZ: 2.9 m rad. Comments: Partly suppressed  
 - crown bias sth.  
 Impact: None. TPZ encroachment 0.0%

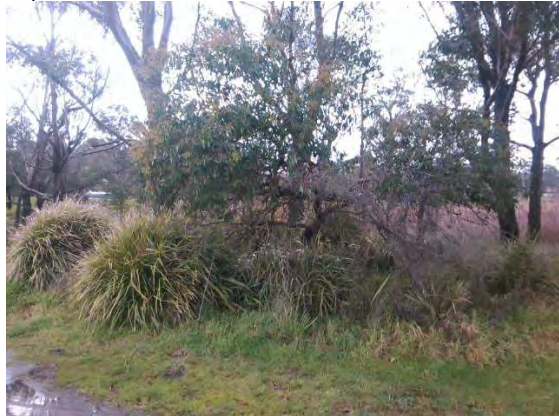
Tree id: 54. *Eucalyptus yarraensis* (Yarra Gum)  
 Early-mature, Indigenous Arb rating. Mod.B  
 DBH: 36 cm) TPZ: 4.3 m rad. Comments:  
 Impact: **Within**. TPZ encroachment 57.3%

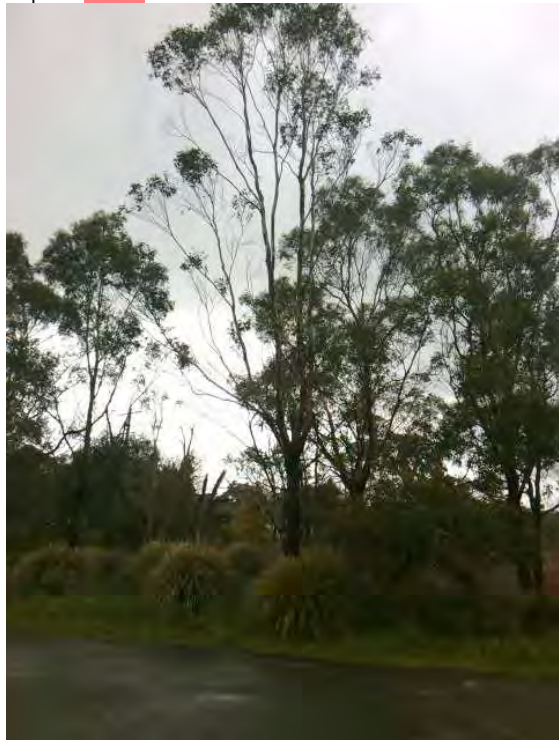
Tree id: 55. *Eucalyptus yarraensis* (Yarra Gum)  
 Early-mature, Indigenous Arb rating. Mod.C  
 DBH: 18 cm) TPZ: 2.2 m rad. Comments: Partly suppressed  
 - crown bias. Heavy trunk lean-NW shaded.  
 Impact: TPZ. TPZ encroachment 6.4%

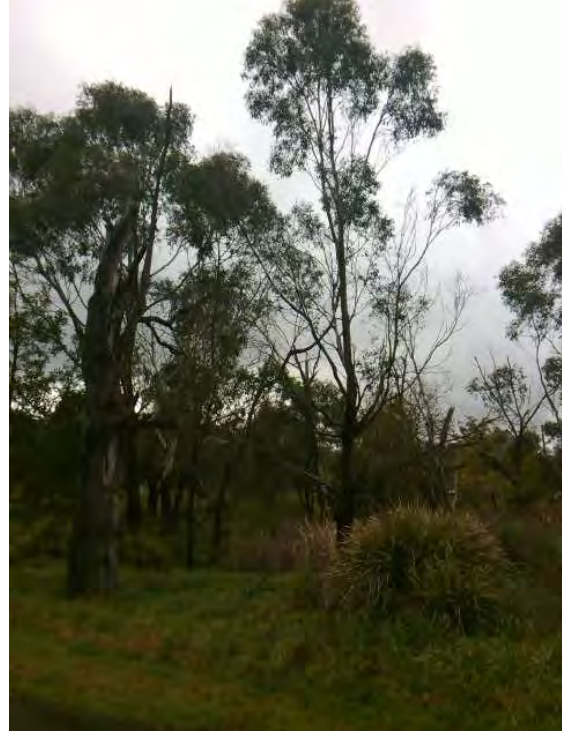
Tree id: 56. *Eucalyptus ovata* (Swamp Gum)  
 Early-mature, Indigenous Arb rating. Mod.B  
 DBH: 35 cm) TPZ: 4.2 m rad. Comments: Reduced foliage  
 density.  
 Impact: **Within**. TPZ encroachment 100.0%

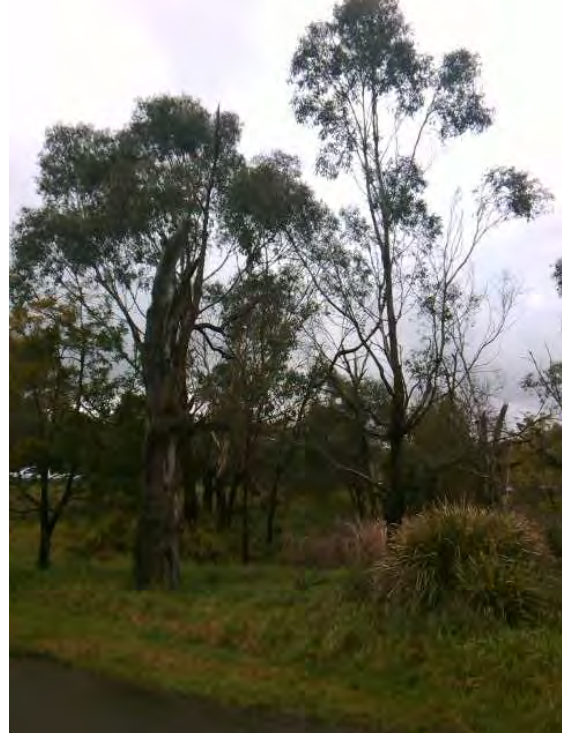
Tree id: 57. *Eucalyptus yarraensis* (Yarra Gum) TREE GONE  
 Semi-mature, Indigenous Arb rating. NA  
 DBH: 0 cm) TPZ: 0 m rad. Comments: Tree Gone.  
 Impact: Within. TPZ encroachment - NA - Tree gone

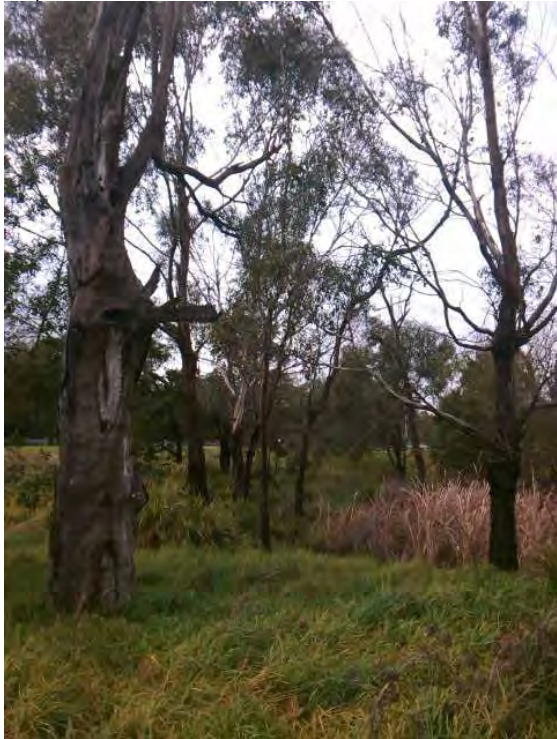
Tree id: 58. *Eucalyptus ovata* (Swamp Gum)  
 Early-mature, Indigenous Arb rating. Mod.B  
 DBH: 30 cm) TPZ: 3.6 m rad. Comments: Acute forks.  
 Impact: None. TPZ encroachment 0.0%

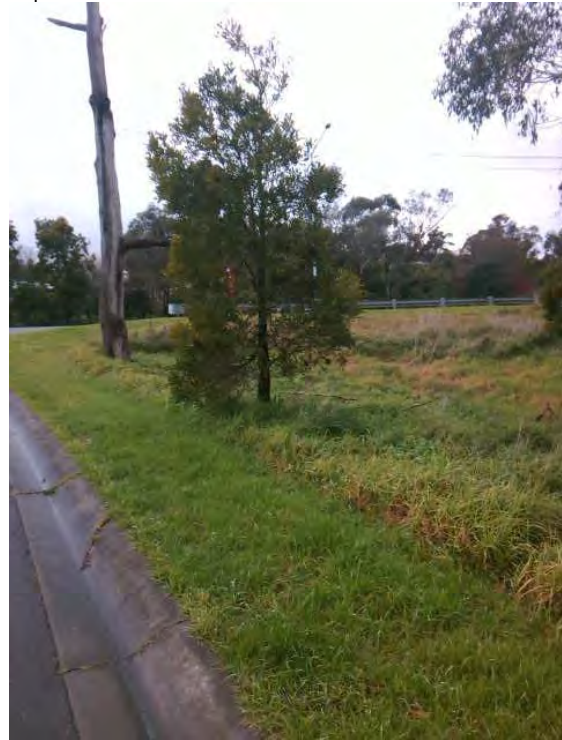
Tree id: 59. *Eucalyptus ovata* (Swamp Gum)  
 Semi-mature, Indigenous Arb rating. Low  
 DBH: 15 cm) TPZ: 2 m rad. Comments: Reduced foliage  
 density, 2 x trees  
 Impact: None. TPZ encroachment 0.0%

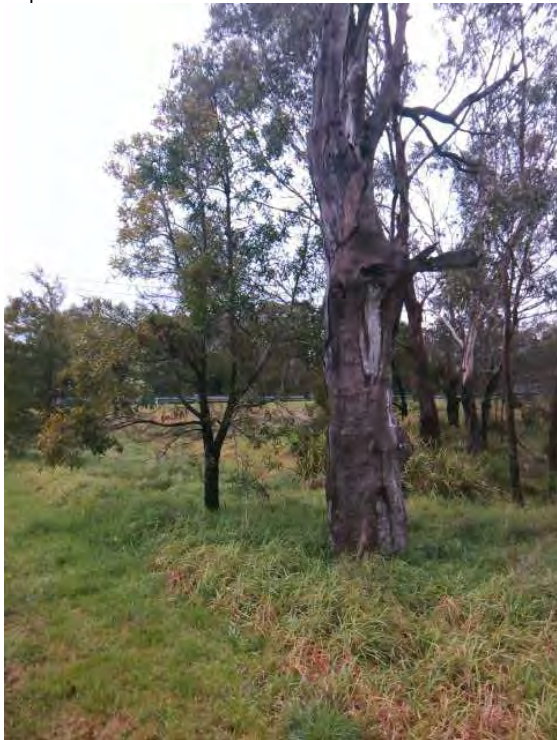
Tree id: 61. *Acacia melanoxylon* (Blackwood)  
 Semi-mature, Indigenous Arb rating. Low  
 DBH: 9 cm) TPZ: 2 m rad. Comments:  
 Impact: None. TPZ encroachment 0.0%

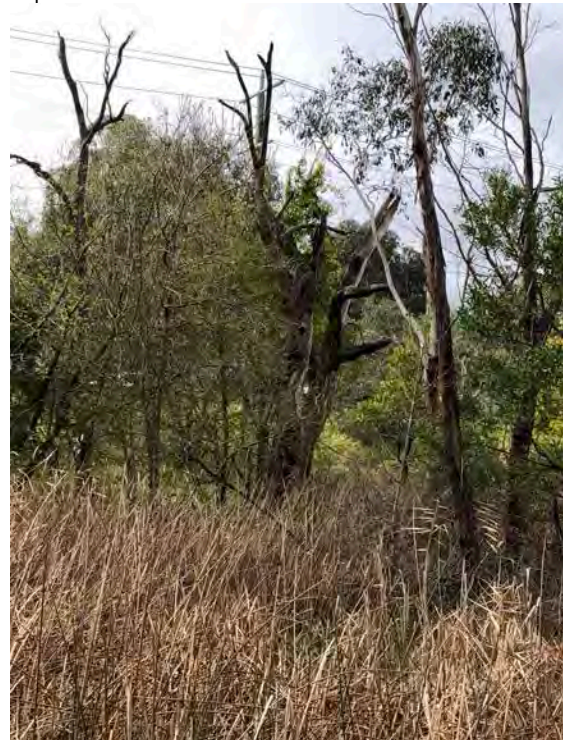
Tree id: 60. *Acacia melanoxylon* (Blackwood)  
 Semi-mature, Indigenous Arb rating. Mod.C  
 DBH: 15 cm) TPZ: 2 m rad. Comments: -  
 Impact: None. TPZ encroachment 0.0%

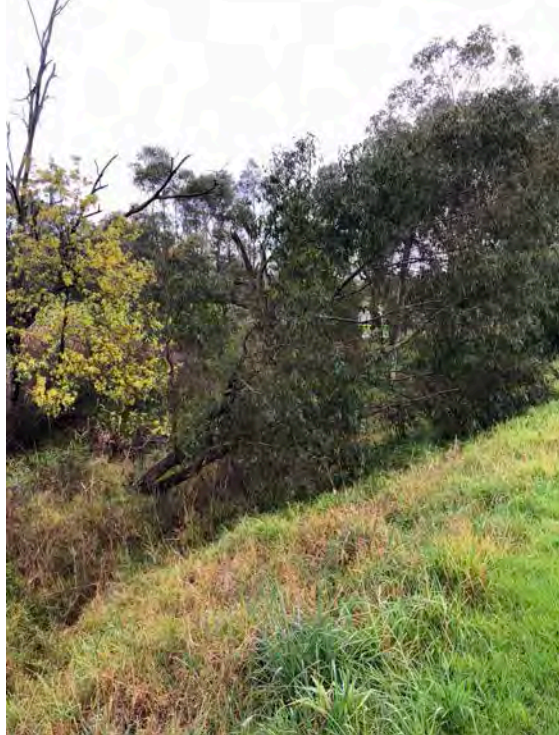
Tree id: 71. *Eucalyptus ovata* (Swamp Gum)  
 Over-mature, Indigenous Arb rating. Very Low  
 DBH: 110 (est.) cm) TPZ: 4 m rad. Comments: Habitat  
 hollows. Crown reduce  
 Impact: SRZ. TPZ encroachment 1.3%

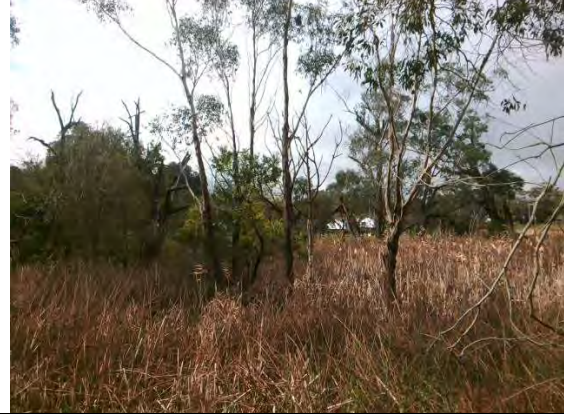
Tree id: 72. *Eucalyptus ovata* (Swamp Gum)  
 Early-mature, Indigenous Arb rating. Low  
 DBH: 28,22 (est.) cm TPZ: 4.3 m rad. Comments: Co-  
 dominant stems, collapsed to East.  
 Impact: SRZ. TPZ encroachment 24.6%

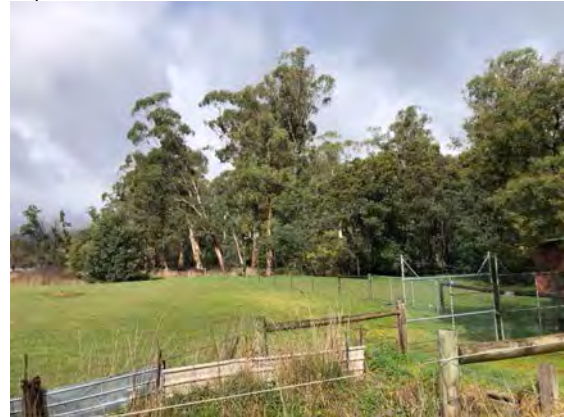
Tree id: G1. *Eucalyptus ovata* (Swamp Gum)  
 Semi-mature, Indigenous Arb rating. Mod.C  
 DBH: 20 cm TPZ: 2.4 m rad. Comments: Group of 5 semi-  
 mature Swamp Gums in swamp  
 Impact: None. TPZ encroachment 0.0%

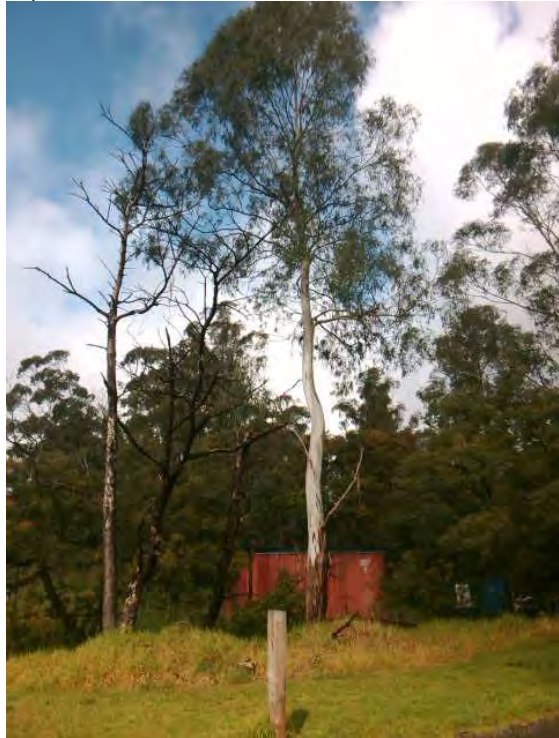
Tree id: G2. *Eucalyptus viminalis*; *Eucalyptus ovata* (Manna  
 Gum; Swamp Gum)  
 Maturing, Indigenous Arb rating. Mod.B  
 DBH: 75 cm TPZ: 9 m rad. Comments:  
 Impact: None. TPZ encroachment 0.0%
