## TREE INSPECTION REPORT

<b>Report number:</b> 1037736	<b>Site address of tree:</b> 14 Milners Road, Yarra Junction	
<b>Date of inspection:</b> 30/03/2022	<b>Melway:</b> 288 F11	
<b>Name:</b> [REDACTED]	<b>Address:</b> 14 Milners Road, Yarra Junction	<b>Phone:</b> [REDACTED]
<b>Recommended action:</b> Trees 1-4, no works		
<b>Reasons for recommended action:</b> All 4 trees are Silver-leaved Stringybarks. They have grown in a cluster with irregular form as is typical of the species. In an effort to grow towards the light, some of the trunks are leaning; however, none appear unstable. Tree 1 has a strong lean over the driveway; however, is well sheltered and failure is unlikely. Tree 2 has been pruned and has a full canopy, none of the branches appear likely to fail. Tree 3 leans over the private property boundary a couple of metres but does not overshadow the house. Tree 4 is large and has had several large failures. None of the branches at this stage appear likely to fail. Spoke briefly with resident, she would like them all removed.

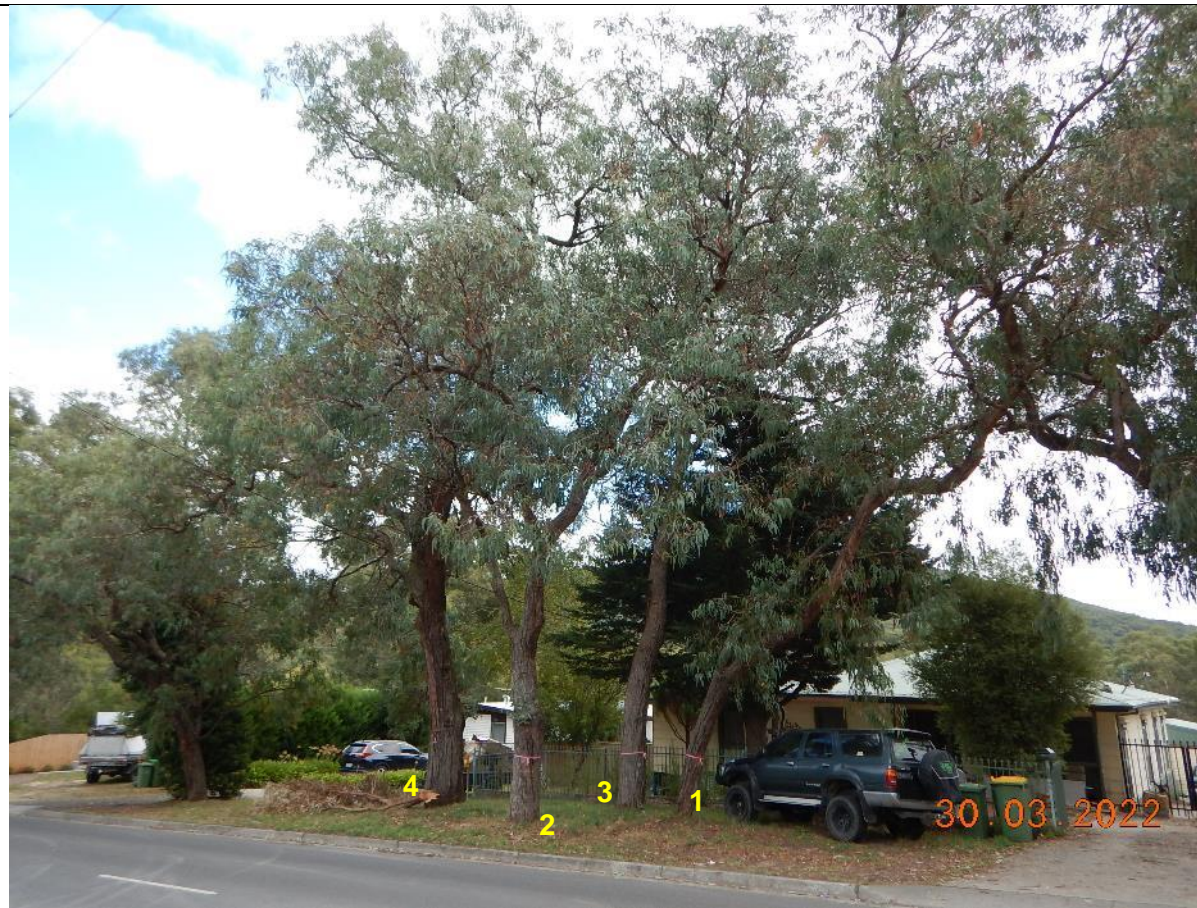
Photo 1

Trees 1-4

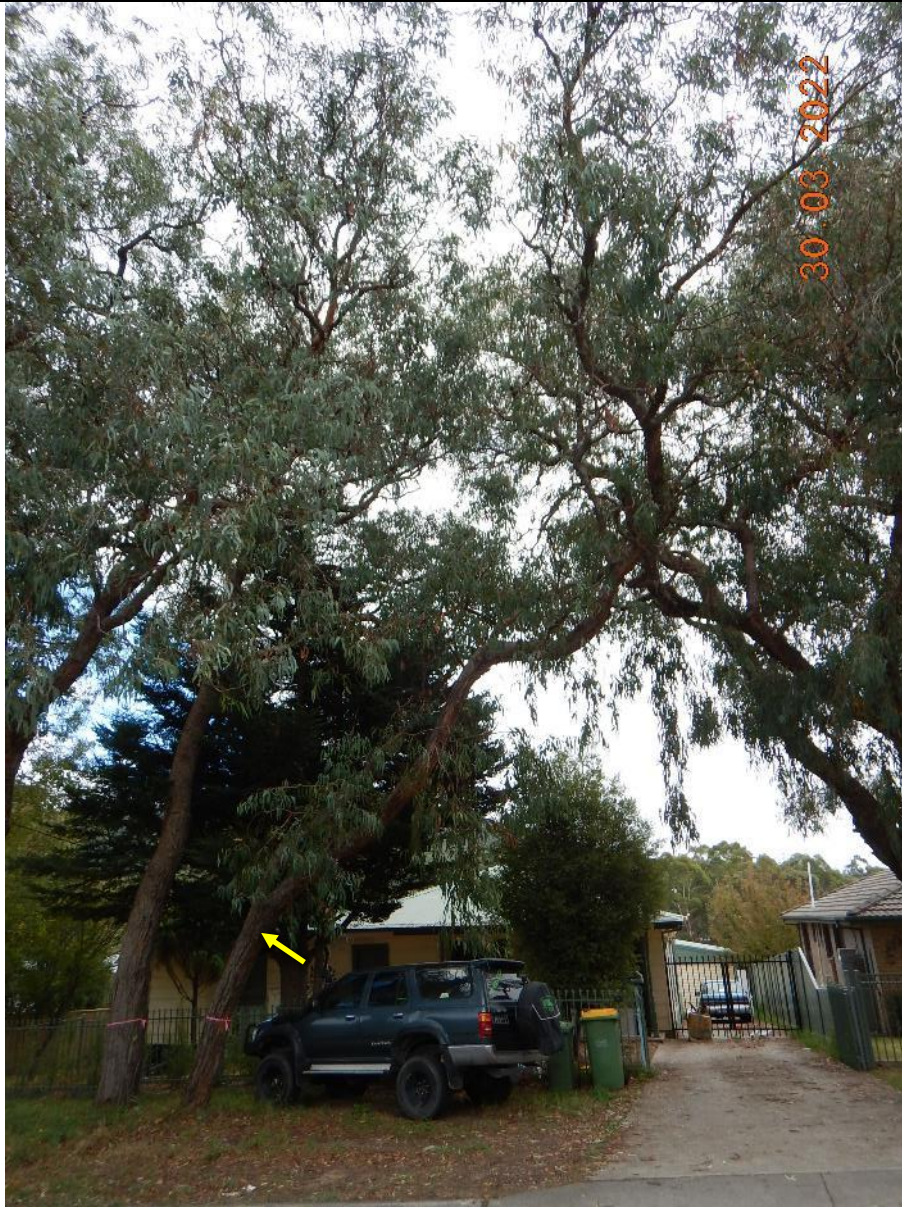
Photo 2

Tree 1

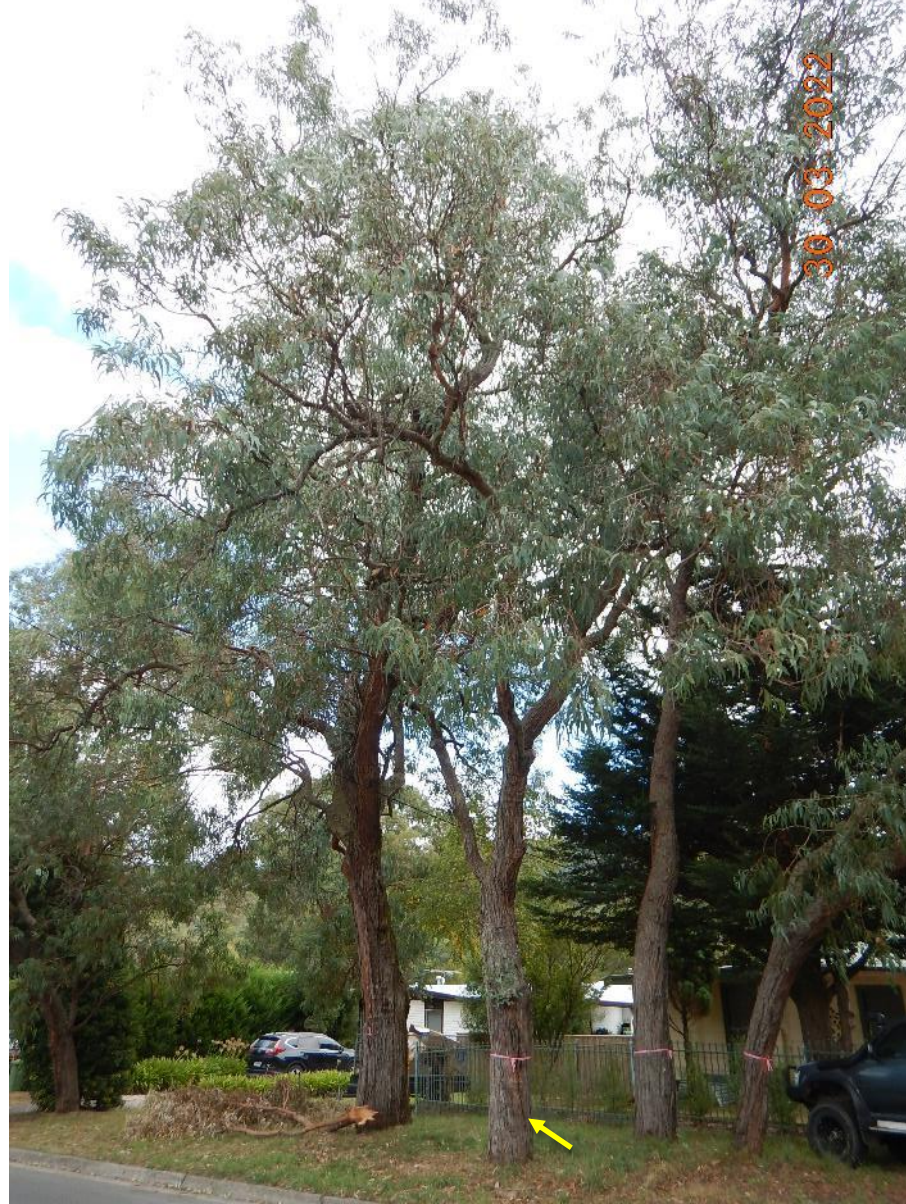
Photo 3

Tree 2

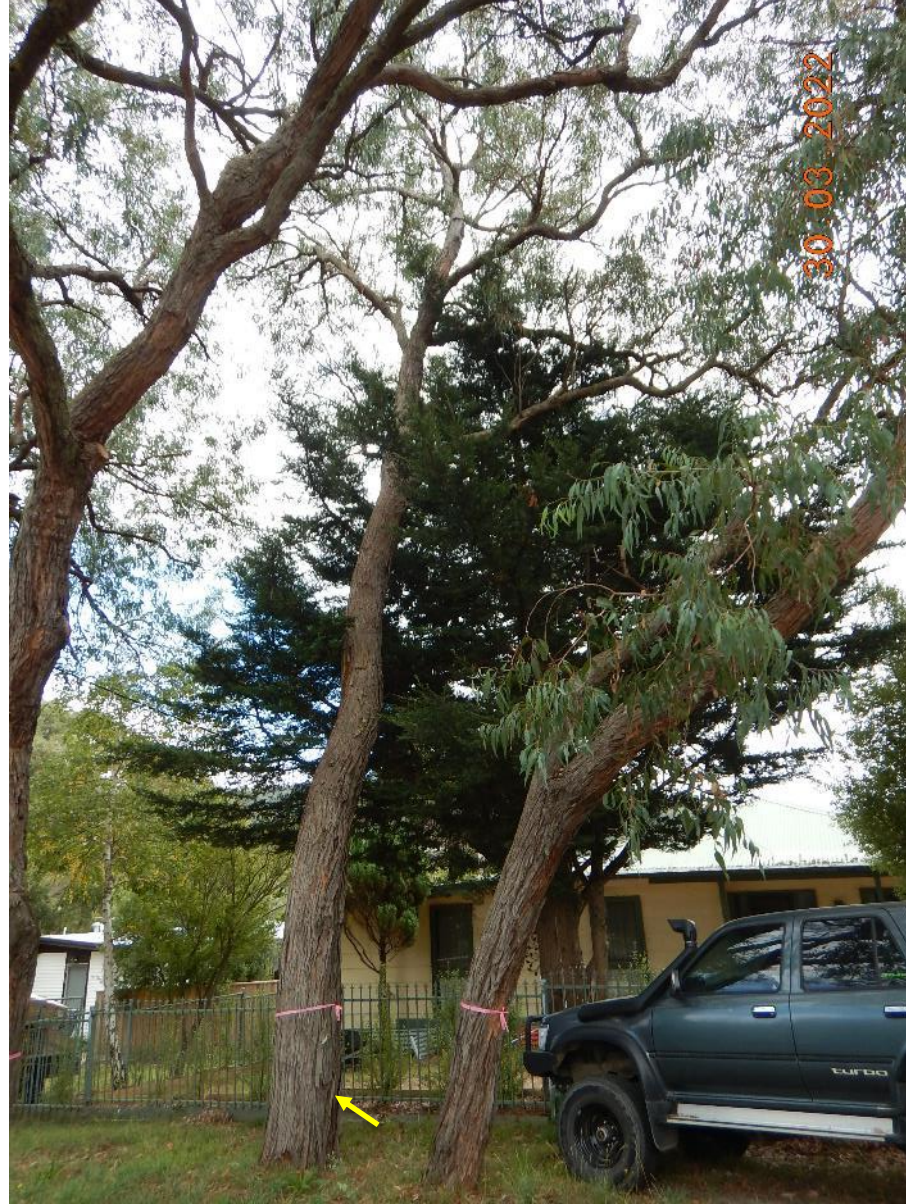
Photo 4

Tree 3

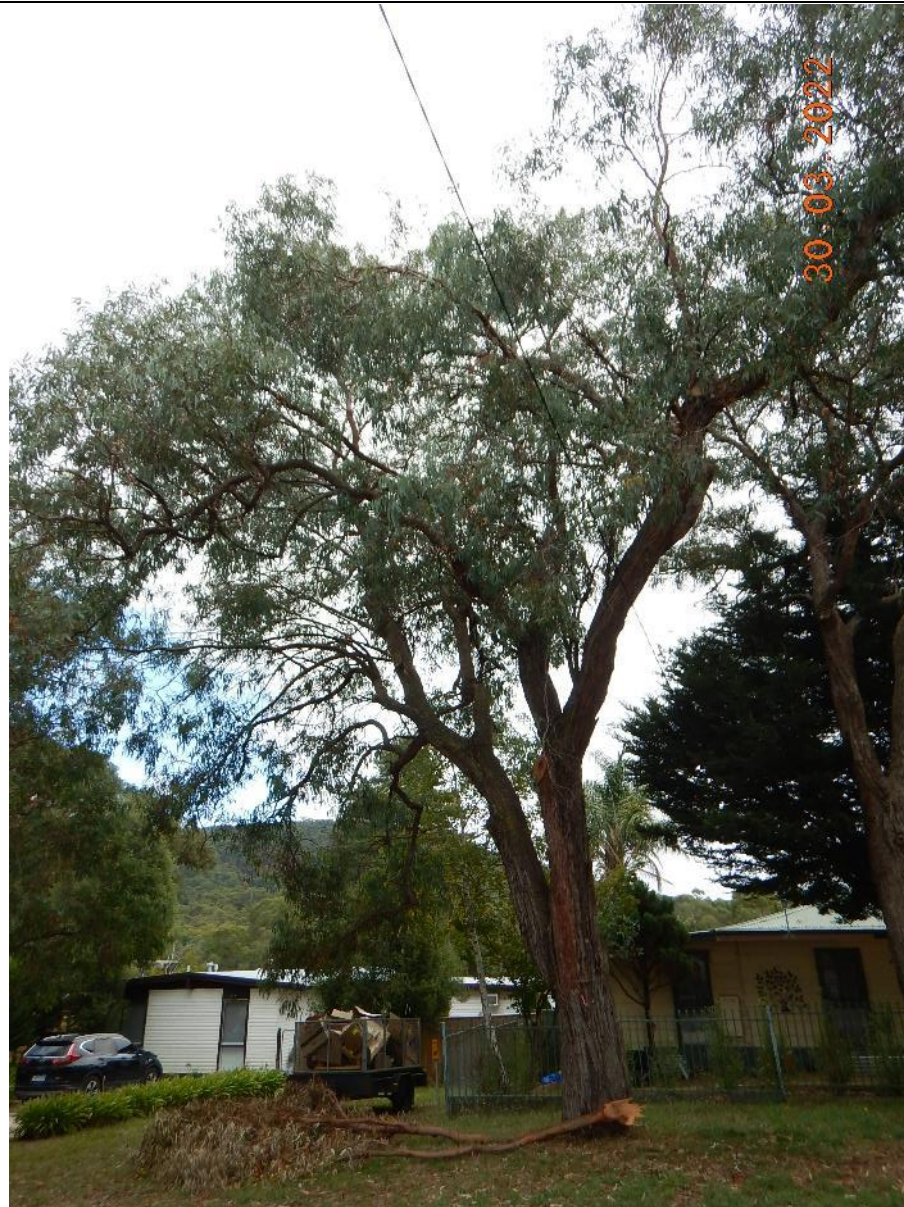
Photo 5

Tree 4 with recent failure evident.
