## TREE INSPECTION REPORT

<b>Report number:</b> 91869	<b>Site address of tree:</b> 88-90 Birmingham Road, Mount Evelyn at rear of property in reserve	
<b>Date of inspection:</b> 16/03/2024	<b>Melway:</b> 38 K12	
<b>Name:</b> [REDACTED]	<b>Address:</b> 88-90 Birmingham Road, Mount Evelyn	<b>Phone:</b> [REDACTED]
<b>Recommended action:</b> Clean up failed branches		
<b>Reasons for recommended action:</b> <p>Only 3 trees are at the rear of the property, all 3 trees are Monterey Pine.</p> <p>Tree 1 is tall and straight and vertical. There is an old wound at the base; however, decay appears minimal. Deadwood exists high up but there are virtually no targets beneath the canopy and pines hold onto deadwood. There have been few failures of note.</p> <p>Tree 2 is a mature tree with a minor lean to the north. There is a basal wound; however, there was no sign of significant decay or root plate instability. This tree has lost several limbs over the years, the reasons are uncertain. Several limbs broke when one from high up failed. No broken or split branches were observed.</p> <p>Tree 3 is mature and has a straight, sound trunk. Branches are generally well attached and there have been relati

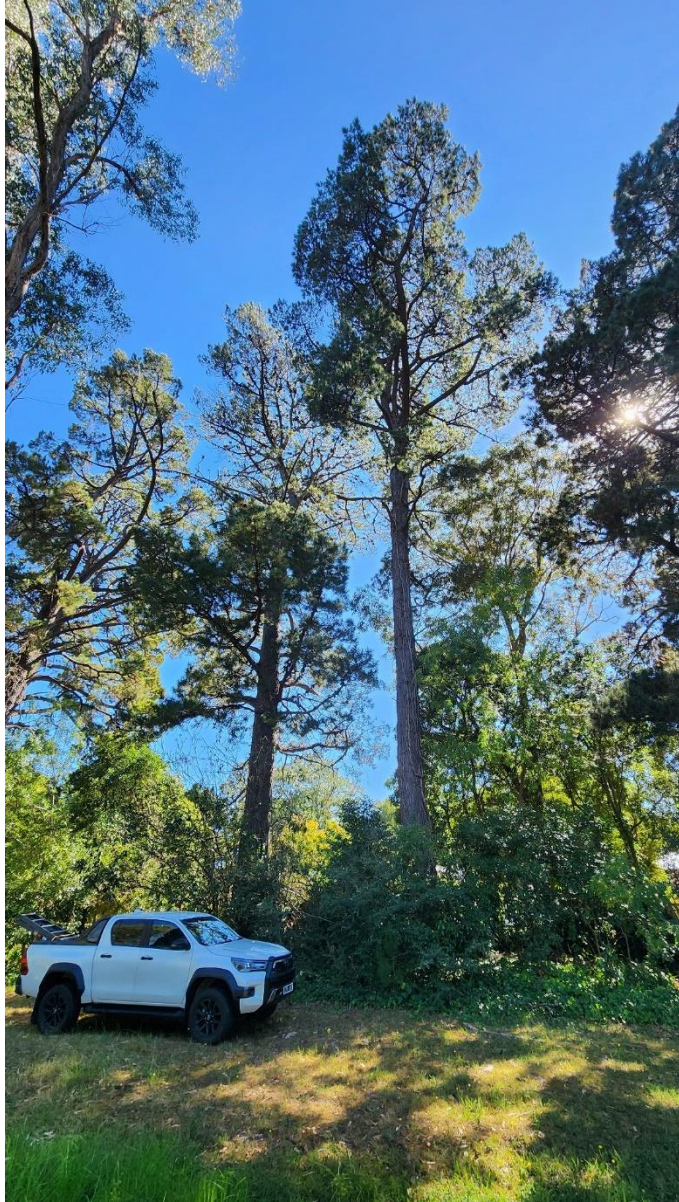
Photo 1

Trees 1 & 2 (right and left)

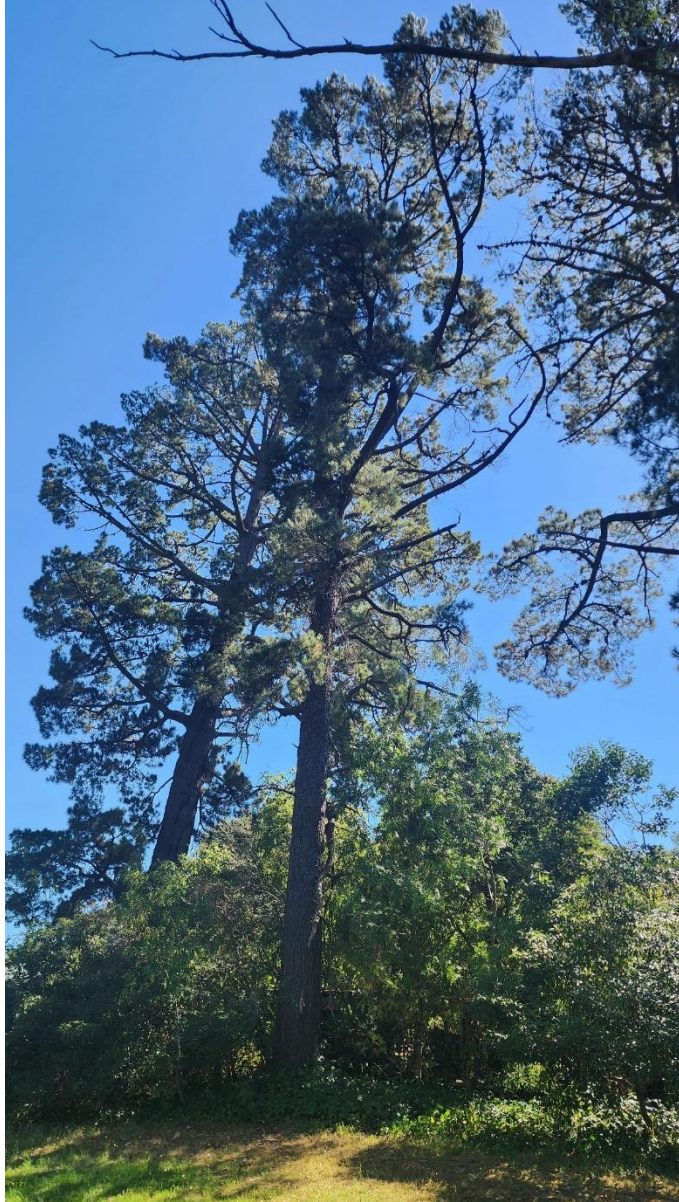
Photo 2

Tree 3

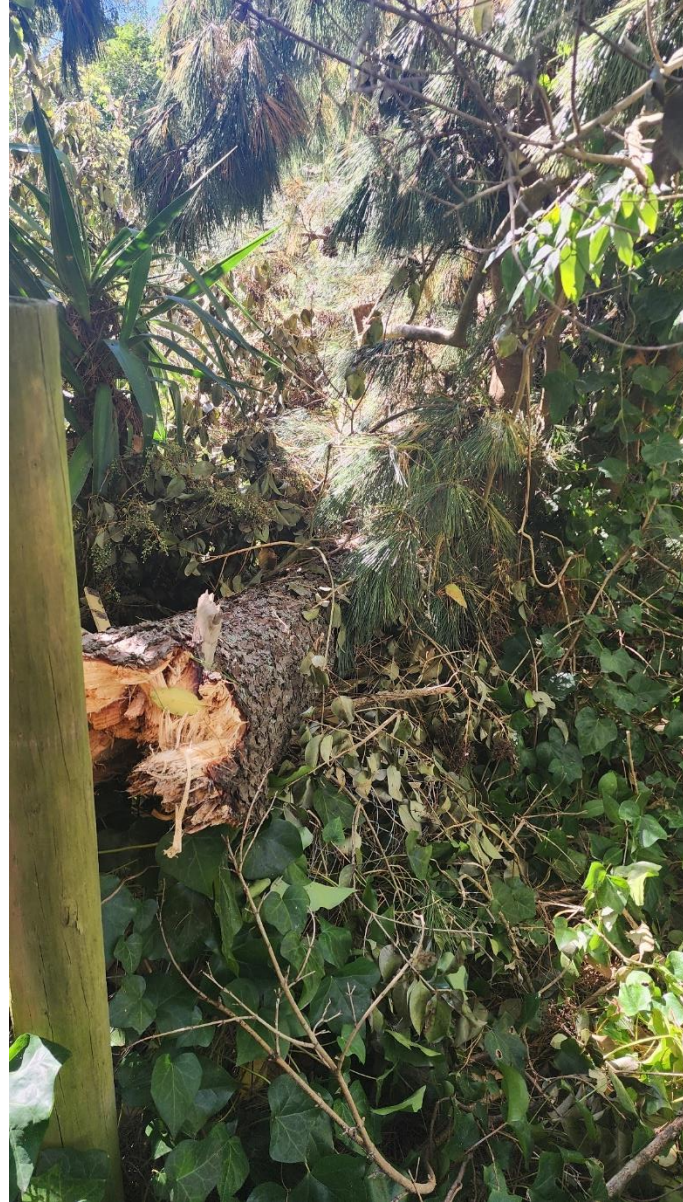
Photo 3

Tree 2, limb laying on the ground

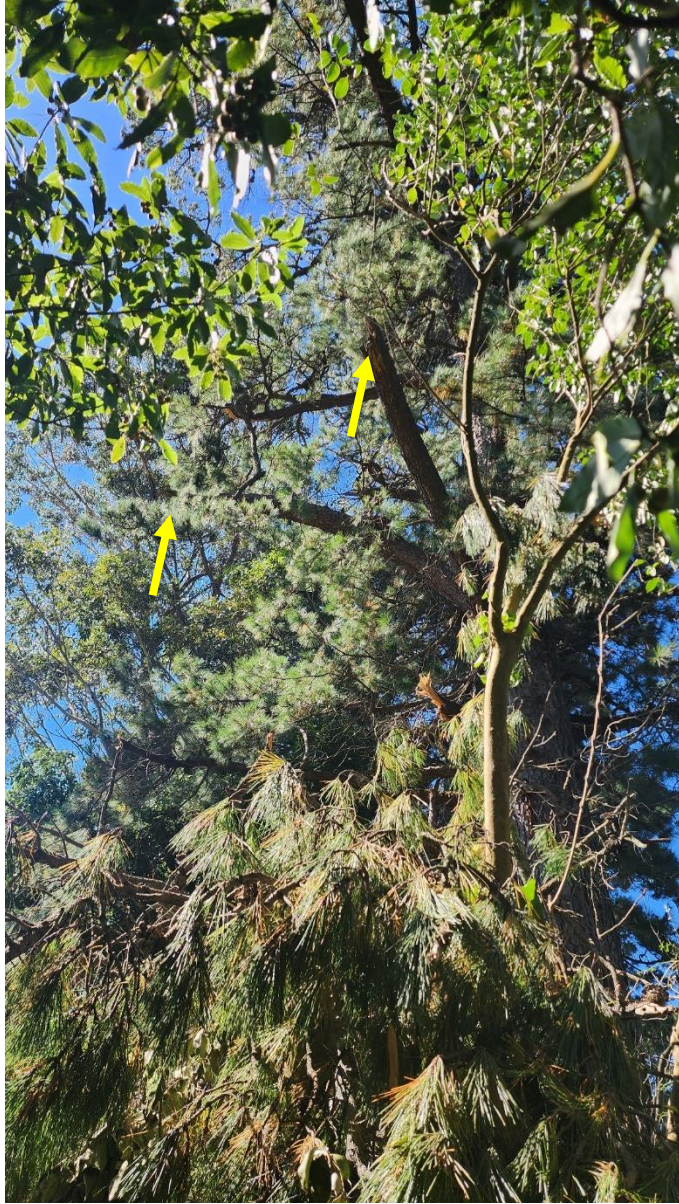
Photo 4

Tree 2, failed stubs
