ARBORICULTURAL REPORT

20 DAVID HILL ROAD, MONBULK

May 2022

October 2022

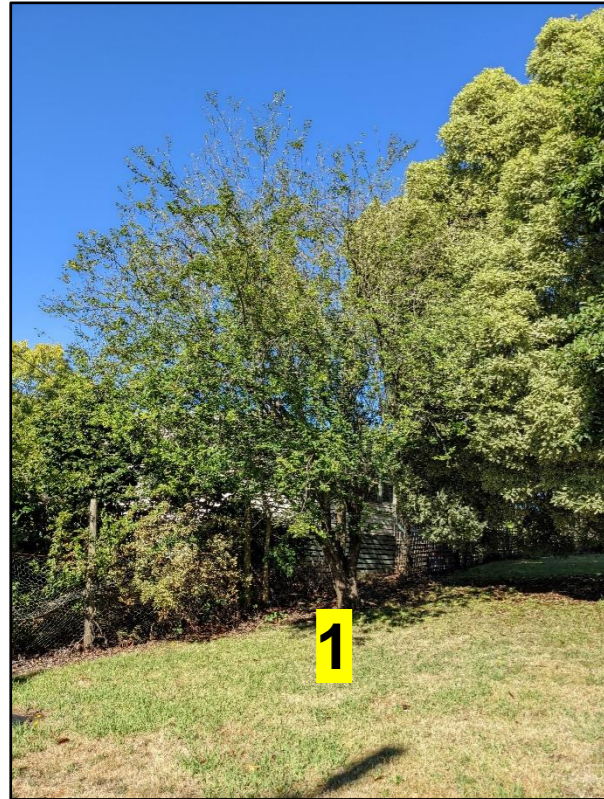
Fig. 2: Tree 1.

- 5.4 All site trees are proposed to be removed to accommodate the development.
- 5.5 Tree 1 is a *Malus sp.* (Apple) located towards the southeast corner of the site along the southern boundary. It is of poor health, fair structure, of low arboricultural value, and not worthy of retention. Due to its DBH it will require a permit for its removal under the SLO22.

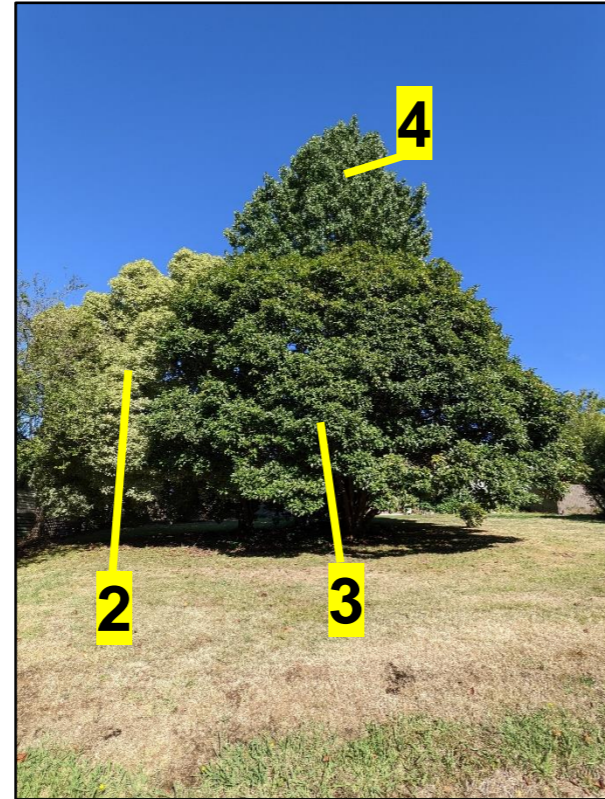
Fig. 3: Trees 2-4.

- 5.6 Tree 2 is a *Pittosporum eugenioides* 'Variegatum' (Lemonwood) located in a small grove of trees within the rear yard towards the southern site boundary. It is of good health, fair structure, medium arboricultural value, and is proposed to be removed to accommodate the development. Due to its DBH it will require a permit for its removal under the SLO22.

- 5.7 Trees 3-5 are a *Photinia robusta* (Red-leaf Photinia), *Liquidambar styraciflua* (Liquidambar), and a *Pittosporum eugenioides* 'Variegatum' (Lemonwood) respectively, all located as a small grove of trees within the rear yard towards the southern boundary. Tree 3 is of good health, fair structure, low arboricultural value, and not worthy of retention. Tree 4 is of good health with a poor structure due to a suspect bifurcated union close to the ground. It is of low arboricultural value and not worthy of retention. Tree 5 is of fair health and structure, low arboricultural value, and not worthy of retention. Due to their sizes all trees will require a permit for their removal under the SLO22.

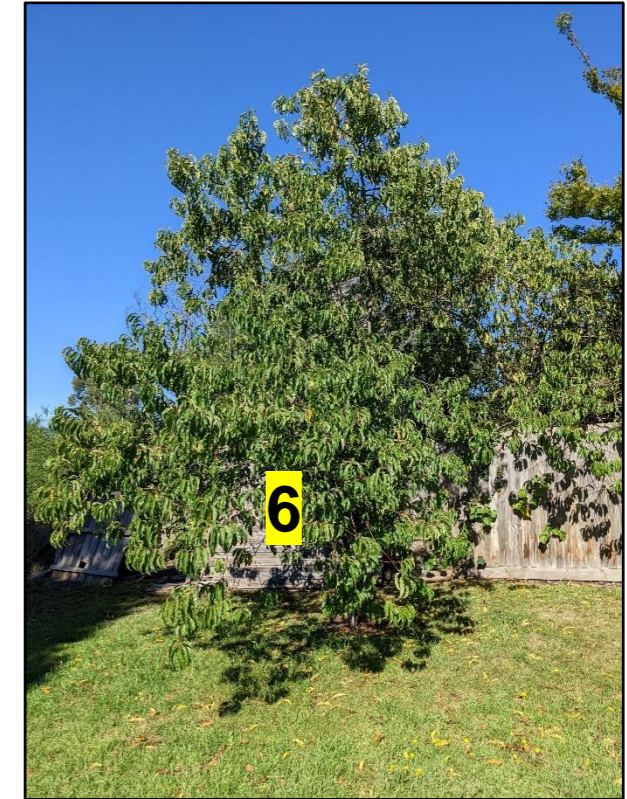
Fig. 5: Tree 6.

- 5.8 Tree 6 is a *Prunus persica* var. *nucipersica* (Nectarine) located along the western boundary within the rear yard. It is of fair health and structure, low arboricultural value, and not worthy of retention.

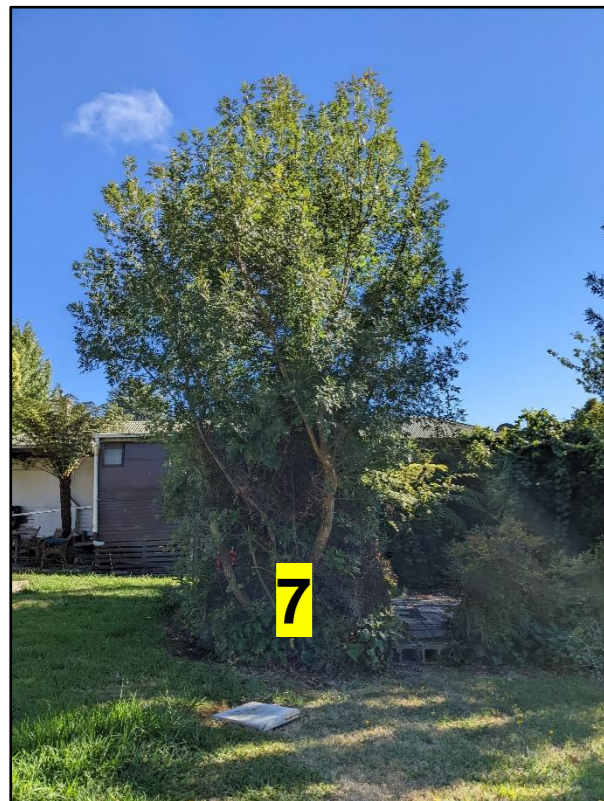
Fig. 6: Tree 7.

- 5.9 Trees 7 and 8 are both *Fraxinus angustifolia* (Narrow-leaved Ash) located approximately central to the site. They are of good health, while structurally Tree 7 has been considered poor, and Tree 8 good. This taxon is listed as a weed on the *Shire of Yarra Ranges Environmental Weed List* and does not require a permit for its removal. They are of low arboricultural value and not worthy of retention.

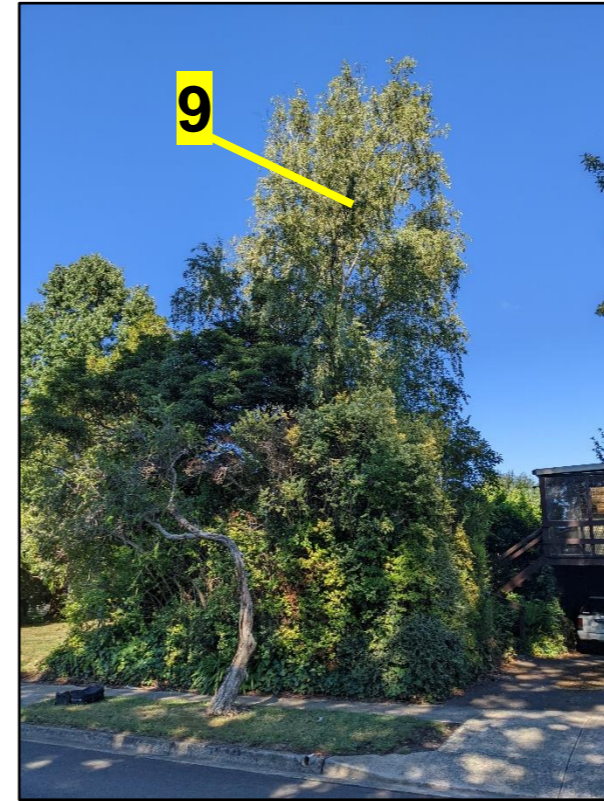
Fig. 8: Tree 9.

- 5.10 Tree 9 is a *Betula pendula* (Silver Birch) located centrally along the eastern boundary of the site. It is of good health and structure. It has been assessed as being of medium arboricultural value and can be considered for retention. Due to its DBH it will require a permit for its removal under the *SLO22*.

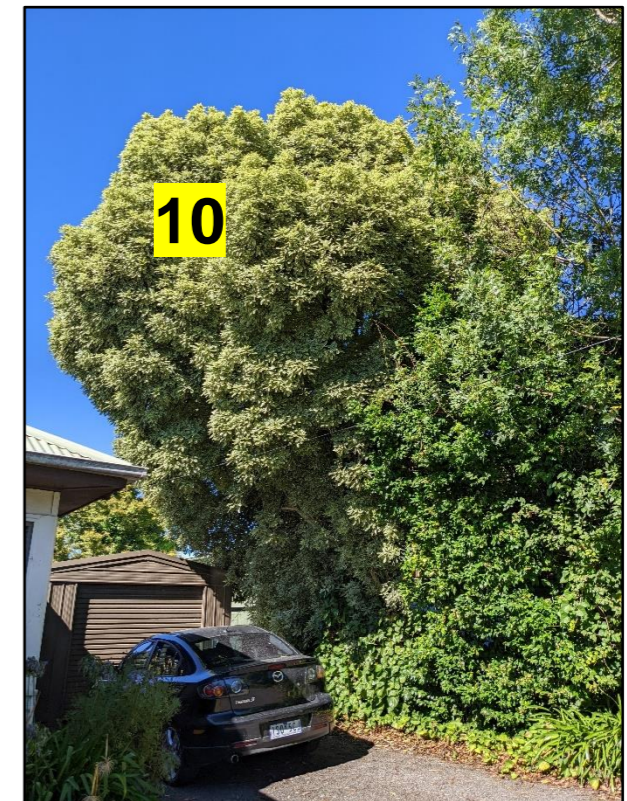
Fig. 9: Tree 10.

- 5.11 Trees 10 and 11 are a *Pittosporum eugenioides* 'Variegatum' (Lemonwood) and a *Fraxinus angustifolia* (Narrow-leaved Ash) respectively located along the boundary towards the northwest of the site. Both are of good health, fair structure, low arboricultural value, and not worthy of retention. Due to its DBH Tree 10 will require a permit for its removal under the *SLO22*. Tree 11 is listed as a weed on the *Shire of Yarra Ranges Environmental Weed List* and does not require a permit for its removal.

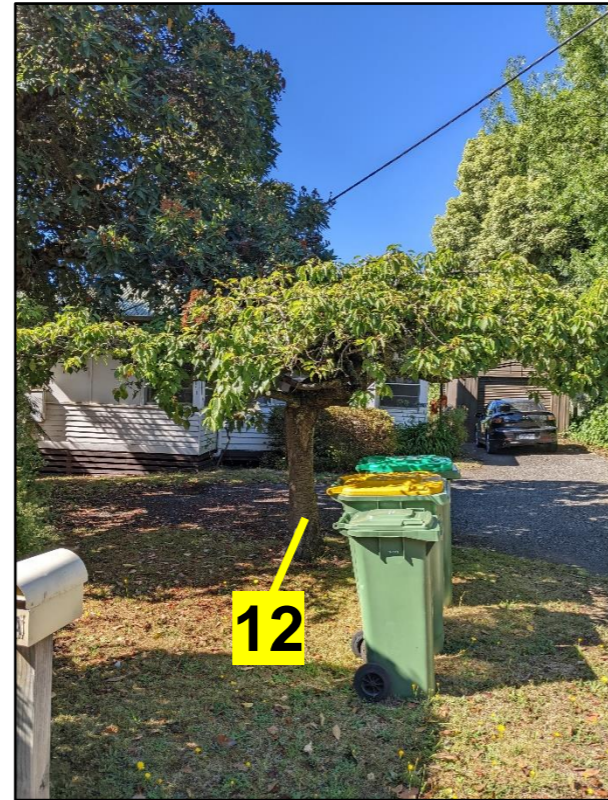
Fig. 11: Tree 12.

- 5.12 Tree 12 is a *Morus alba* (Mulberry) located towards the northwest corner of the site. It is of fair health and structure, low arboricultural value, and not worthy of retention. Due to its DBH it will require a permit for its removal under the *SLO22*.

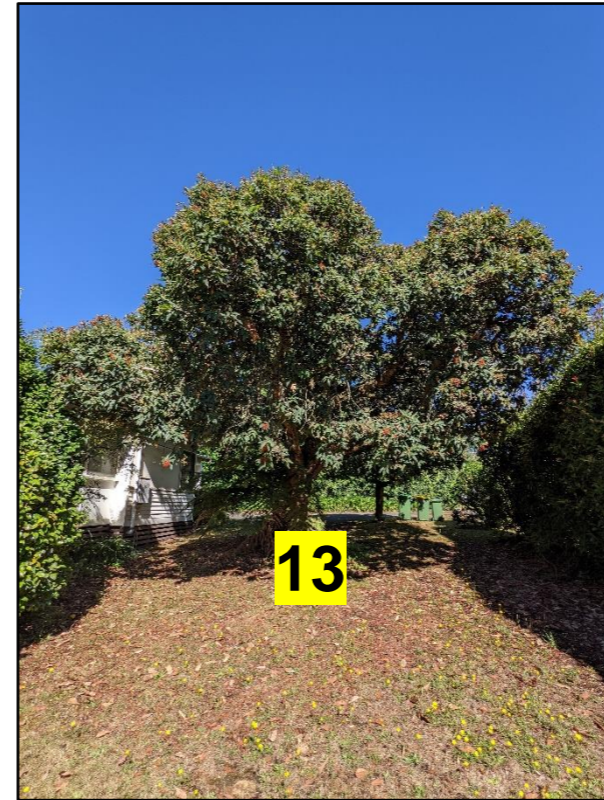
Fig. 12: Tree 13.

- 5.13 Tree 13 is a *Corymbia ficifolia* (Red Flowering Gum) located within the front yard of the subject site. It is of good health and structure, of medium arboricultural value, and worthy of retention. Due to its DBH it will require a permit for its removal under the *SLO22*.

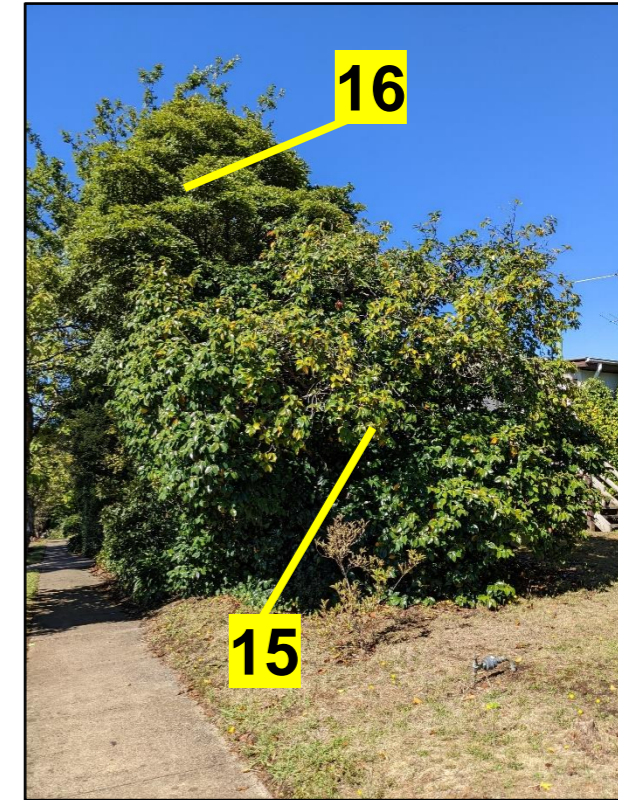
Fig. 13: Trees 15 and 16.

- 5.15 Trees 15 and 16 are a *Camellia japonica* (Camellia) and a *Pittosporum undulatum* (Sweet Pittosporum) respectively, located towards the northeast corner of the site. They are of good to fair health, fair structure, low arboricultural value, and not worthy of retention. Due to its DBH Tree 15 will require a permit for its removal under the *SLO22*. Tree 16 is listed as a weed on the *Shire of Yarra Ranges Environmental Weed List* and does not require a permit for its removal.

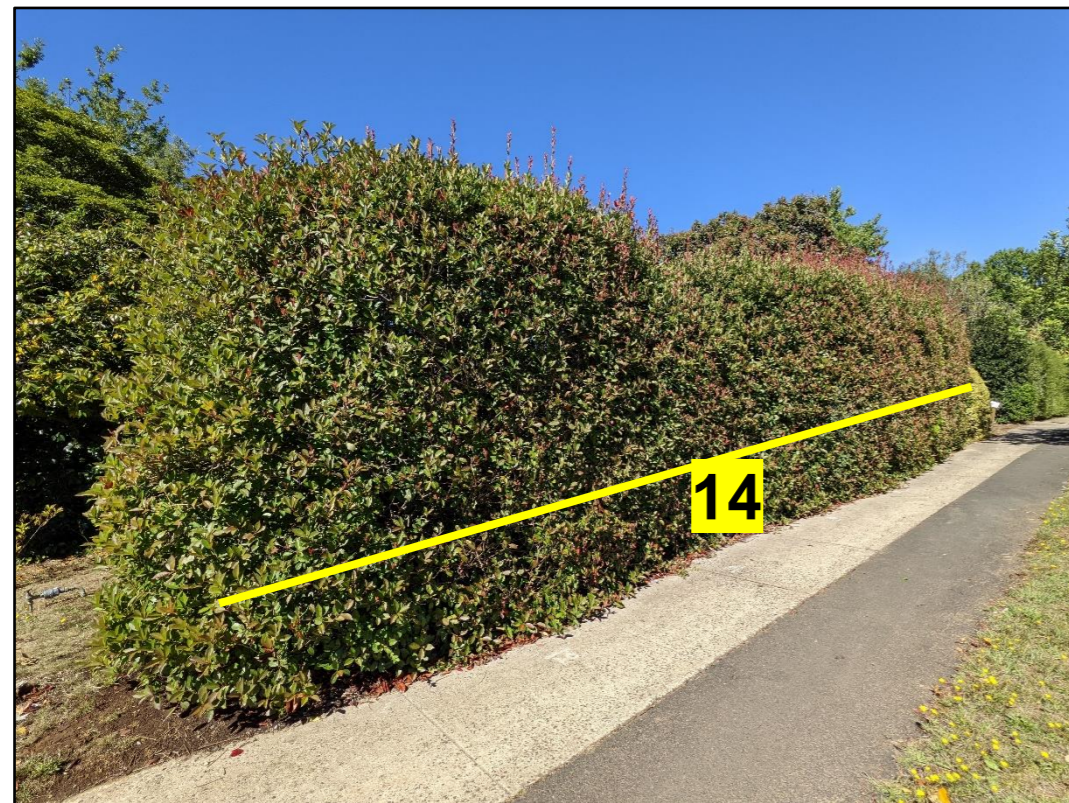
Fig. 14: Tree Group 14.

- 5.14 Tree Group 14 is a hedge of *Photinia robusta* (Red-leaf Photinia) along the northern boundary of the site. The trees are of fair to good health and fair structure. Considered as a hedge they have been assessed as being of medium arboricultural value for the screening they provide and can be considered for retention.

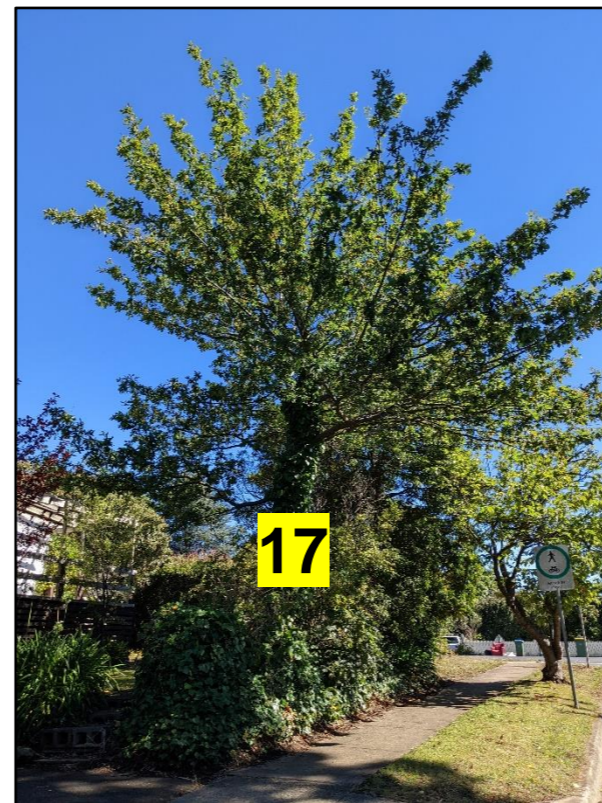
Fig. 15: Tree 17.

- 5.16 Tree 17 is a *Quercus robur* (English Oak) located along the eastern boundary of the site. It is of fair health and structure with ivy starting to choke the trunk and canopy. It is of low arboricultural value and not worthy of retention. Due to its DBH it will require a permit for its removal under the *SLO22*.

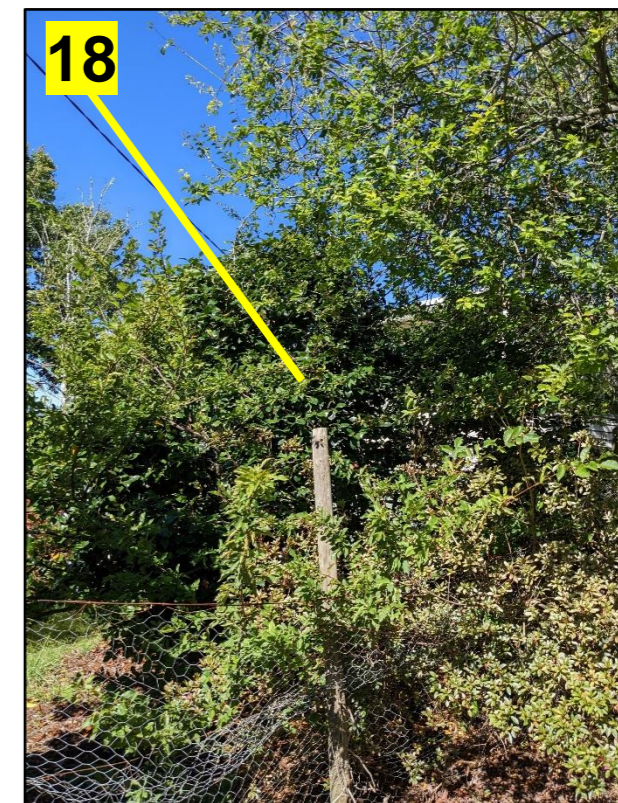
Fig. 16: Neighbouring Tree 18.

- 5.18 Trees 18-20 are a *Camellia japonica* (Camellia), *Juniperus sp.* (Juniper), and a *Prunus sp.* (Stone Fruit) respectively, located in the neighbouring yard along the southern boundary of the site. Their TPZs are not encroached, and they are not expected to be impacted by the proposed development.

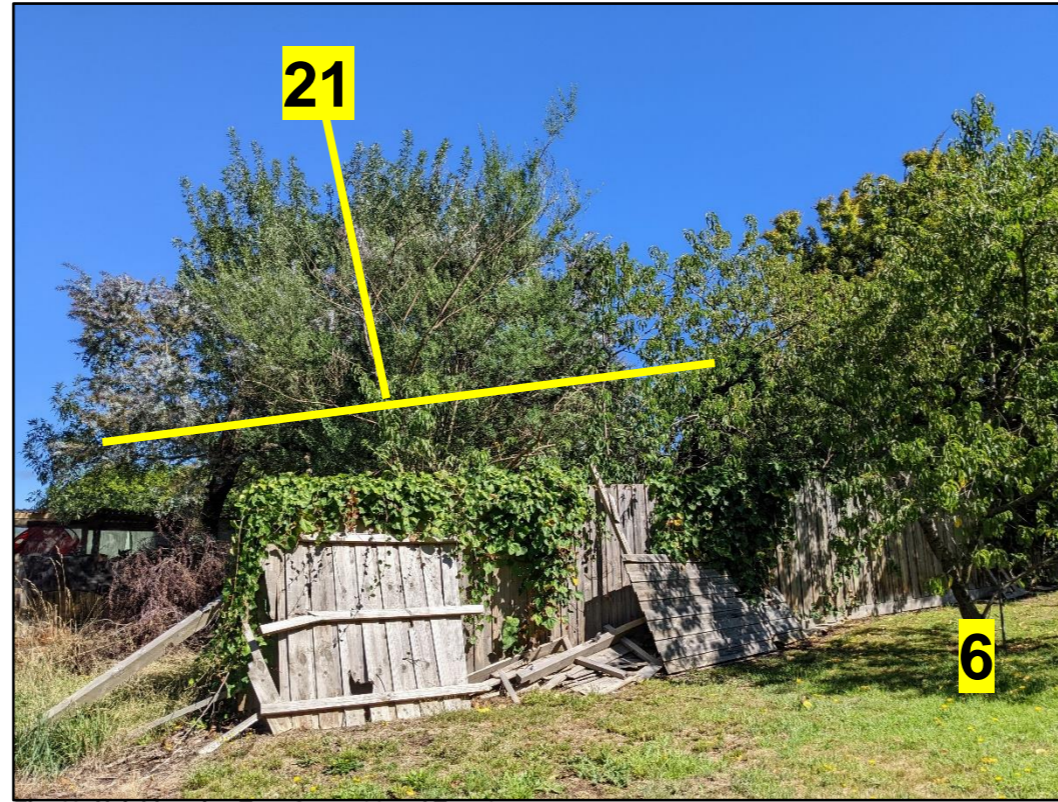
Fig. 18: Neighbouring Tree Group 21 and Tree 6.

- 5.19 Tree Group 21 is a mix of *Prunus sp.* (Stone Fruit), *Acacia sp.* (Wattle), and *Cytisus sp.* (Tree Lucerne) located in the neighbouring yard along the western boundary towards the south of the site. One of these trees' TPZ is encroached by 6.7% caused by the proposed retaining wall. This is considered a minor encroachment (<10%) under AS4970 and is not expected to impact the long-term health of the tree. The rest of the trees within this group are not encroached and are not expected to be impacted.

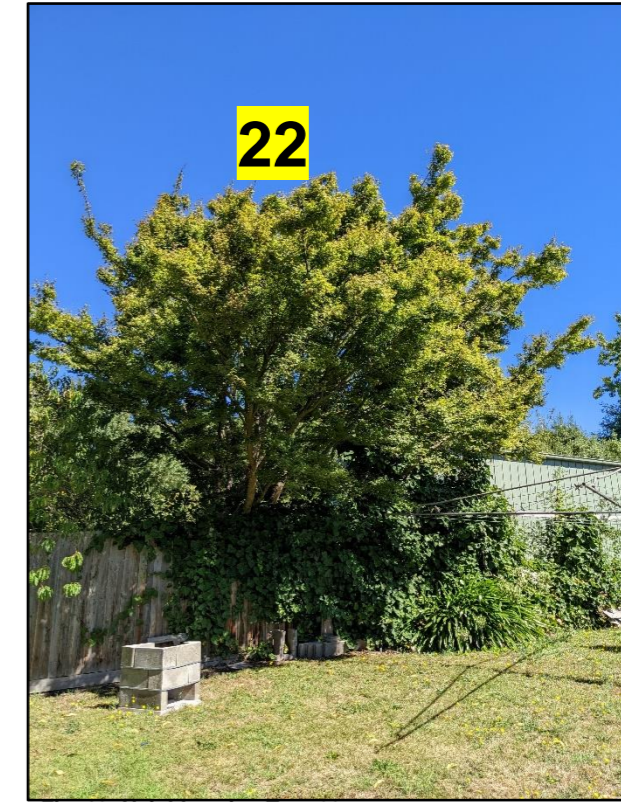
Fig. 19: Neighbouring Tree 22.

- 5.20 Trees 22 and 23 are both *Acer palmatum* (Japanese Maple) located in the neighbouring yard along the western boundary of the site. Tree 22's TPZ is encroached by 6.7% caused by the proposed retaining wall. This is considered a minor encroachment (<10%) under AS4970 and is not expected to impact the long-term health of the tree. Tree 23's TPZ is encroached by 12.7% caused by the proposed retaining wall, considered a major encroachment (>10%) under AS4970. The retaining wall is proposed to be constructed of post and rail with no strip-footing. If pads for the posts are located to avoid any major roots (>40mm dia.) within the tree's TPZ, the long-term health of the tree is not expected to be impacted.

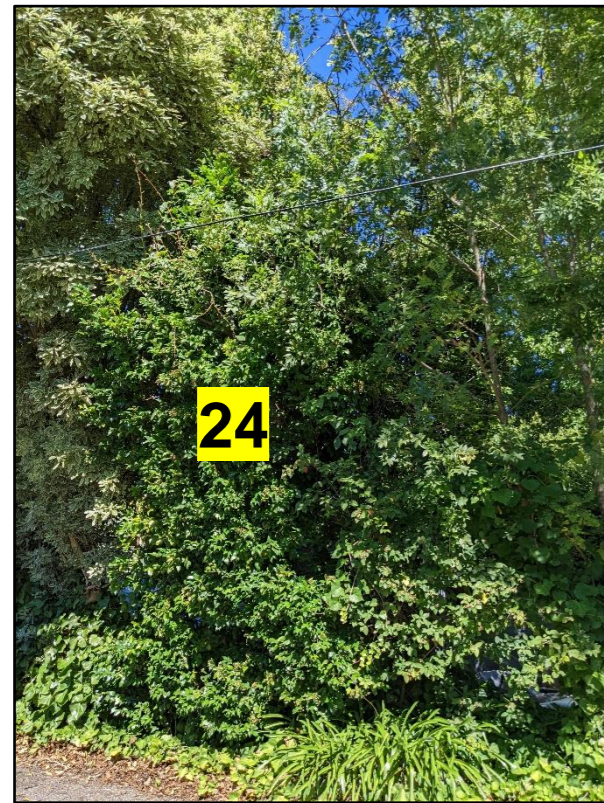
Fig. 20: Neighbouring Tree 24.

- 5.21 Trees 24 and 25 are a *Syzygium smithii* (Lilly Pilly) and a suspected *Malus sp.* (Apple) located within the neighbouring property along the western boundary of the site. Their TPZs are encroached by 39.6% and 42.8% respectively caused by the proposed retaining wall, considered a major encroachment (>10%) under AS4970. The retaining wall is proposed to be constructed of post and rail with no strip-footing. If pads for the posts are located to avoid any major roots (>40mm dia.) within the trees' TPZ, the long-term health of the trees are not expected to be impacted.

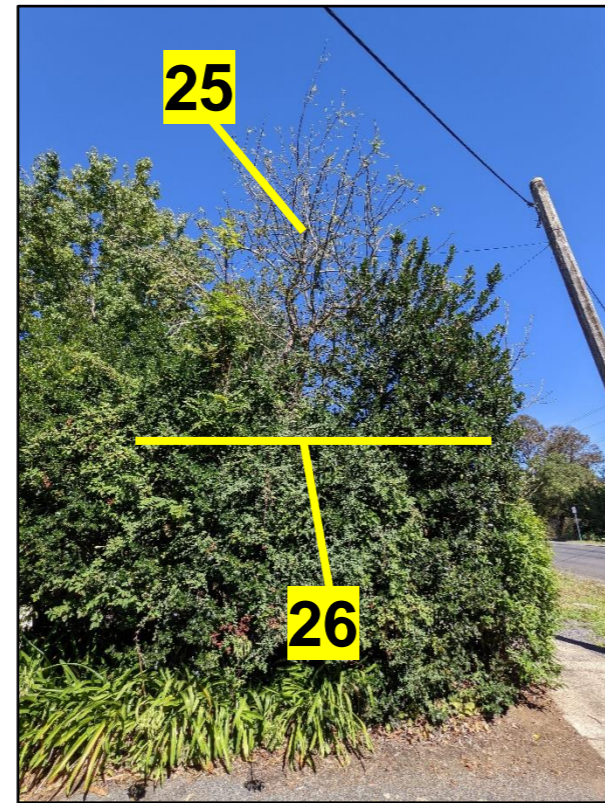
Fig. 21: Neighbouring Trees 25 and 26.

- 5.17 Tree Group 26 is a mix of *Privet sp.* (Privet), *Ilex sp.* (Holly), *Fraxinus sp.* (Ash), and *Cotoneaster sp.* (Cotoneaster) located at the northwest corner of the site. Their health ranges from good to poor, their structure from fair to poor, and all are of low arboricultural value. This group of trees are all listed on the *Shire of Yarra Ranges Environmental Weed List* and do not require a permit for their removal.

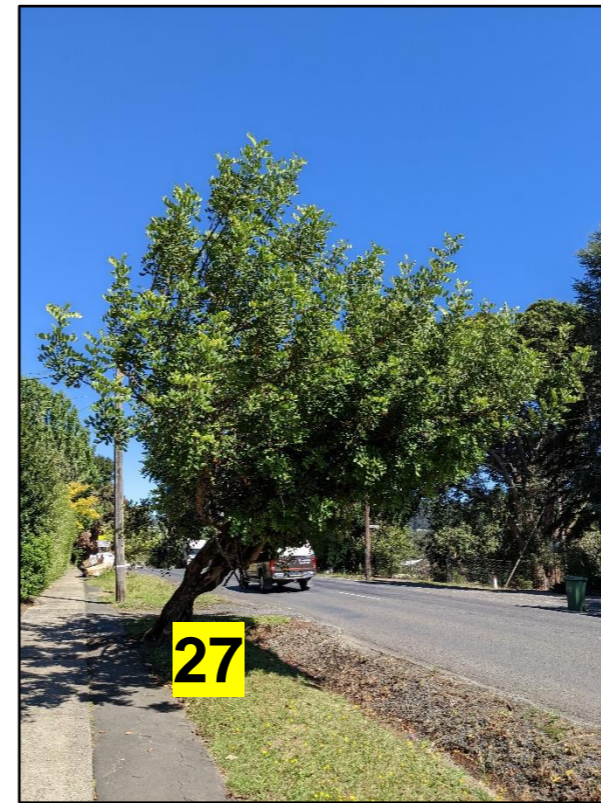
Fig. 22: Street Tree 27.

- 5.22 Tree 27 is a *Ceratonia siliqua* (Carob) located in the nature strip along David Hill Road to the north of the subject site. Its TPZ is encroached by 13.6% caused by the proposed stepping retaining wall. This is considered a major encroachment (>10%) under AS4970. If any major root located within the site are cleanly severed by hand the tree is not expected to suffer any long-term health effects due to the development.

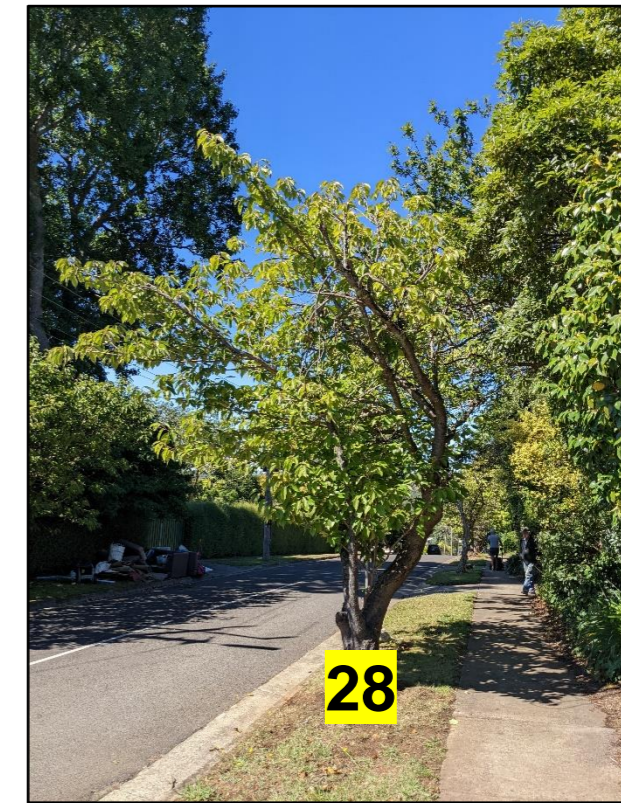
Fig. 23: Street Tree 28.

- 5.23 Tree 28 is a *Prunus sp.* (Stone Fruit) located in the nature strip along Victoria Avenue towards the northwest corner of the site. Its TPZ is encroached by 8.2% caused by the proposed stepping retaining wall and new crossover. This is considered a minor encroachment under AS4970 and is not expected to significantly impact the long-term health of the tree.

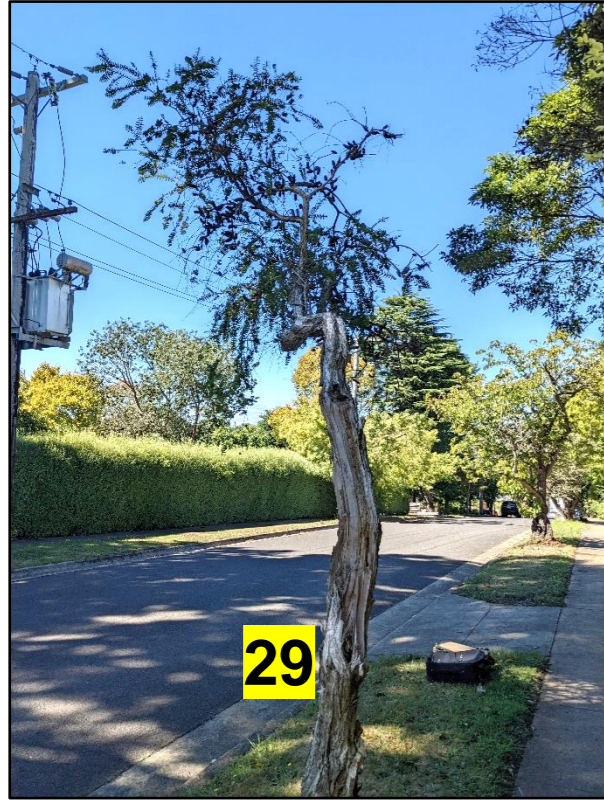
Fig. 24: Street Tree 29.

- 5.24 Trees 29 and 31 are a *Melaleuca sp.* (Paperbark) and a *Juniperus communis* (Common Juniper) located in the nature strip along Victoria Avenue to the east of the subject site. Their TPZs are not encroached, and they are not expected to be impacted by the development.

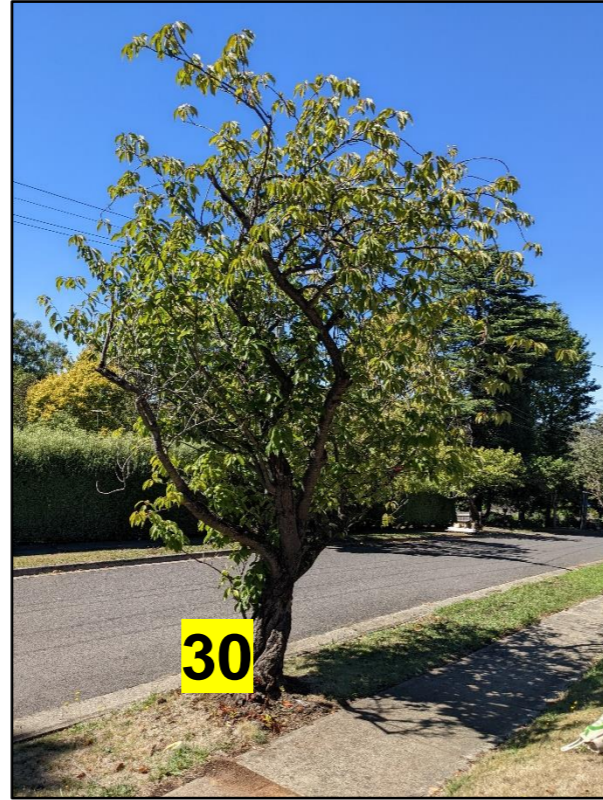
Fig. 25: Street Tree 30.

- 5.25 Tree 30 is a *Prunus sp.* (Stone Fruit) located in the nature strip along Victoria Avenue to the east of the subject site. Its TPZ is encroached by 13.6% caused by the proposed retaining wall, considered to be a major encroachment (>10%) under AS4970. The retaining wall is proposed to be constructed of post and rail with no

strip-footing. If pads for the post are located to avoid any major roots (>40mm dia.) within the tree's TPZ, the long term-health of the tree is not expected to be impacted.
