A.1 Summary of Field Observations

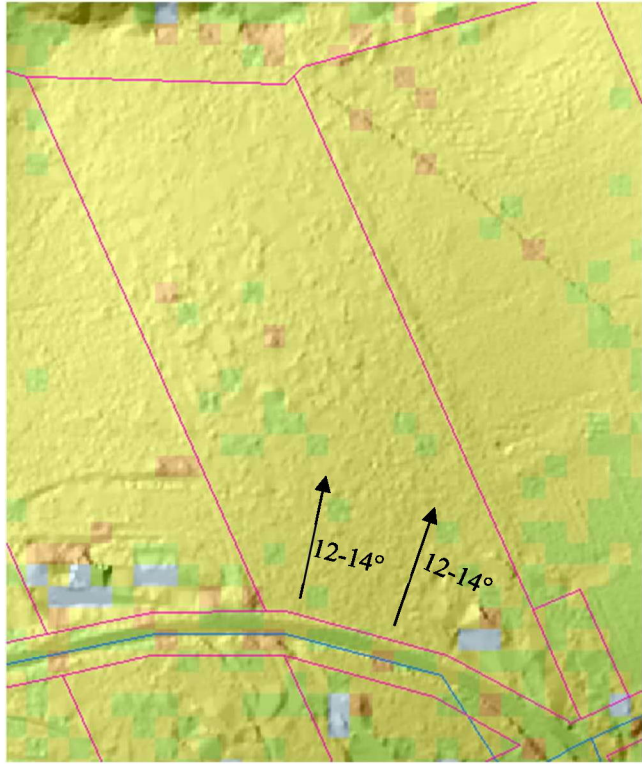
<p>Submission 1</p> <p>The average natural slope angle on the north side of Olinda-Monbulk Road was measured to be consistently 12° to 14°, which is above the 11° threshold for susceptibility in areas underlain by Ferny Creek Rhyodacite geology, such as this property. Slope angle information from LiDAR elevation data indicates that the property generally steepens to the north, which means that the property is generally above the slope angle threshold. The south east corner is flatter and there is scope for a slight adjustment to the boundary in this area.</p>

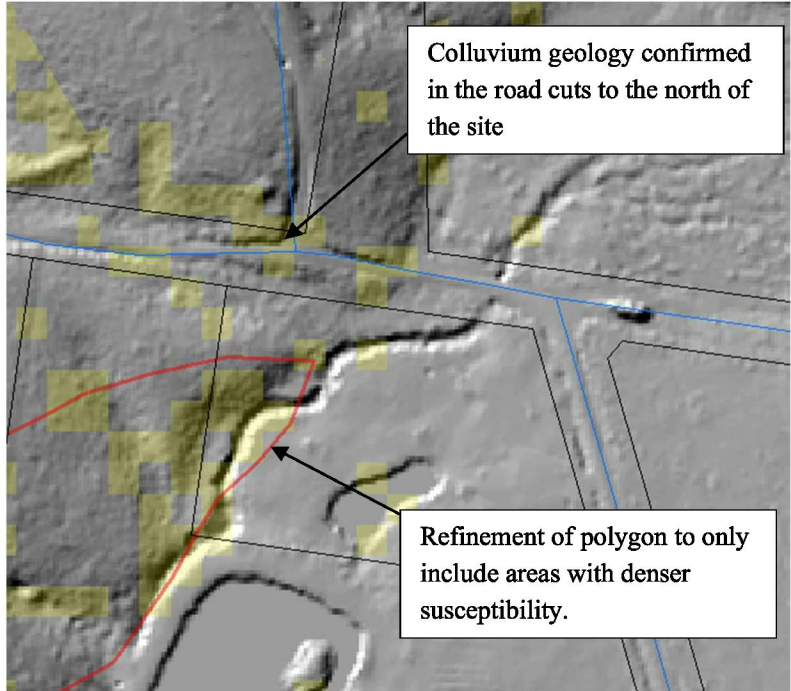
<p>Submission 2</p> <p>The areas indicated as susceptible to landslide (areas in yellow in the adjacent figure) could not be accessed in the field but are generally above the 11° slope angle threshold for the underlying mapped colluvium geology, based on LiDAR elevation data. Observations of the surface geological materials in the low cuts along Coopers Road to the north confirm that colluvium is present on the slopes in the area.</p> <p>Adjustment of the proposed EMO boundaries to only capture denser susceptibility areas is recommended.</p>

<p>Colluvium geology confirmed in the road cuts to the north of the site</p> <p>Refinement of polygon to only include areas with denser susceptibility.</p>

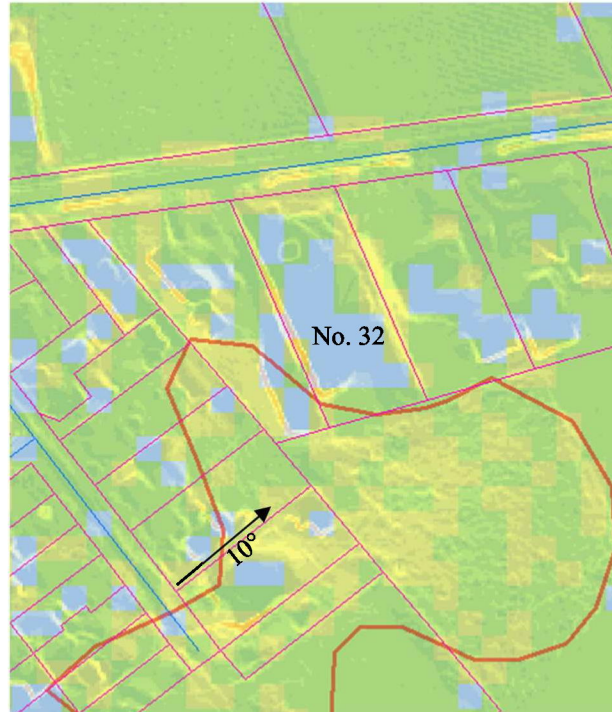
Submission 6

Some areas in the vicinity of the property meet the criteria for inclusion in the EMO (yellow) based on the slope angle ($> 9^\circ$) and the underlying geology of Older Volcanics. Field slope measurements indicate the slopes are locally between 10° and 12° in these areas.

It is recommended that refining the polygon be undertaken at a more detailed scale in this area.

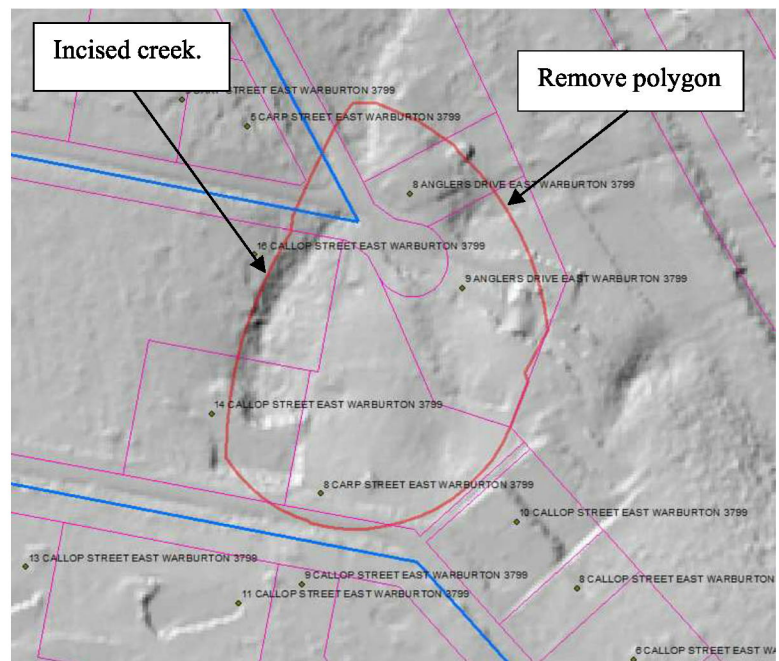
Submission 12

A feature was identified in LiDAR as indicative of a landslide feature. Field visits indicate the feature is likely fluvial, formed by a now abandoned river channel.

Recommend removal of polygon indicating landslide.

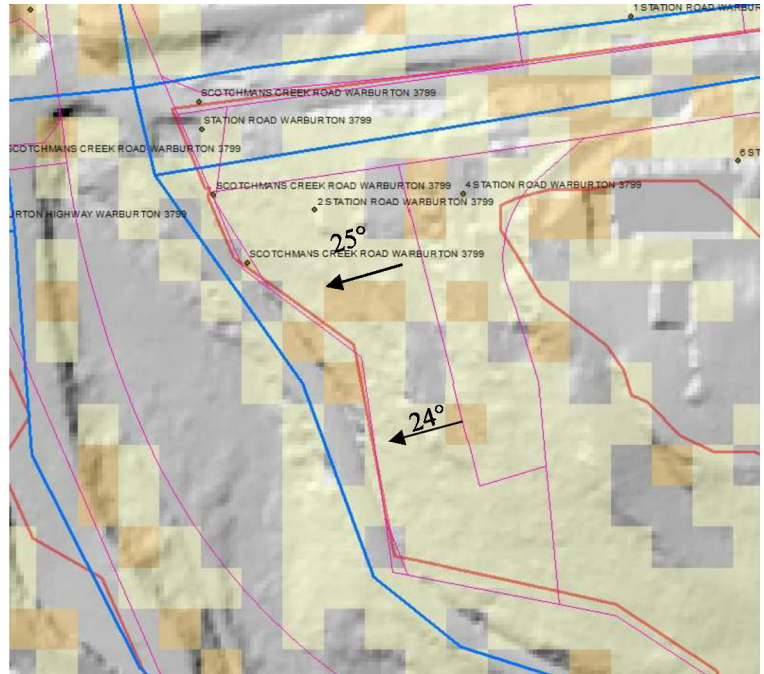
Submission 13

The average slope angle was measured to be 24° to 25° which exceeds the threshold for inclusion. Rock outcrops in Station Street and along Glenbrook Road were assessed and found to be consistent with geological map indications.

No change to mapping recommended.

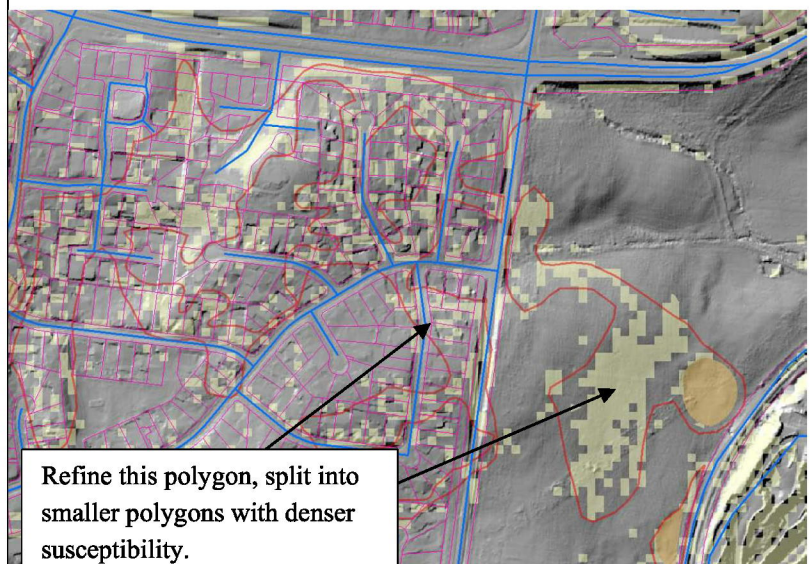
Submission 16

Natural slope angles in the areas with denser mapped susceptibility were typically 9° or more, above the threshold for inclusion and within less dense areas typically less than 9° putting the two polygons in this area on the cusp of inclusion.

The area is heavily impacted by earthworks.

We recommend refining the polygon in this area by mapping at a finer scale and splitting it into smaller polygons encompassing denser mapped susceptibility.

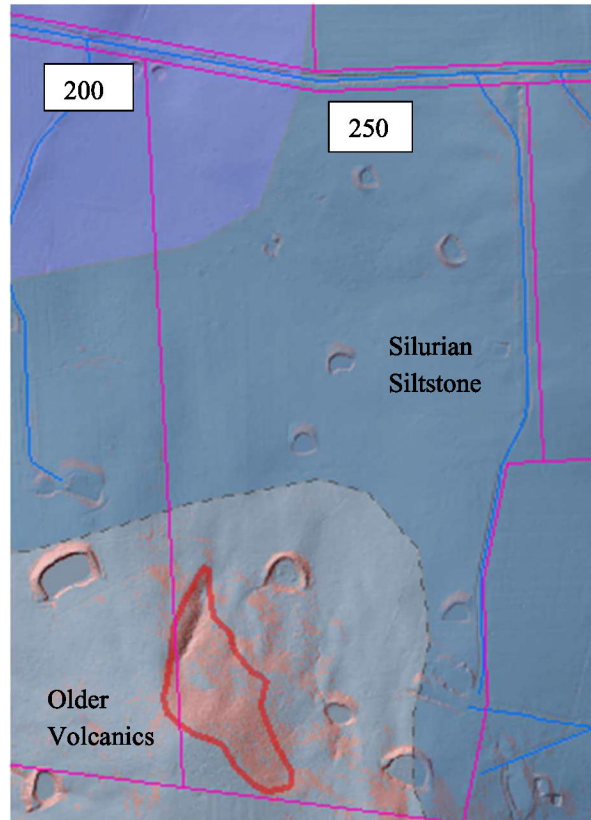
Submission 20

The area identified as susceptible generally has a slope angle of $> 9^\circ$ (areas in red in adjacent figure). Geomorphological desktop mapping and field observations nearby indicate that the ridge to the south and adjacent slopes, including the susceptible area, is underlain by a surface layer of Older Volcanics, which has been assessed to be susceptible to instability where slope angles are above 9° . The desktop mapping shows geomorphological signs of slope instability having occurred in the past on this slope.

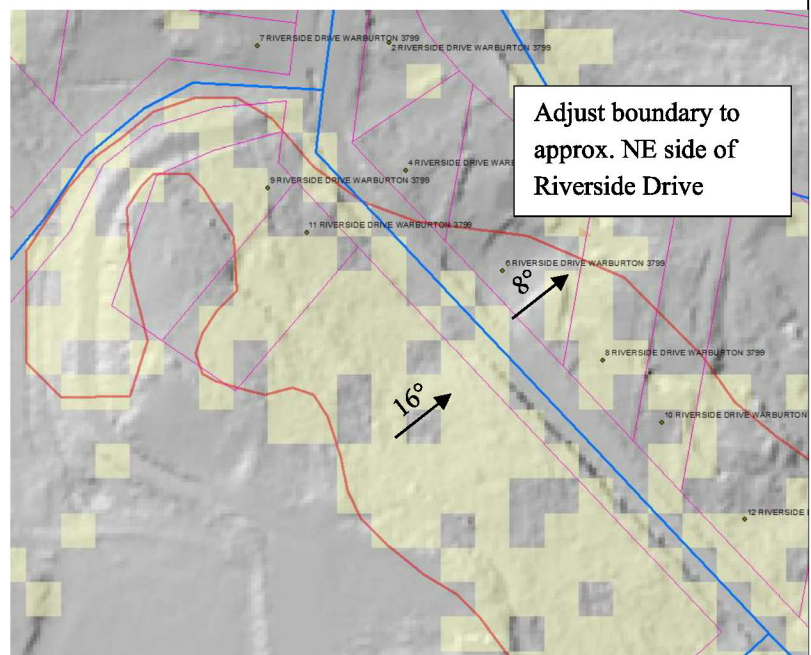
Submission 25

The natural slope on the north east side of Riverside Drive shallows to about 8° , below the 11° threshold. The mapped susceptible areas shown northeast of Riverside Drive are related to earthworks.

Recommend adjusting the northeast EMO boundary in this area 20 m to 30 m towards Riverside Drive.

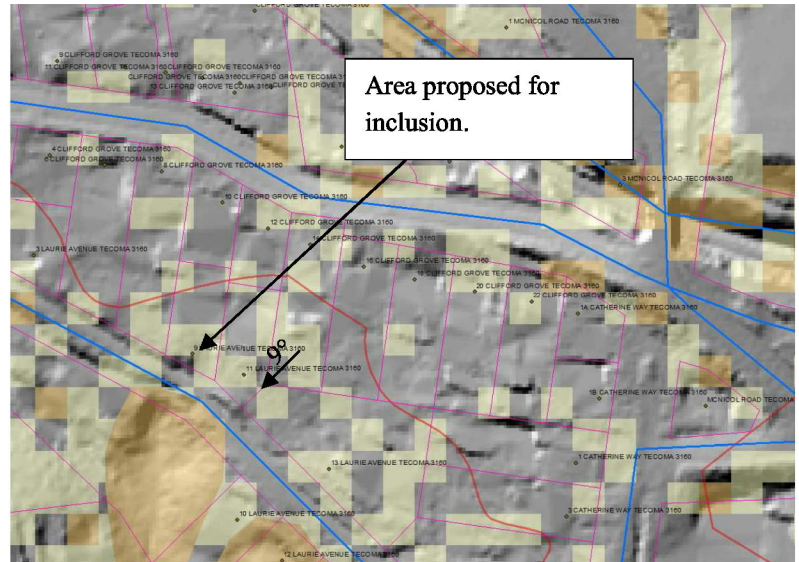
Submission 29

Natural slope angle between Laurie Avenue and Clifford Grove in this area is 9° to 10° , below the threshold of 11° . Mapped susceptible areas relate to earthworks.

Recommend adjusting boundary about 30 m to the south west towards Laurie Avenue.

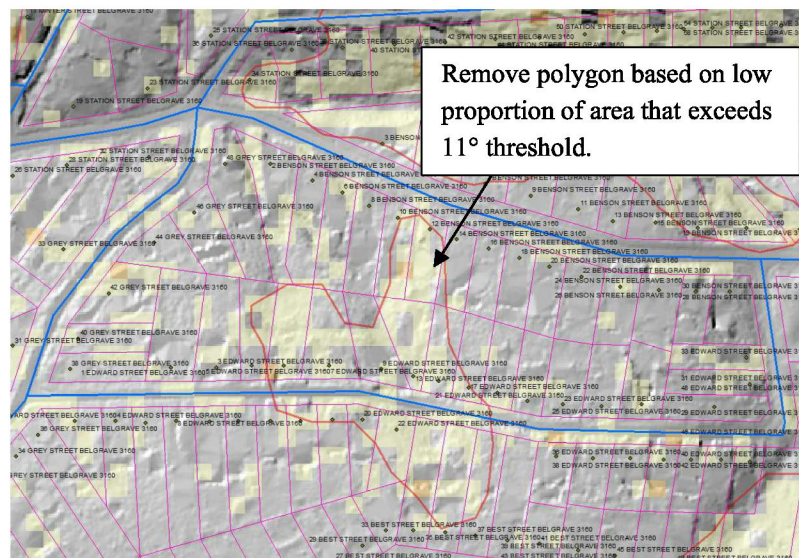
Submission 30

The mapped susceptible area relates to what appears to be past filling on the area.

Recommend removal of the polygon shown on the basis that the area has a natural slope angle of 10° to 12° . Although in some parts of this polygon the natural slope angle exceeds the criteria for inclusion, these areas are too small to be delineated as a separate polygon. Recommend removal of this polygon.

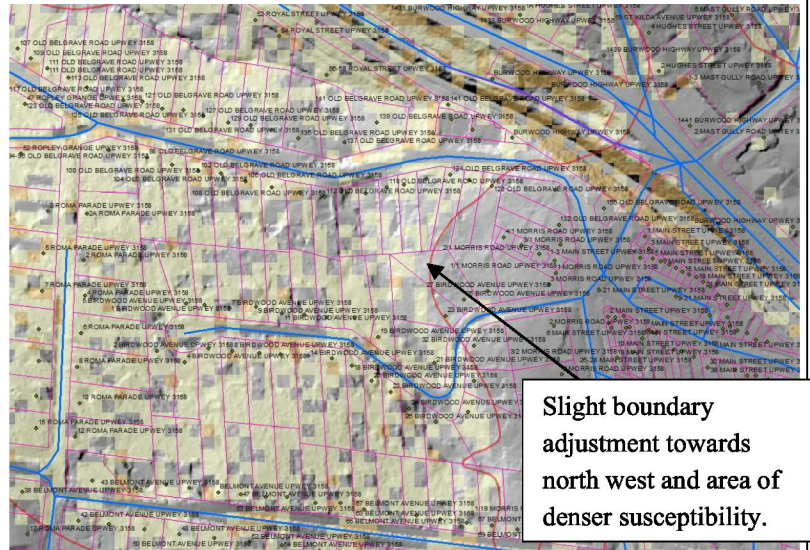
Submission 33

There is a gully through this area which meets the criteria for inclusion and some properties have placed fill up to the edge of the gully. The areas of less dense mapped susceptibility are related to earthworks.

Recommend a slight boundary adjustment through here to shift the boundary closer to the areas of denser mapped susceptibility.

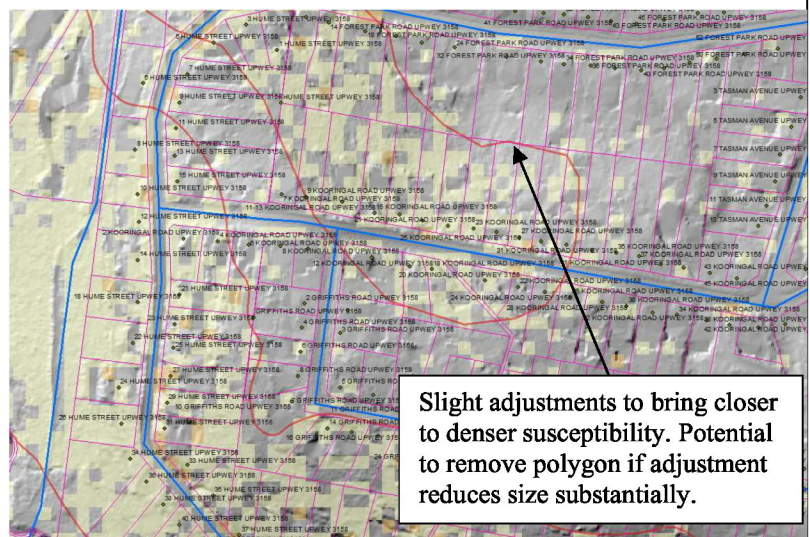
Submission 39

Natural slopes were measured at 11° to 12° through this area, including on properties south of Koorlingal Road in the vicinity of 16 Koorlingal which is marginal for inclusion based on a threshold of >11°. The mapped susceptibility is also influenced by earthworks. Given the marginal slope angle, there is scope for a slight adjustment of the boundary of this polygon, in the order of 20 m to shift it closer to areas of denser mapped susceptibility.

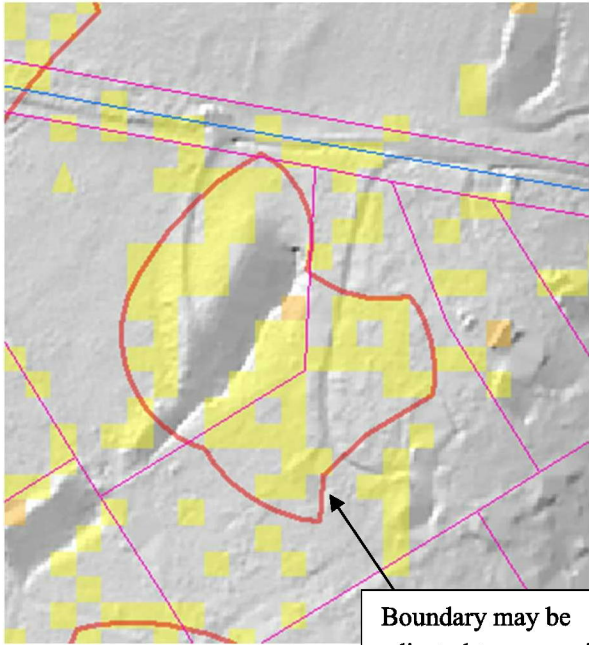
<p>Submission 40</p> <p>The measured natural slope angle at the north end of the property, adjacent to the road, was 14°, with the areas in the central part of the property assessed as susceptible (yellow) having generally not been affected by earthworks and having a similar slope angle based on LiDAR elevation data.</p> <p>There is some scope for fine adjustment of the area delineated as susceptible if mapped at a finer scale. Recommend finer mapping at 1:1000 to adjust these polygons.</p>

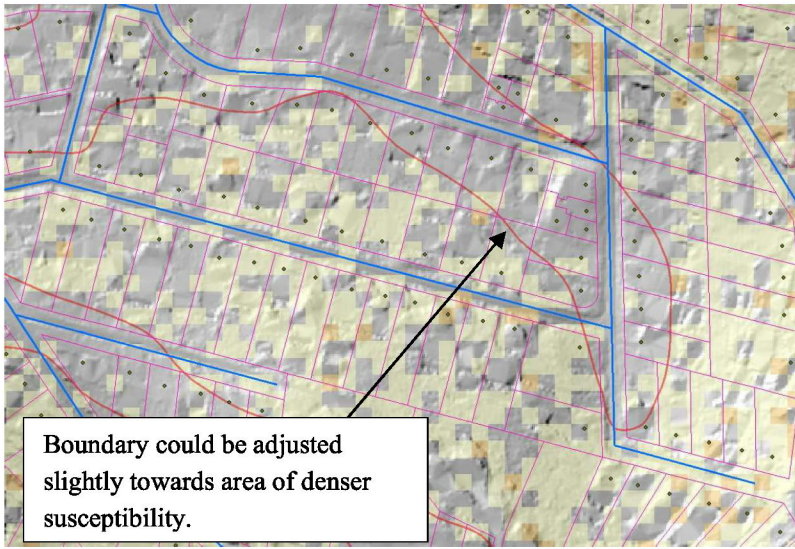
<p>Boundary may be adjusted to areas with denser susceptibility.</p>
<p>Submission 43</p> <p>There is a gradual transition of the natural slope gradient through this area ranging from >11° in the southern portion of the polygon to less than 11° towards the north. The mapped susceptible areas near the boundary of the proposed EMO are influenced by earthworks. There is some scope to slightly adjust the boundary towards the south by 10 m to 20 m towards the area of denser mapped susceptibility.</p>

<p>Boundary could be adjusted slightly towards area of denser susceptibility.</p>

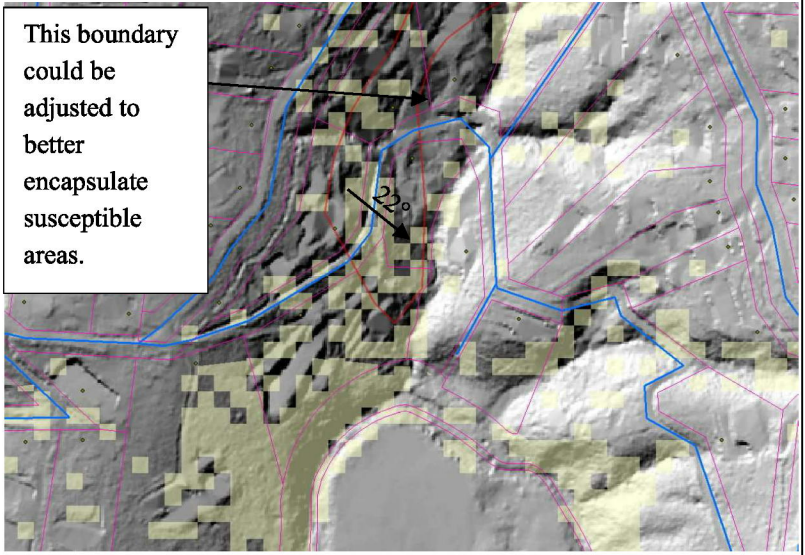
<p>Submission 44</p> <p>The measured natural slope angles in the area delineated as susceptible are $>22^\circ$ and therefore consistent with LiDAR indications.</p> <p>There is some scope for fine adjustment of the area delineated as susceptible if mapped at a finer scale. Recommend finer mapping at 1:1000 to adjust these polygons.</p>

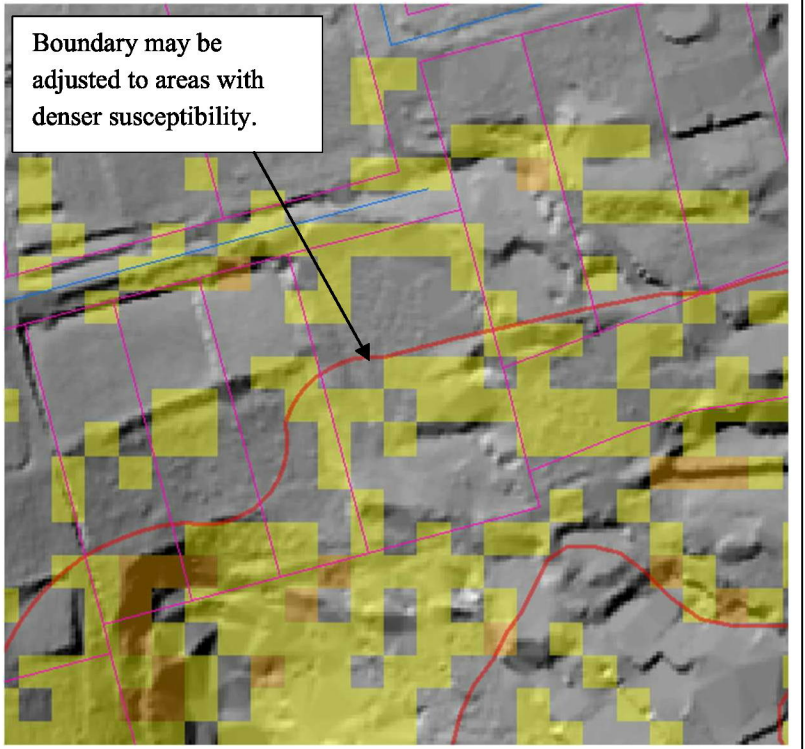
<p>This boundary could be adjusted to better encapsulate susceptible areas.</p>
<p>Submission 45</p> <p>The property slope conditions have been observed in the field from the northern boundary and appear to comprise some natural slopes and broad terraced areas where previous earthworks have occurred. The area assessed as susceptible that has been included in the EMO appears to contain both these conditions.</p> <p>There is some scope for fine adjustment of the area delineated as susceptible if mapped at a finer scale. Recommend finer mapping at 1:1000 to adjust these polygons.</p>

<p>Boundary may be adjusted to areas with denser susceptibility.</p>

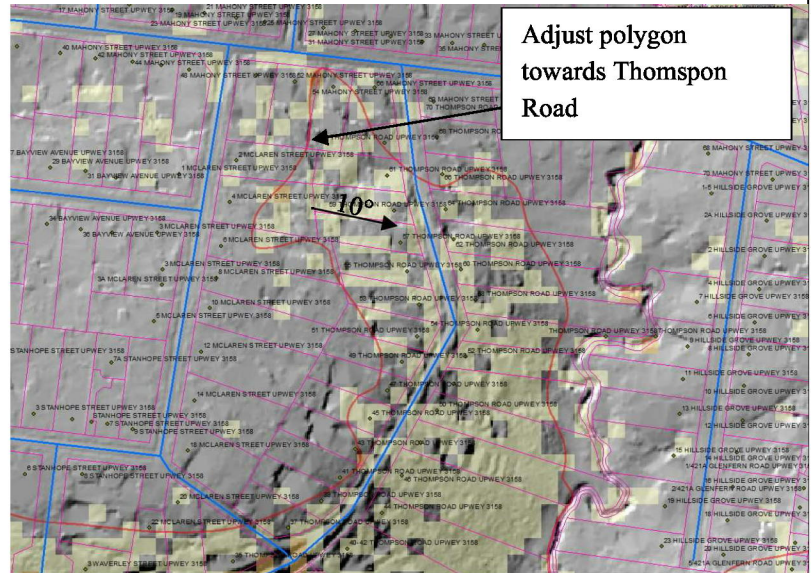
Submission 47

The natural slope angle was measured at 10° in areas to the west of Thompson Road, with the areas indicated as susceptible influenced by earthworks. Criteria for inclusion is 11° .

Recommend adjustment of this polygon to move the western boundary further to the East.

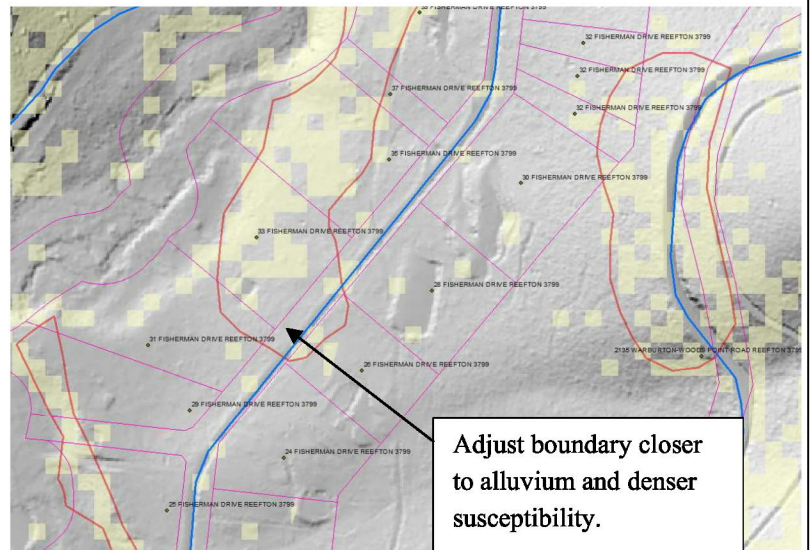
Submission 49

Note that this site was not visited, however LiDAR allows identification of the geological boundary of alluvium through this area, which differs from geological map indications. There is therefore a basis to adjust the geological boundary and adjust the EMO extent accordingly.

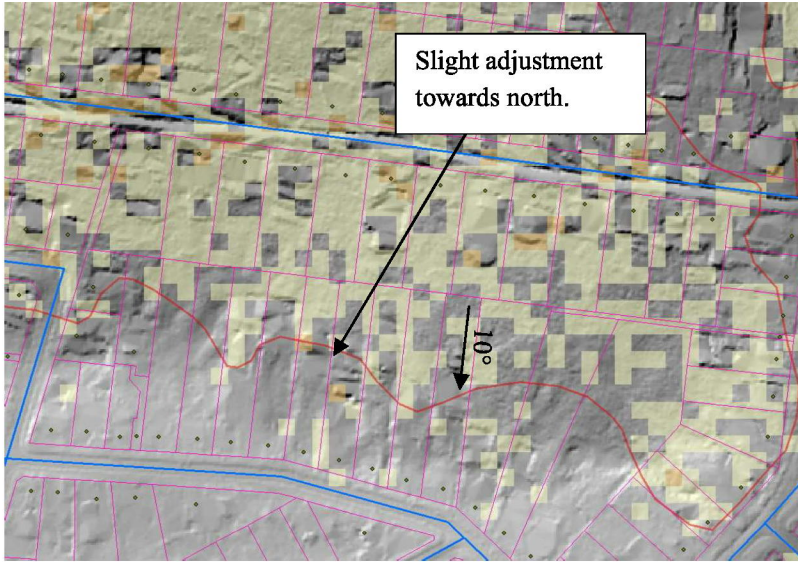
<p>Submission 50</p> <p>The natural slope angle near the southern boundary of the polygon increases gradually towards the north from 10° to greater than 11° which is the threshold for inclusion. Furthermore, the area is affected by dense earthworks.</p> <p>Recommend adjusting the boundary 10 m to 20 m north and smoothing out kinks. This approach can be applied to the broader Upwey area.</p>

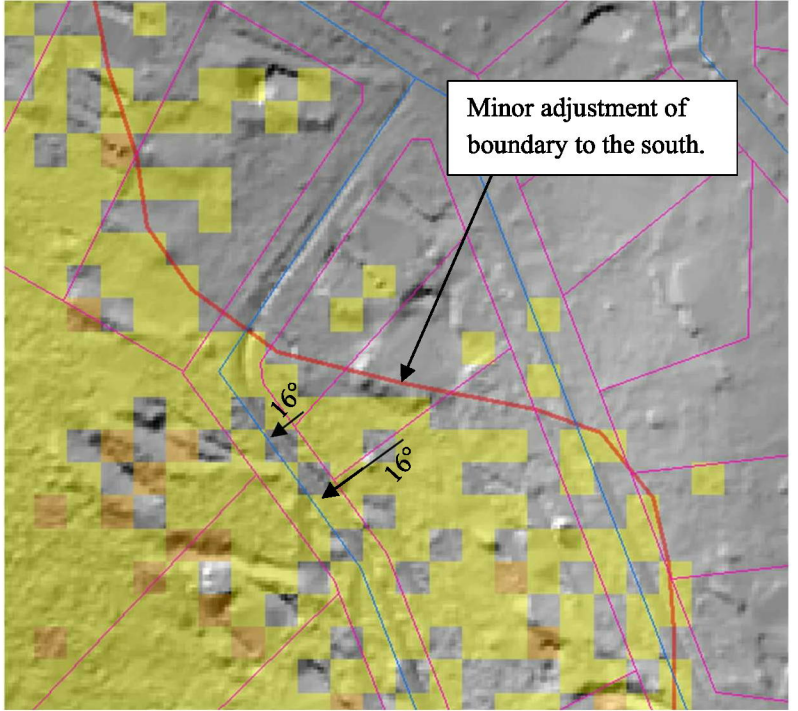
<p>Submission 51</p> <p>The natural slope angles measured at the southern boundaries of the property were 16°, which is greater than the threshold for inclusion of 11°.</p> <p>There is some scope for minor adjustment of the boundary towards the south to align with areas of denser mapped susceptibility.</p>

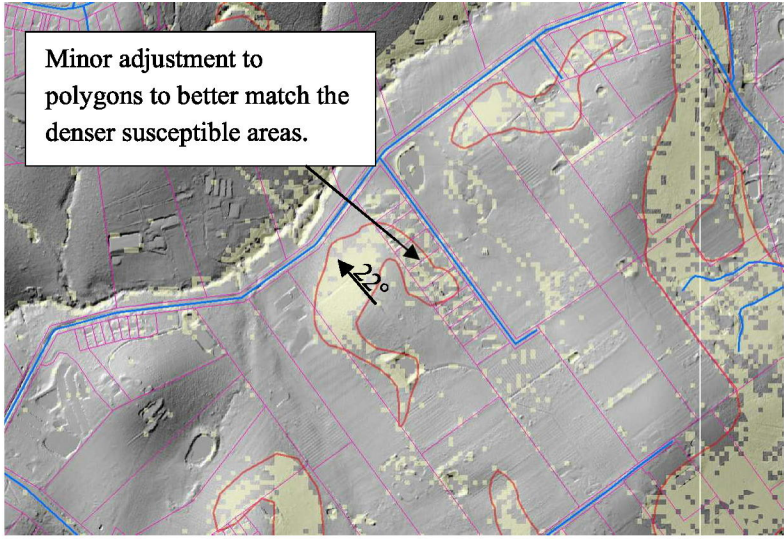
<p>Submission 54</p>	
<p>The slope angles measured in the mapped susceptible areas are marginal for inclusion at around 22° in Devonian Siltstone. Recommend slight adjustment to boundaries of polygons in this area to better encompass denser mapper susceptibility areas.</p>

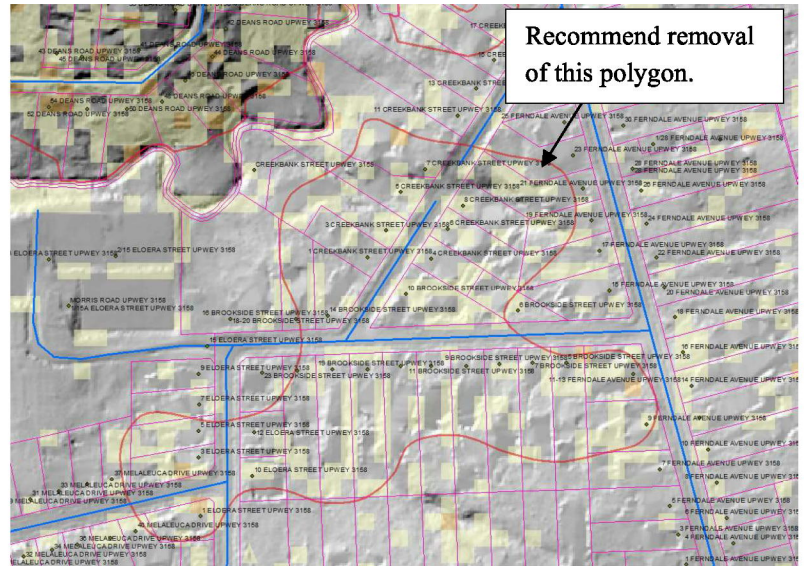
Submission 56

The natural slope angle of the polygon in this area varies through this area between 10° and 11°, but overall is around 11° or marginally lower, noting 11° is the threshold for inclusion.

Recommend removal of this polygon.

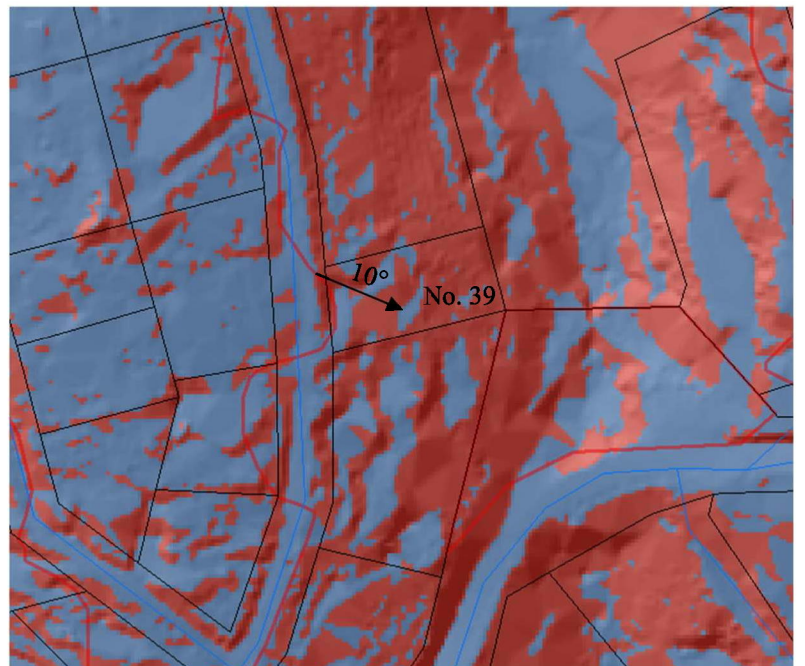
Submission 59

Natural slope angles measured at 10° in the western part of the site, in the vicinity of the house and driveway. Slope angles in the eastern part of the site are generally steeper and above 11° (areas in red in adjacent figure) based on LiDAR elevation data, which is the threshold for inclusion in the EMO where underlain by Ferny Creek Rhyodacite. Areas below the threshold are generally benched earthworks areas for the house and driveway.

Some minor adjustment of the EMO boundaries may be possible to capture denser mapped susceptibility areas but part of the property would be included in the proposed EMO.

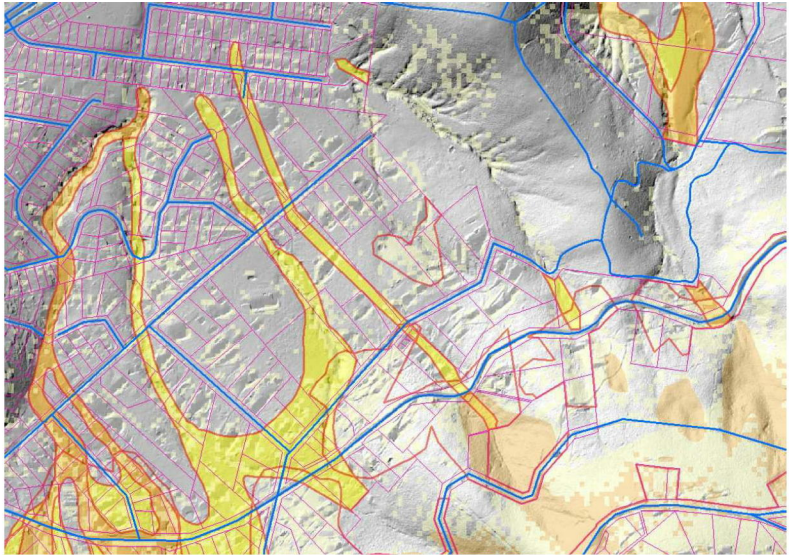
Submission 63

<p>There is a shallow gully, at some points buried directly downstream of a catchment area. The University of Melbourne modelling appears consistent with site observations. No change recommended through here.</p>

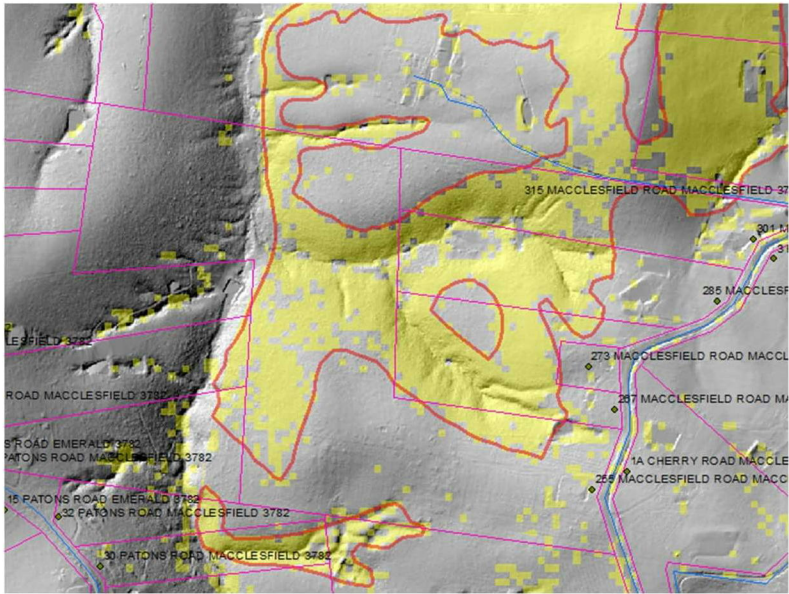
Submission 65

<p>The areas indicated as susceptible to landslide (areas in yellow in adjacent figure) could not be accessed in the field but are generally above the 11° slope angle threshold for the underlying Ferny Creek Rhyodacite geology, based on LiDAR elevation data.</p> <p>Some minor adjustment of the proposed EMO boundaries may be possible to only capture denser mapped susceptibility areas.</p>

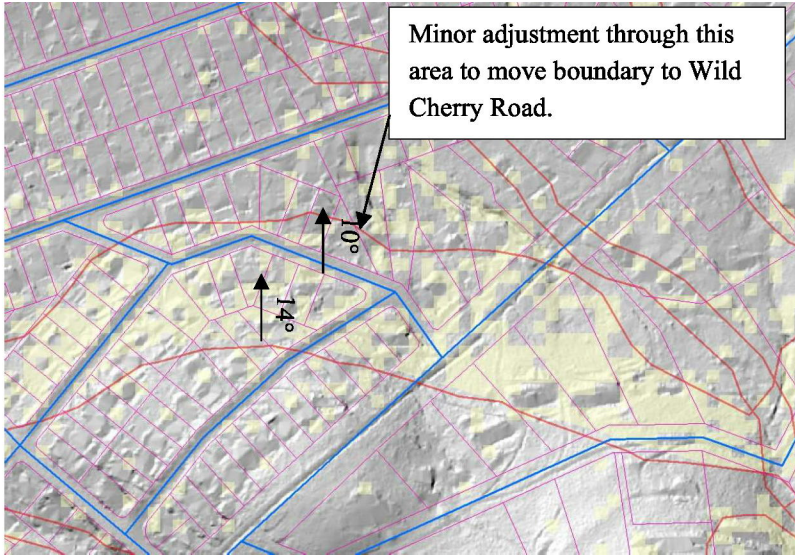
<p>Submission 67</p> <p>Natural slope angle downslope of Wild Cherry Road is about 10° and upslope is about 14°.</p> <p>Some minor adjustment of the proposed EMO boundaries may be possible to reflect the field observations and capture denser mapped susceptibility areas.</p>

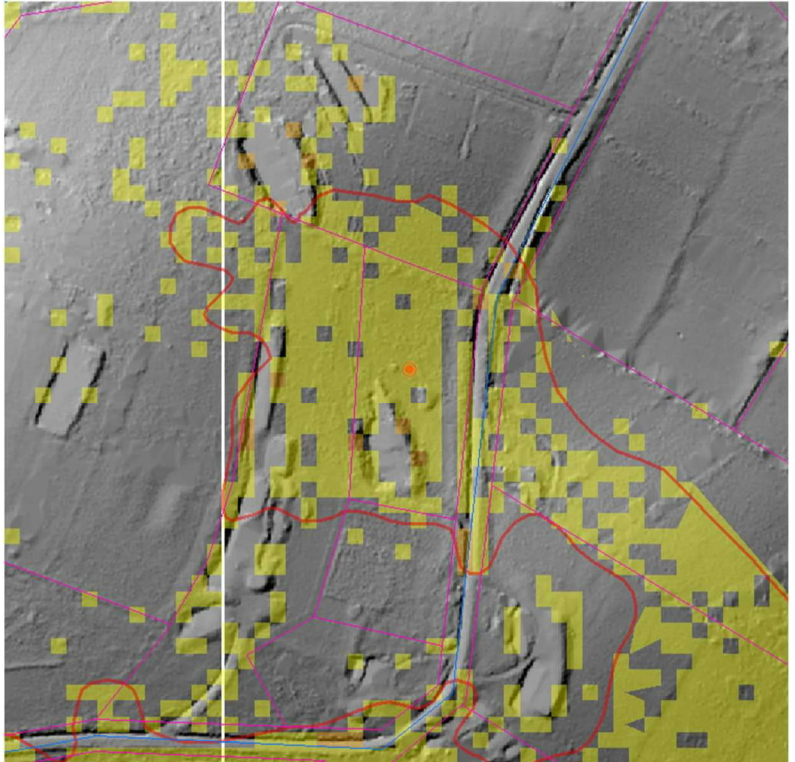
<p>Submission 68</p> <p>The natural slope angles measured from the eastern boundaries of the property were generally >16°, which is steeper than the threshold for inclusion of 11° in the EMO for areas underlain by Ferny Creek Rhyodacite geology such as this property.</p> <p>It is also noted that a relatively minor landslide is recorded in the historic YRSC database as having occurred at the property.</p> <p>We recommend that no change occur to the proposed EMO boundaries in relation to this property.</p>

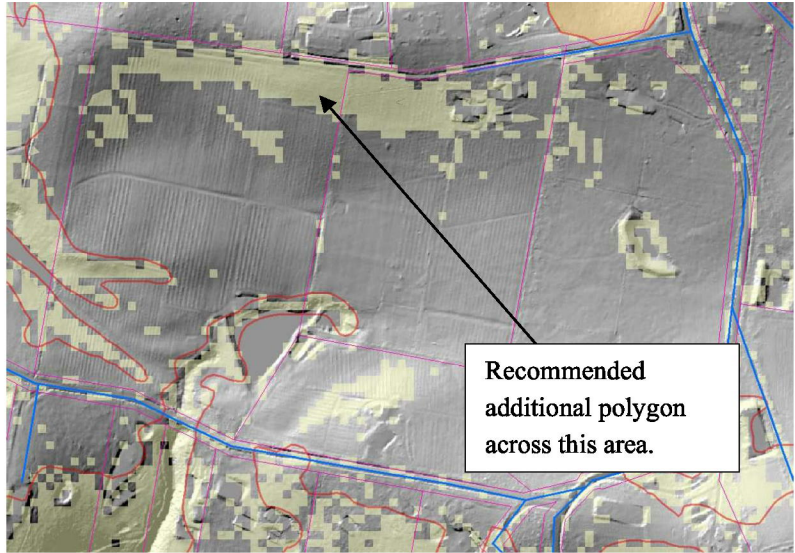
Submission 69

<p>Creek area that is delineated as susceptible is a deeply incised steep sided creek.</p> <p>There is a mapped susceptible area near the crest of the slope which has not been included and is recommended for inclusion.</p> <p>No change recommended to the other proposed susceptibility mapping through this area.</p>

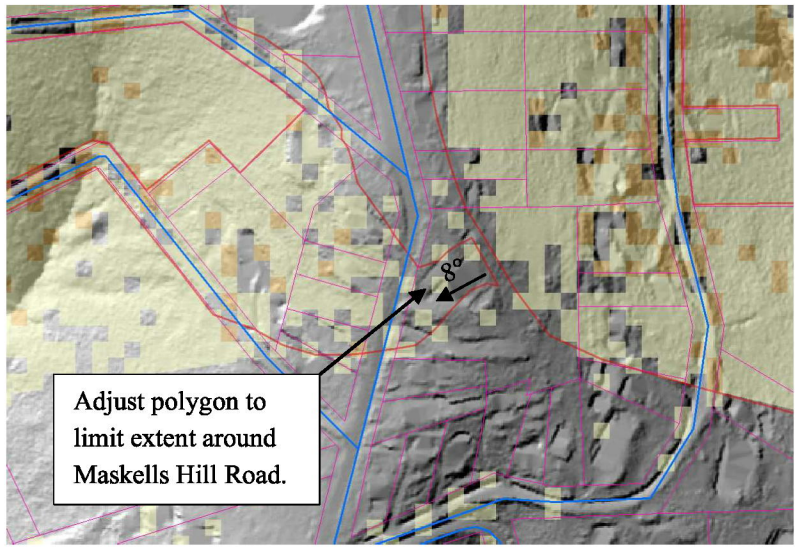
Submission 70

<p>The natural slope angle in the eastern portion of the polygon was measured at 8°, below the threshold for inclusion. Recommend adjusting polygon to remove this portion.</p>

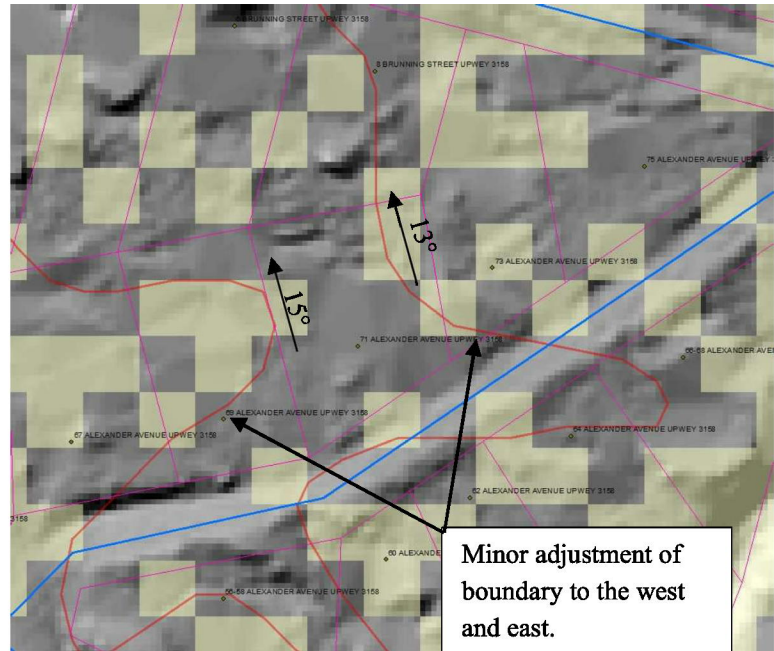
Submission 73

Natural slope angles are 13° to 15° adjacent to the house. Which exceeds the threshold for inclusion in the EMO.

Mapping at a finer scale and some minor adjustment of the proposed EMO boundaries may be possible to better capture denser mapped susceptibility areas.

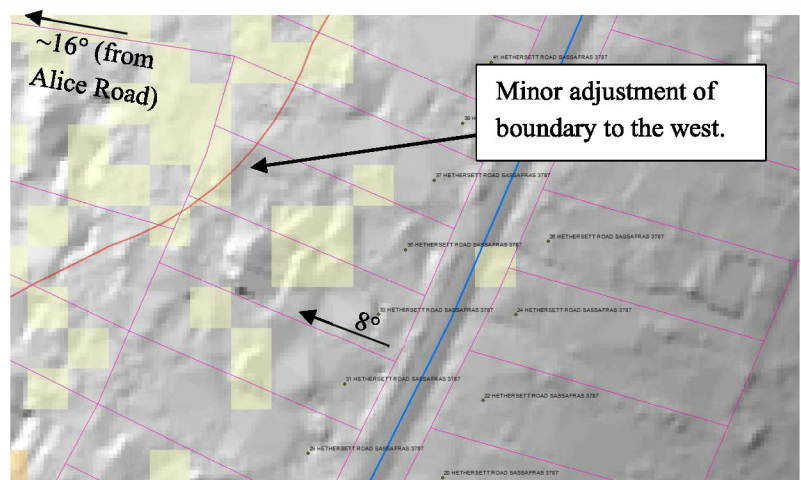
Submission 74

The natural slope angle at the eastern end of the property is 8° , below the threshold for inclusion. The natural slope angles on the properties to the west of 35 Hethersett Road (16 to 20 Alice Road) were measured to be 14° to 20° which is above the threshold for inclusion.

There is some scope to map in finer detail and to make minor adjustments to the boundary towards the west to align with areas of denser mapped susceptibility.

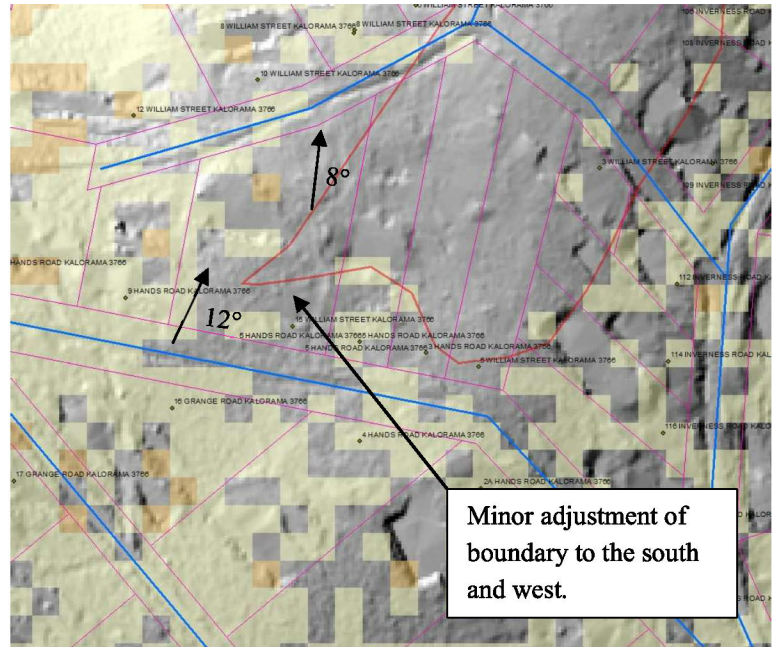
Submission 76

Natural slope angles are 8° at the William Street end of the property, 10° in the south east corner and 12° to 13° at the south west corner of the property, adjacent to Hands Road. The slope in the south west corner of the property has a slope angle above property is below the threshold for inclusion in the EMO.

There is scope to map at a finer scale and to make minor adjustments to the boundary on the south and west to western side of the property to better align with areas of denser mapped susceptibility.

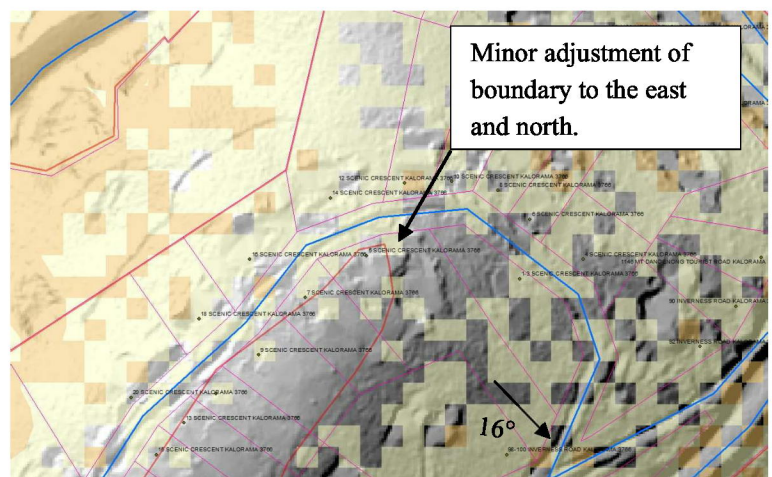
Submission 77

Natural slope angles in the south east part of the property are 16° , which is above the threshold for landslide susceptibility. The north west area of the property becomes flat at the crest of the ridge.

There is scope for more detailed mapping and minor adjustment of the boundary towards the east and north to align with areas of denser mapped susceptibility.
