Warburton Highway Developments Pty Ltd

2420 Warburton Hwy Yarra Junction

Arboricultural Construction Impact Assessment

Friday, 29 April 2022

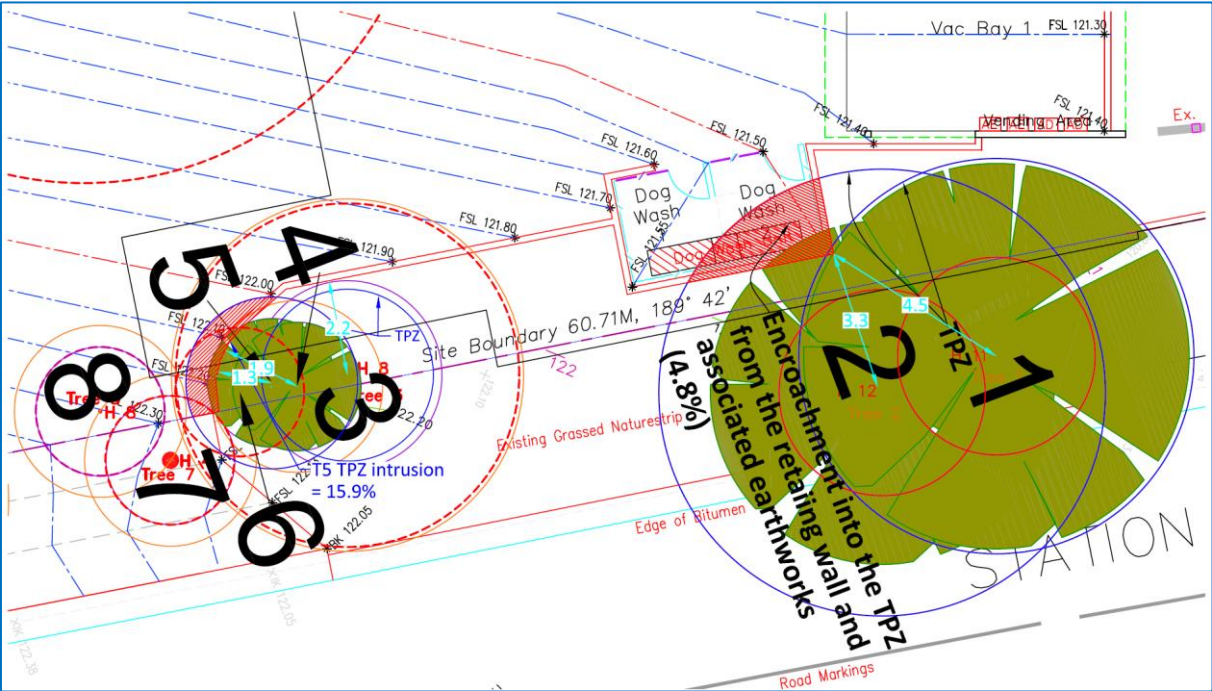
This tree will remain viable within the proposed development provided the recommendations of this report are adopted and effectively implemented.

Figure 1 Trees 2 & 5 TPZ intrusions

The excavation alignment should be excavated by hand and any significant tree roots must be neatly pruned by a qualified arborist using sharp hand tools.

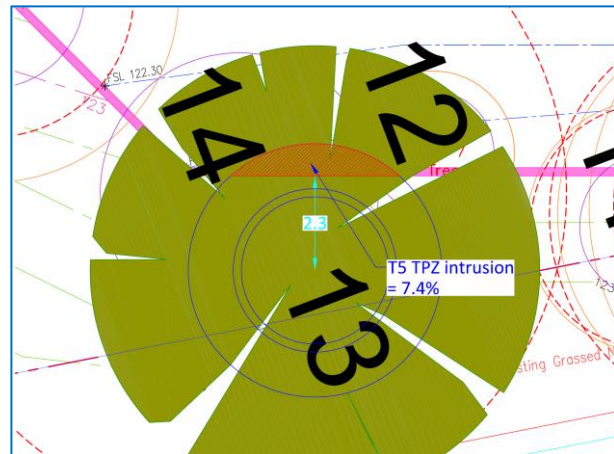
The hard standing edge and hard standing intrude into the TPZ for Tree 13 by 7.4% but does not intrude into the SRZ for this tree.

Under AS 4970 (2009) *Protection of Trees on Development Sites* this is considered to be a minor intrusion and is not expected to significantly impact on the tree. This tree is expected to remain viable within the proposed development.

Figure 2 Tree 13 TPZ intrusion

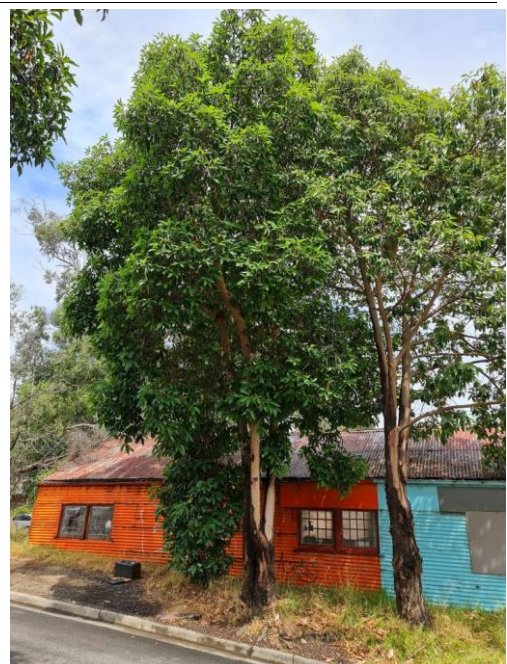
Tree ID: 2

Genus / species: *Lophostemon confertus*
 Evergreen Queensland Brush Box
Height (m): 12 **Structure:** Fair
Width (m): 8 **Health:** Good
DBH (cm): 43 Measured **Maturity:** Mature
Origin: Australian **ULE (years):** 30 - 60
Retained?: Retained **Form:** Good
Retention Value: Moderate
Removal / retention reason: Road reserve.
Amenity value: Moderate
Works Required: N/A.

SRZ (m): 2.4 **Works priority:** N/A
TPZ (m): 5.2 **Construction Proximity:** 3.3
mTPZ (m): = TPZ

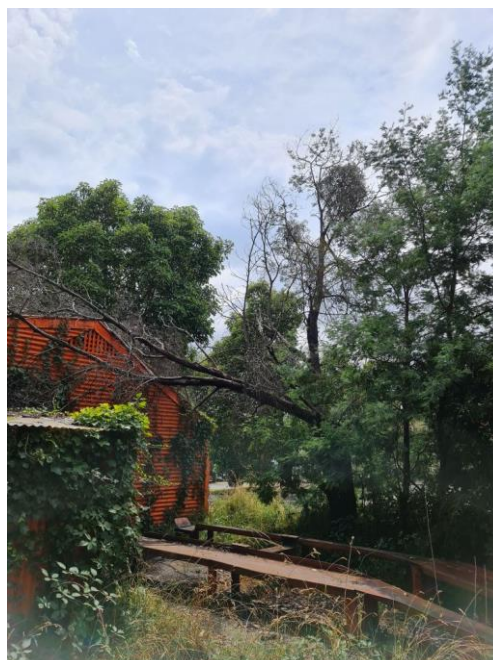
Tree ID: 3

Genus / species: *Acacia mearnsii*
 Evergreen Black Wattle
Height (m): 8 **Structure:** Very poor
Width (m): 8 **Health:** Very poor
DBH (cm): 34 Measured **Maturity:** Over mature
Origin: Melbourne **ULE (years):** 0
Retained?: Removed **Form:** Very poor
Retention Value: Remove.
Removal / retention reason: Structure ULE.
Amenity value: Very low
Works Required: N/A.

SRZ (m): 2.2 **Works priority:** High
TPZ (m): 4.1 **Construction Proximity:** 2.2
mTPZ (m): = TPZ

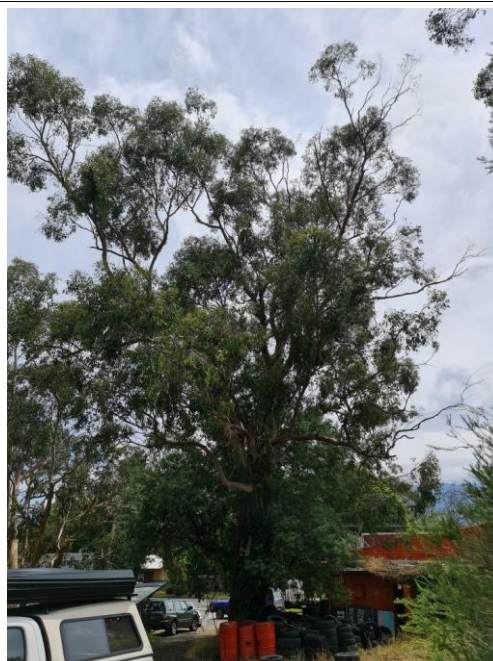
Tree ID: 18

Works Required: > 50mm dead wood, Aerial inspection.

SRZ (m): 3.4 **Works priority:** Moderate
TPZ (m): 13.2 **Construction Proximity:** 0.1
mTPZ (m): = TPZ
