Document Reference 16025L01

Application No YR – 2022/944 – 59 Morris Road, Upwey

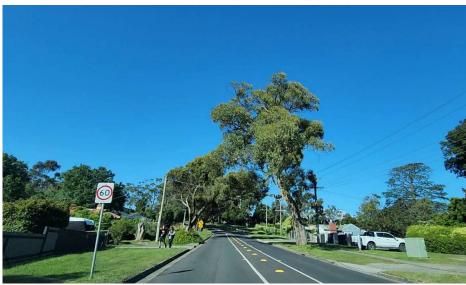
Figure 1: Morris Road facing north

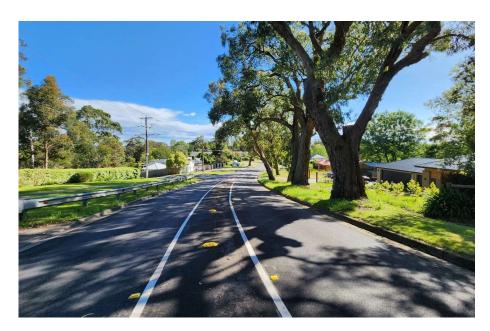
Figure 2: Morris Road facing south

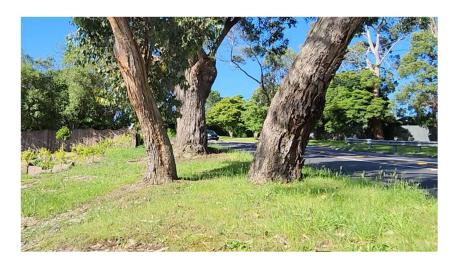
Movement to be accommodated onto Morris Road	Direction of Sight distance checked	Speed Limit	Desirable Sight Distance	Minimum Sight Distance	Sight Distance observed during site inspection
Left turn	South	60 km/h	83 m	65 m	96m
Right turn	North				41m

Figure 3: Drivers sight line facing north when egressing from 59 Morris Road

Whilst no crashes have occurred within the vicinity of the site in the most recent five year period it is noted the sight distance to the north of the site does not satisfy the sight distance requirements included in AS2890.1 This is generally not achieved for multiple sites along Morris Road including some intersections. It is noted however in the context of the subject site, vehicles travelling south along Morris Road are travelling down hill when approaching the subject site. This exacerbates the noncompliance of sight lines for right turning given vehicles would be likely to accelerate whilst travelling downhill towards the site and also require a greater distance to stop on the downhill slope. Drivers also have a restricted view of vehicles due to trunks of mature tree obstructs drivers' sightlines. Given the commercial use of the site proposed, drivers are unlikely to be familiar with the road conditions along Morris Road.

In light of the above it is recommended that "Left Only" signage is installed within the subject to restrict vehicle movements left only when egressing from the site. This can be implemented by way of permit condition.

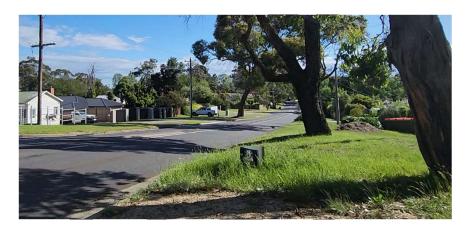
Figure 4: Drivers sight line facing south when egressing from 59 Morris Road
