ARBORICULTURAL & IMPACT ASSESSMENT REPORT

23 MADDENS LANE, GRUYERE

REPORT PREPARED FOR: MILLAR MERRIGAN

REPORT PREPARED BY: DAMIEN BURGESS
CONSULTING ARBORIST - DB HORTICULTURE PTY LTD.

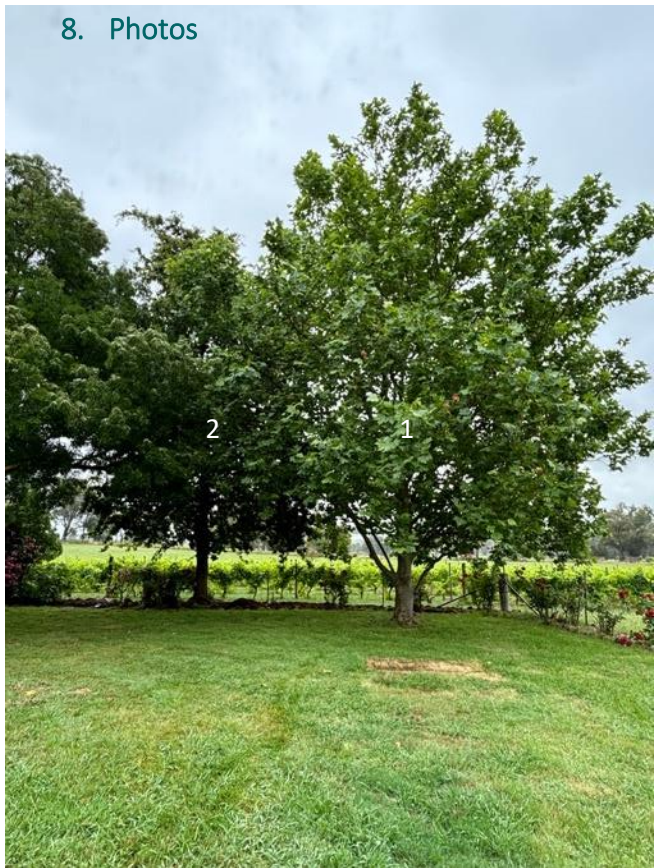
- Tree 1 – London Plane
- Tree 2 – English Oak
- Tree 3 – Desert Ash
- Tree 19 – Silver Elm
- Tree 23 – Swamp Mahogany Gum
- Tree 33 – Manna Gum
- Tree 34 – Manna Gum

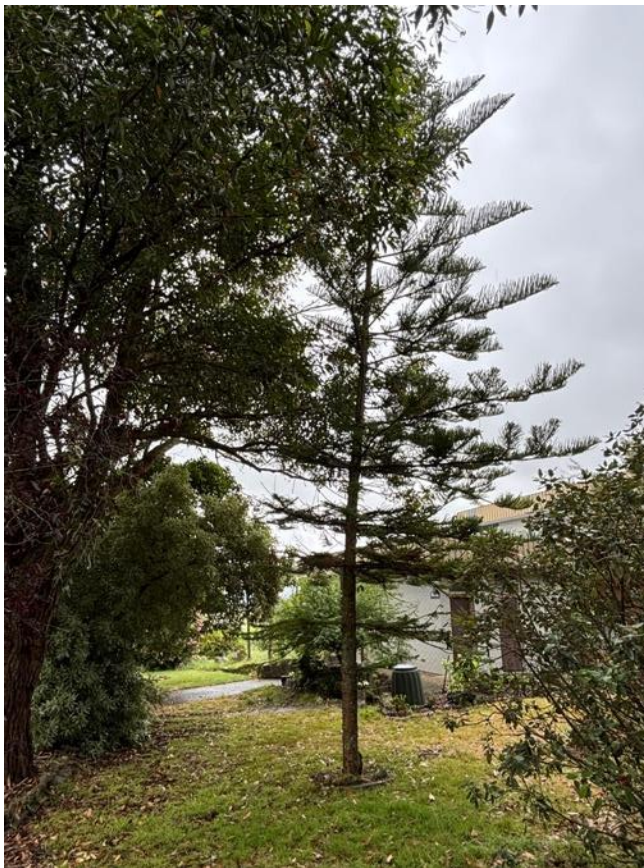
Tree 25

#	Species	Common name	Native/ Exotic	Height (m)	Spread (m)	DBH (cm)	TPZ (m)	SRZ (m)	SULE	Age	Condition	Structure	Form	Amenity value	Retention value	Comments
25	<i>Araucaria heterophylla</i>	Norfolk Island Pine	E	10	4	19	2.3	1.8	L	SM	F	G	G	P	L	
26	<i>Cotoneaster glaucophyllus</i>	Cotoneaster	E						R						L	Permit exempt weed species
27	<i>Cotoneaster glaucophyllus</i>	Cotoneaster	E						R						L	Permit exempt weed species
28	<i>Acer negundo</i>	Box Elder	E	10	7	24	2.9	2.1	L	SM	G	G	G	P	L	
29	<i>Platanus x acerifolia</i>	London Plane	E	8	6	42	5.0	2.5	L	SM	G	F	G	P	L	
30	<i>Pittosporum undulatum</i>	Sweet Pittosporum	N						R						L	Permit exempt weed species
31	<i>Pittosporum undulatum</i>	Sweet Pittosporum	N						R						L	Permit exempt weed species
G32	<i>Ulmus glabra</i>	Wych Elm	E	12	6	18/20/15	3.7	2.1	L	SM	F	F	F	P	L	Nine trees assessed as a group
33	<i>Eucalyptus viminalis</i>	Manna Gum	N	15	5	35	4.2	2.3	L	SM	G	G	G	F	M

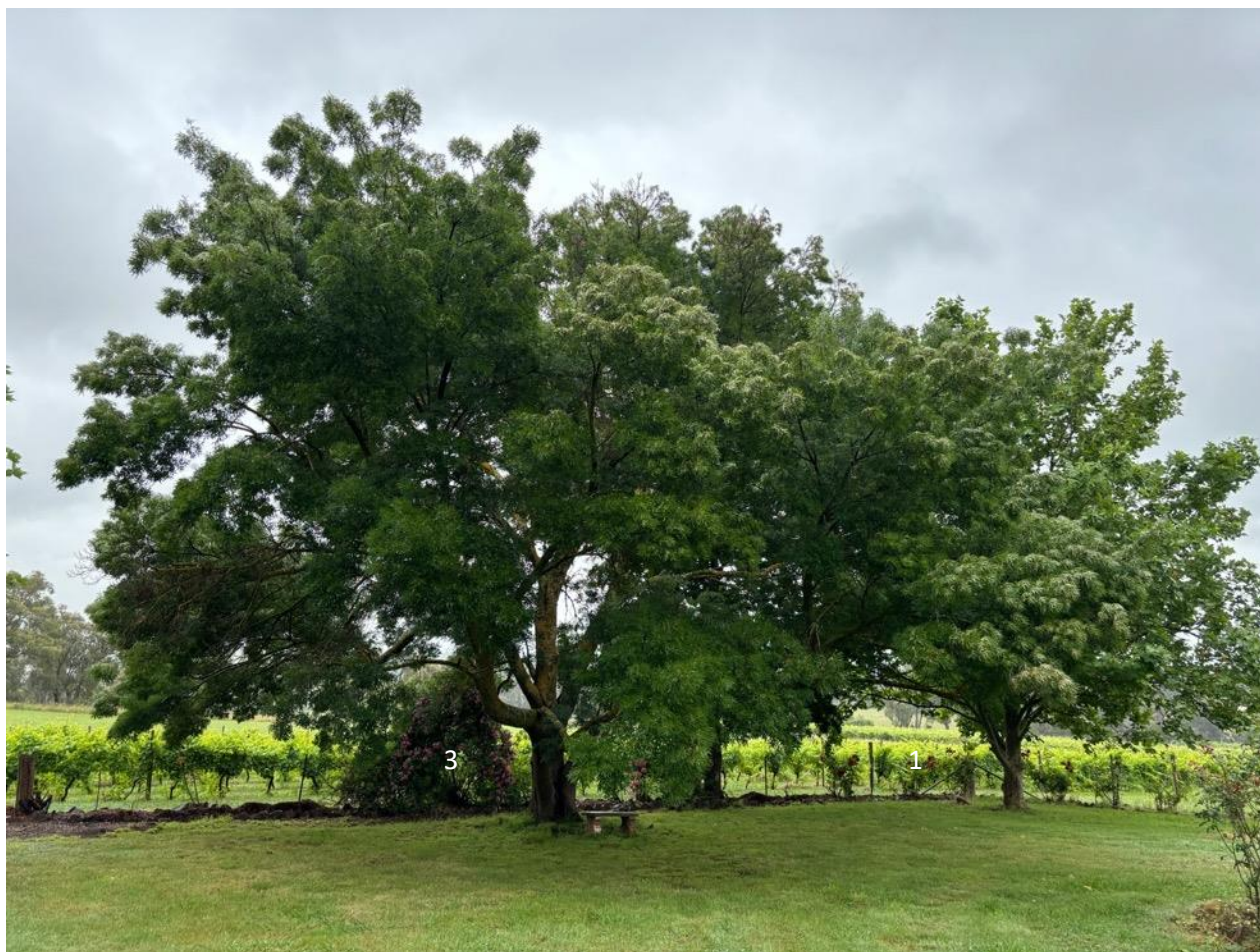
Trees 1 & 3

It is noted that Tree 3, the Desert Ash is a permit exempt weed species, however this tree is a very good specimen which provides good amenity value to the site and should be considered for retention.

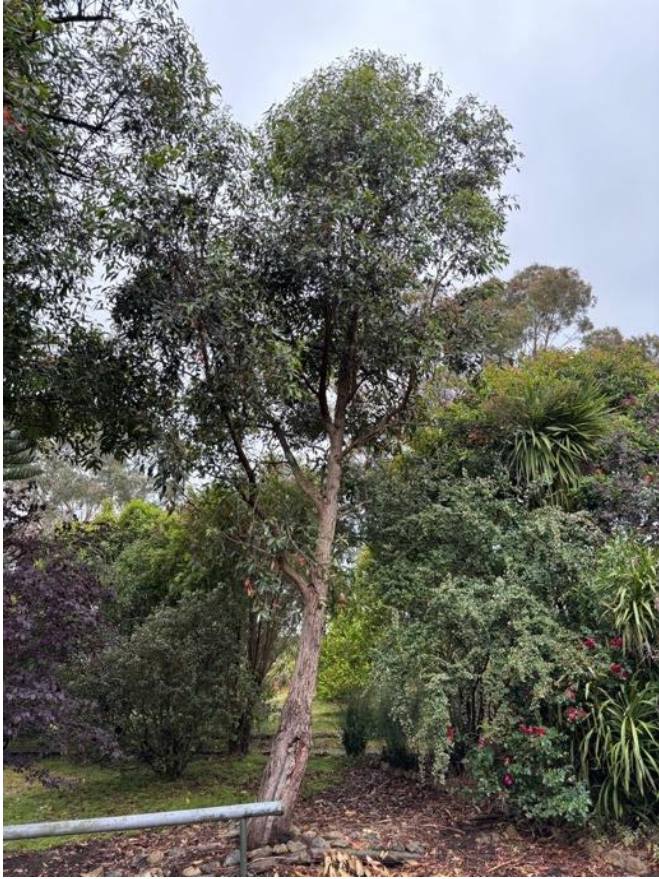
Tree 24

24	<i>Corymbia ficifolia</i>	Red-flowering Gum	N	13	6	29	3.5	2.3	L	M	G	P	F	P	L

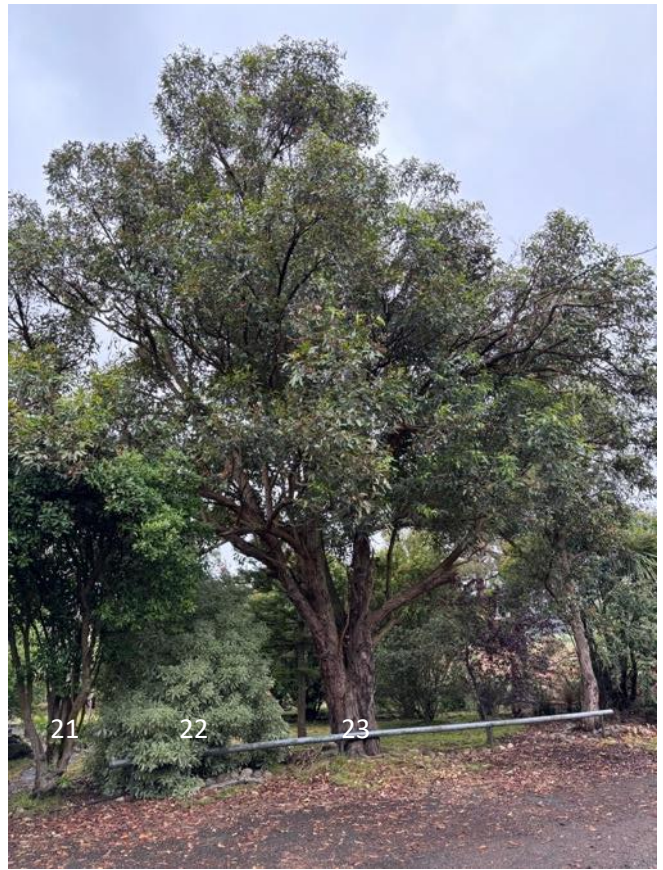
Trees 21-23

11	<i>Acer pseudoplatanus</i>	Sycamore Maple	E						R						L	Permit exempt weed species
12	<i>Ligustrum lucidum</i>	Glossy Privet	E						R						L	Permit exempt weed species
13	<i>Ulmus glabra</i>	Wych Elm	E	12	8	35/26	5.2	2.3	L	M	G	G	G	P	L	
14	<i>Ulmus glabra</i>	Wych Elm	E	11	9	20/23	3.7	2.3	L	M	G	F	G	P	L	
15	<i>Acer negundo</i>	Box Elder	E	7	4	13	2.0	1.6	L	SM	G	G	G	P	L	
16	<i>Acer negundo</i>	Box Elder	E	8	6	12/12/12	2.0	1.8	L	SM	G	F	G	P	L	
17	<i>Acer negundo</i>	Box Elder	E	9	7	18/14	2.7	2.1	L	SM	G	F	G	P	L	
18	<i>Acer negundo</i>	Box Elder	E	8	4	18	2.2	1.9	L	SM	G	G	G	P	L	
19	<i>Ulmus minor 'Variegata'</i>	Silver Elm	E	14	9	38	4.6	2.5	L	M	G	G	G	F	M	
20	<i>Acer negundo</i>	Box Elder	E	8	5	12/17	2.5	1.8	L	SM	G	F	G	P	L	
21	<i>Photinia robusta</i>	Photinia	E	7	5	12/12/12	2.5	1.7	L	SM	F	F	F	P	L	
22	<i>Pittosporum eugenoides 'Variegatum'</i>	Variegated Pittosporum	E	5	3	12/12	2.0	1.7	L	M	G	F	G	P	L	
23	<i>Eucalyptus robusta</i>	Swamp Mahogany	N	15	15	91	10.9	3.4	L	M	G	P	G	G	M

- **The proposed effluent fields are 15.0m away from adjacent neighbouring trees to the west and are therefore outside Tree Protection Zones.**
- A small extension is proposed to the north side of the existing, central gravel carpark, which will result in encroachment into the TPZ's of **Trees 13, 19 and 23**. In all cases, encroachment is <2%. **These trees can be viably retained.**

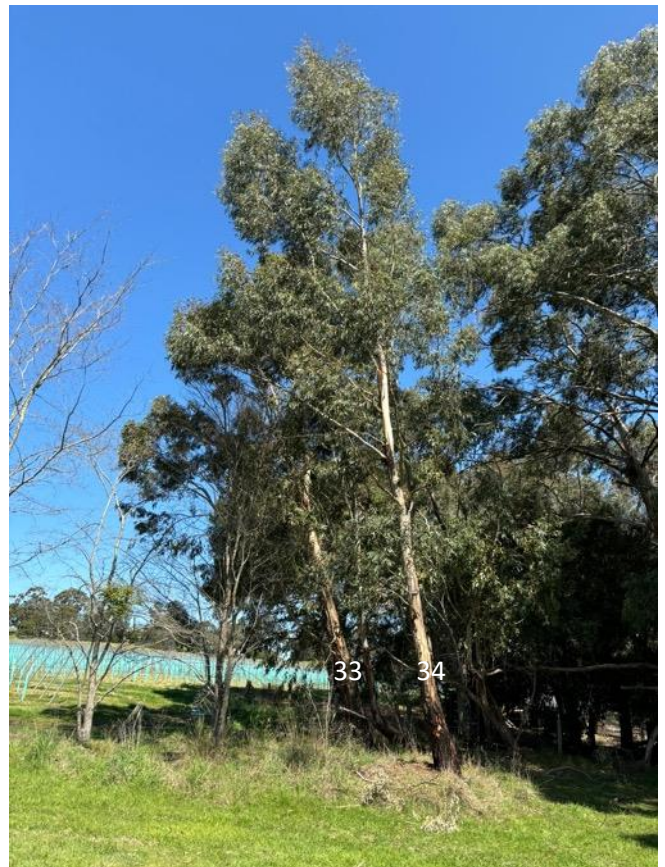
Trees 33 & 34

34	<i>Eucalyptus viminalis</i>	Manna Gum	N	13	8	50	6.0	2.6	L	SM	G	G	G	F	M	
35	<i>Betula pendula</i>	Silver Birch	E	9	4	20	2.4	2.0	L	M	G	G	G	P	L	
36	<i>Fraxinus angustifolia</i>	Desert Ash	E	8	3	16	2.0	1.7	R	SM	G	G	G	P	L	Permit exempt weed species
<p><i>*Dimensions listed for neighbouring trees are estimates due to site inaccessibility *Trees listed in red are rated as Low Retention Value</i></p>
