Peer Review of Stage 1a Lilydale Heritage Review Gap Study Lilydale Heritage Study (Task 1)

Prepared for Yarra Ranges Shire Council

October 2021 — Final

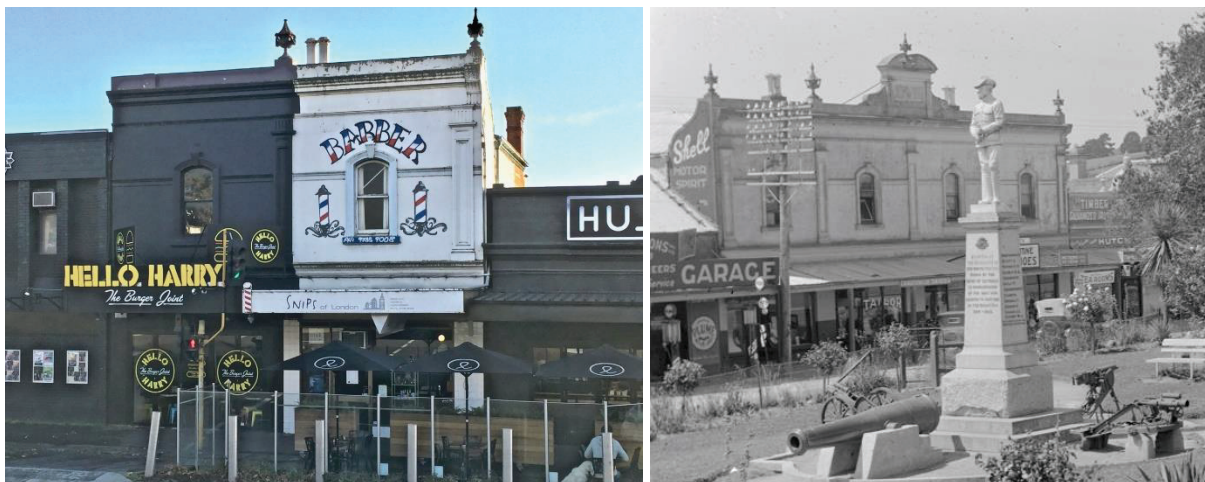
Figure 1. Contemporary image of the Poyner shops in comparison with a historical image (c.1930s) showing the previous built form and detailing. Half of the building and other detailing has been demolished, and the lower façade heavily altered.

- A review of this citation, in particular the level of integrity and the application of HERCON criteria, shows that the argument for inclusion of this property on the HO is weak and that the building does not meet the threshold for local heritage significance.
- The place comprises a pair of attached double storey shops with storefronts on the ground floor and residences on the upper storey. However, this building has low physical integrity overall, having originally formed part of a much larger and more elaborate terrace group with four individual stores and residences (refer to Figure 1). The following key changes are noted:

- Half of the building has been demolished and replaced with the structure at 243 Main Street;
- The parapet has been heavily altered with the removal of two of the four urns and the large central pediment;
- The left engaged pilaster (which was once in the middle of the façade) has been removed from 245 Main Street; and
- The ground floor shop fronts have been completely altered.

With the above changes in mind, only one quarter of the original façade and half the roof form is intact. The overall integrity is low.
