**REPORT**

# Yarra Ranges Erosion Management Overlay

## *Basis for Mapping Amendment*

PS134170-010-R-Rev1

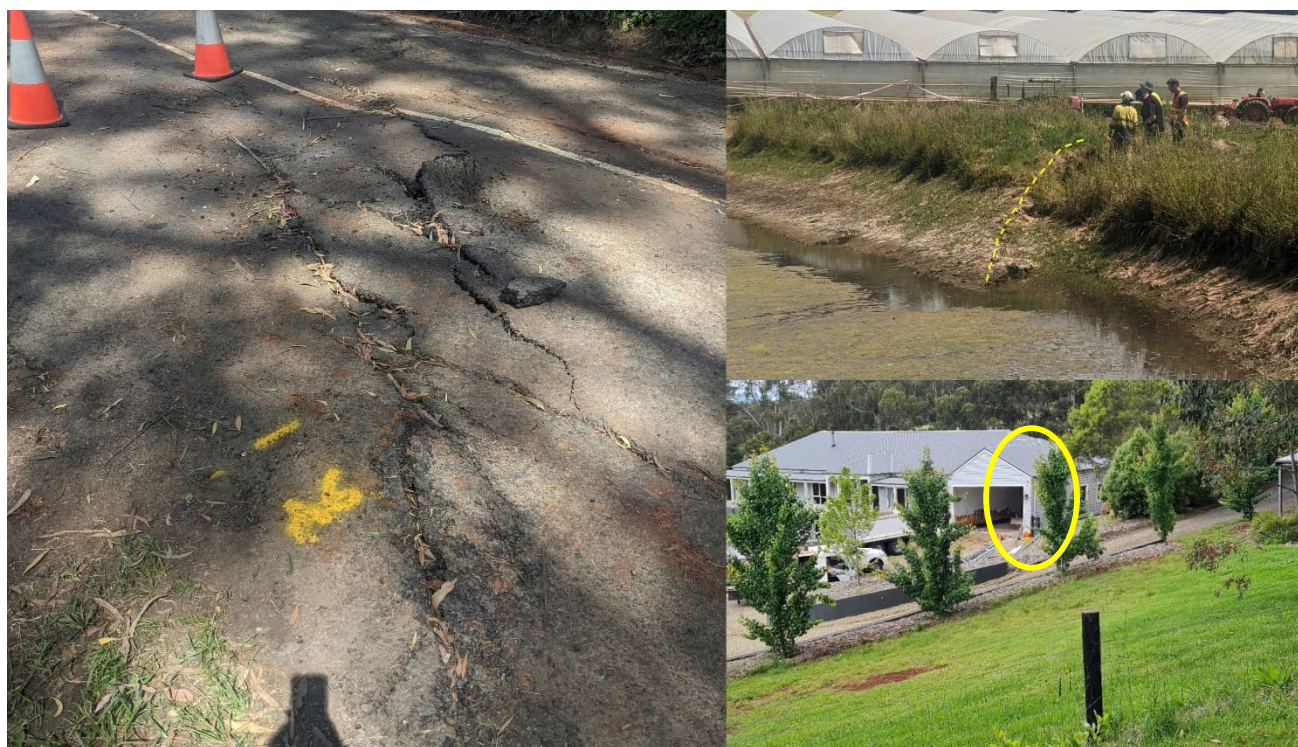
**Figure 9: Recent infrastructure damage, Monbulk-Seville Road, Seville. Left: Damage to road. Top right: Landslide scarp through dam wall. Bottom right: Damage to property.**

A relatively large landslide occurred in October 2022 occurred across Monbulk – Seville Road in Seville which caused damage to the road, an adjacent house and a dam upslope of the road (Figure 9). The recent ground movement appears to have occurred on ground that could have previously been subject to landslide. However, based on LiDAR terrain information, the evidence for a previous landslide is subdued and had not previously been identified (Figure 10), nor was the area in which the landslide occurred within the extent of the current EMO. The overall slope angle at the site is about 5°, which is not steep enough to meet the requirements for inclusion in the EMO based on the existing slope angle criteria (Table 1).

It is possible that the landslide is associated with nearby development including a dam and earthworks which triggered reactivation of the ancient landslide. It may also indicate that landslides in the Tertiary Older Volcanics are susceptible to remobilisation at lower slope angles than is assumed in the susceptibility mapping which informs the current EMO extent. Had this area been subject to the EMO, the dam and earthworks which are inferred to have contributed to the landslide reactivation may have been constructed differently or not at all, possibly preventing the damage that has occurred. This case provides evidence and a basis to include ancient subdued landslides within the Tertiary Older Volcanics within the EMO.
