Arboricultural Assessment and Tree Impact Report

41 Monbulk Road,
Mount Evelyn

8 February 2022

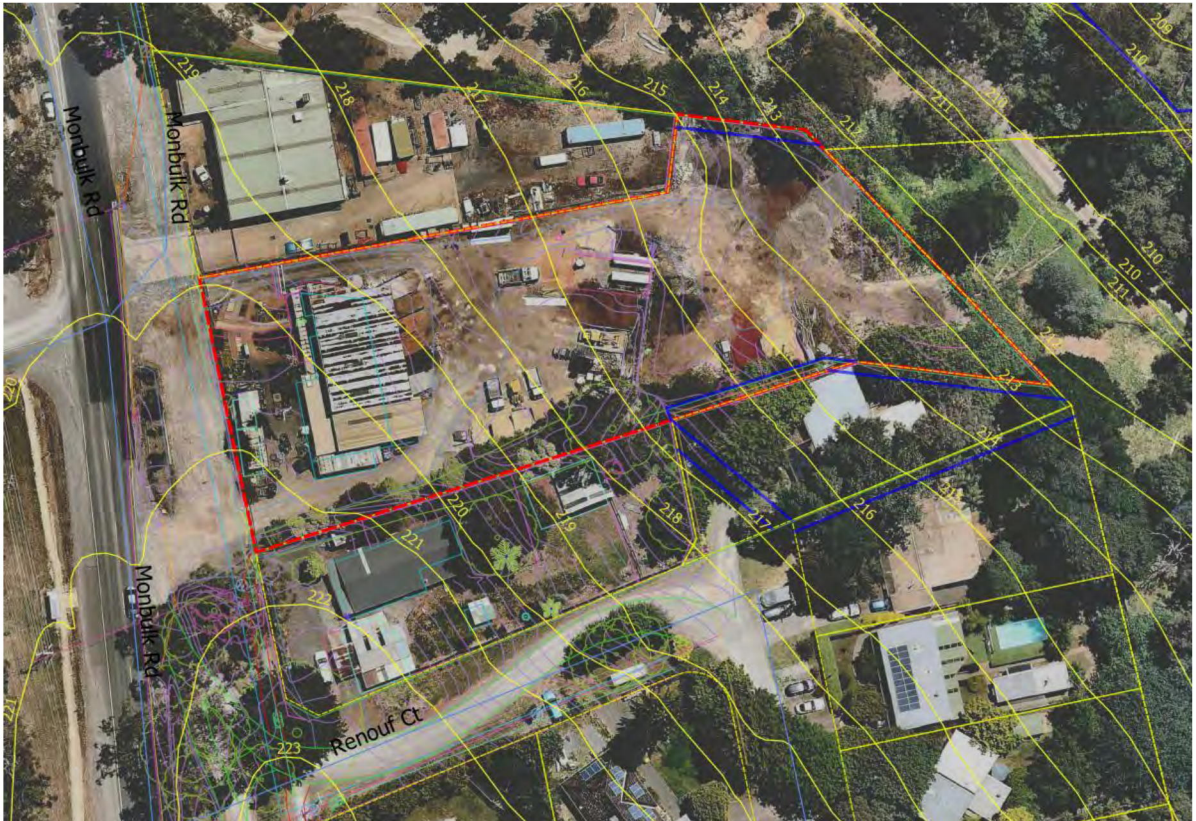
Plate 1. Aerial view of the subject sites, 41 Monbulk Road, Mount Evelyn. Red dash line indicates extents of tree study area. Yellow contour lines are shown. Blue lines indicate approved easements.

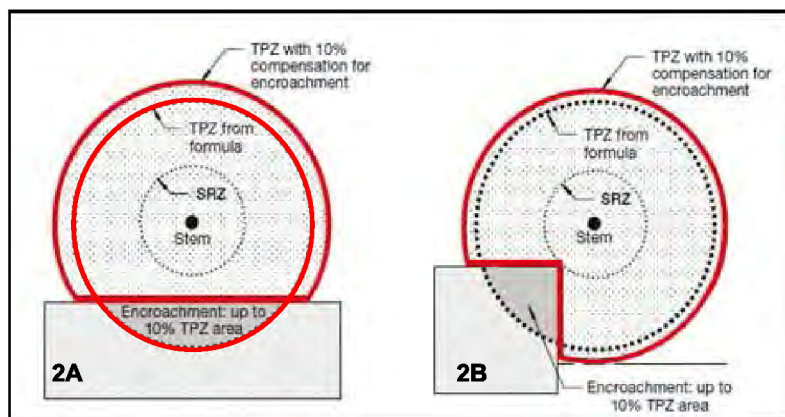
Figure 2: 2A & 2B - Examples of minor encroachment into a TPZ.

Extract from: AS4970-2009, Appendix D, pg. 30 of 32

Minor encroachment, up to 10% of the TPZ area, is generally permissible provided encroachment is compensated for by recruitment of an equal area contiguous with the TPZ. Encroachment greater than 10% is considered major encroachment under AS4970 and is only permissible if it can be demonstrated that after such encroachment the tree would remain viable. Refer to Figure 2A and 2B.

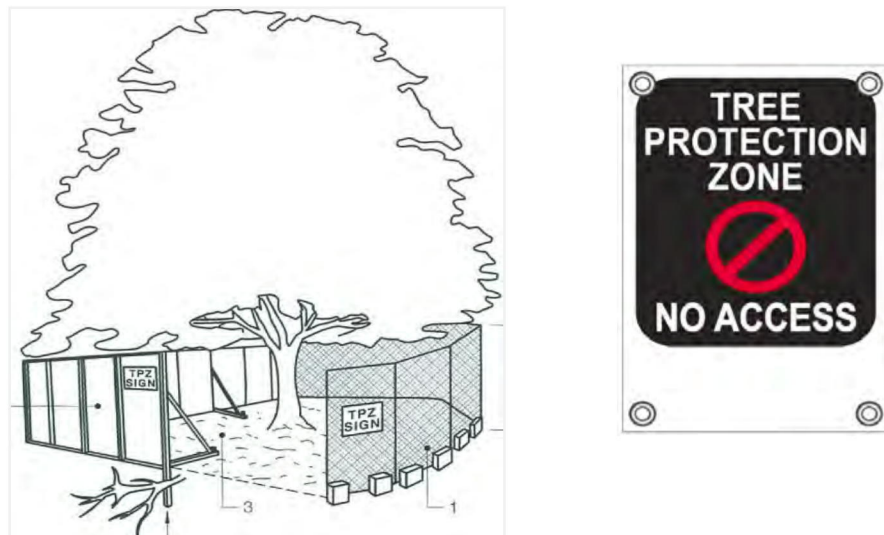
Figure 1. Above left - Example of TPZ fencing above right -Example of TPZ signage.

- 7.5 Appropriate signage stating 'Tree protection Zone- No access' is to be fixed to the fencing to alert people as to importance of the tree protection zone.
Refer to Figure 1 for fencing example.

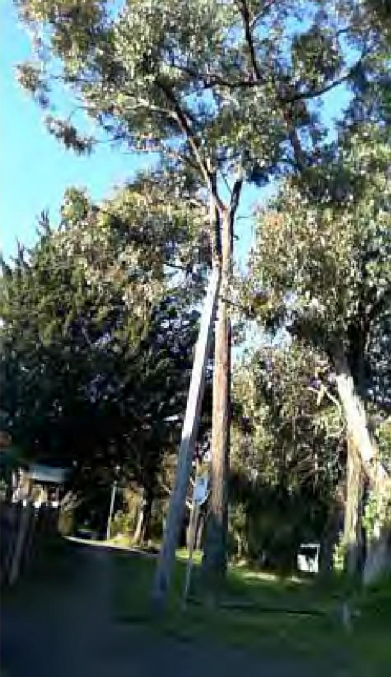
Tree No: 1. Brown Stringybark
(*Eucalyptus baxteri*) Maturing, Indigenous
DBH: 62cm. Height x Width: 23 x 15m.
Arb. Rating: Moderate B. TPZ: 7.4m rad.

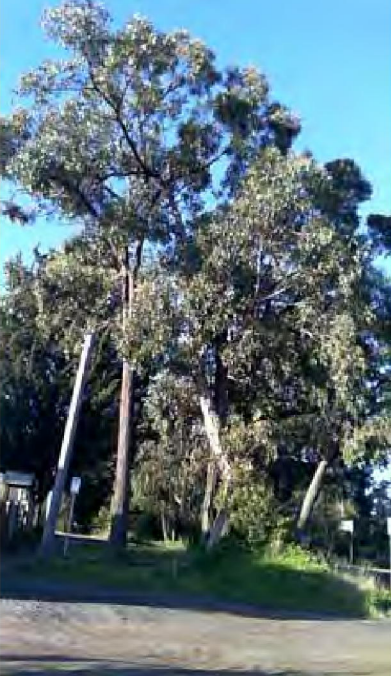
Tree No: 2. Messmate Stringybark
(*Eucalyptus obliqua*) Maturing, Indigenous
DBH: 63,62cm. Height x Width: 21 x 14m.
Arb. Rating: Moderate B. TPZ: 10.6m rad.

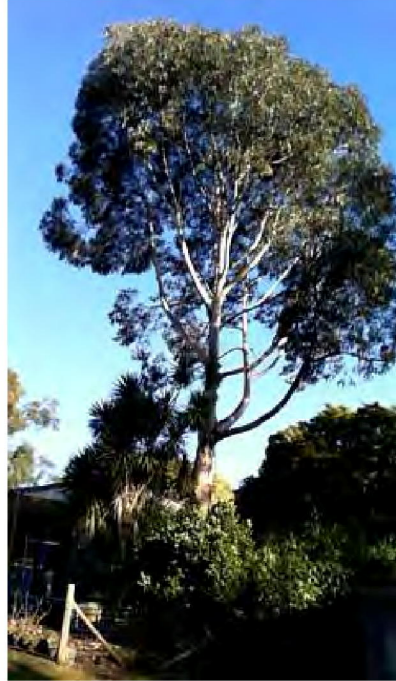
6.3 Tree 3, Victorian Blue Gum, located in the rear yard of 43 Monbulk Road has structural deficiencies associated with advancing wood decay that will reduce the long-term safety and viability of the tree. The driveway will encroach the TPZ of Tree by less than 2% in an area that has a long history of being used as a driveway within the garden centre. Refer to Plate 3.

- 8.4 The trees generally displayed health and structural condition considered to be typical and acceptable for these species and age growing in this area under prevailing conditions with the exception of Tree 3 which displayed evidence of progressing trunk and limb decay.

Tree No: 3. Victorian Blue Gum
(*Eucalyptus globulus subsp. bicostata*)
Maturing, Victorian native
DBH: 81cm. Height x Width: 21 x 17m.
Arb. Rating: Low (Decay affected).
TPZ: 9.7m rad.

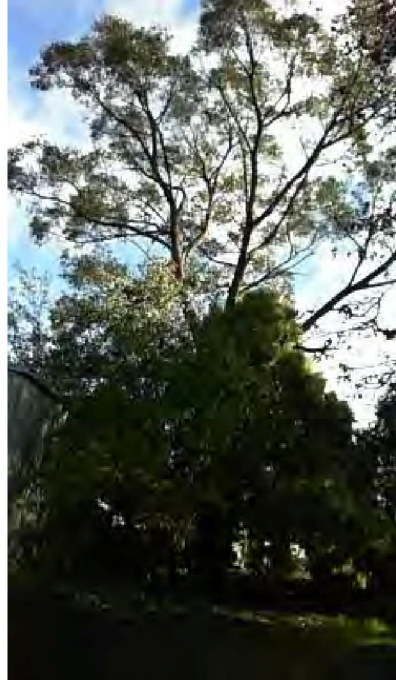
4	<i>Eucalyptus obliqua</i>	Messmate Stringybark	Maturing	Indigenous	89	22	19	Fair	Fair	Moderate B	11-20 y	Low	Hangers, Minor dieback, Over-extended limbs, Past branch failure, Possible hanger caught up in top of hedge trees	52.12 exempt, IZ, 52.17	10.7	3.4	TPZ (major)	21.51
5	<i>Allocasuarina torulosa</i>	Rose She-oak	Over-mature	Australian native	47,40,40 (est.)	14	14	Fair	Fair to Poor	Moderate C	6-10 y	Low	Acute forks, Included bark forks, Multi-stemmed, Neighbour's tree, Past stem failure	Neighbour's tree, SLO22	8.8	3.0	TPZ	5.42
6	<i>Liquidambar formosana</i>	Fornosan Evergreen Liquidamber	Maturing	Exotic deciduous	70 (est.)	13	14	Fair	Fair to Poor	Moderate B	11-20 y		Neighbour's tree, ~5m off boundary	Neighbour's tree, SLO22	8.4	2.9	TPZ	0.61
7	<i>Cryptomeria japonica</i>	Japanese Cedar	Early-mature	Exotic conifer	37 (est.)	14	8	Fair	Fair	Moderate B	11-20 y		Neighbour's tree, Partly suppressed - crown bias, NE. Impacting fence	Neighbour's tree, SLO22	4.4	2.3	TPZ	0.58

Tree No: 4. Messmate Stringybark
(*Eucalyptus obliqua*) Maturing, Indigenous
DBH: 89cm. Height x Width: 22 x 19m.
Arb. Rating: Moderate B. TPZ: 10.7m rad.

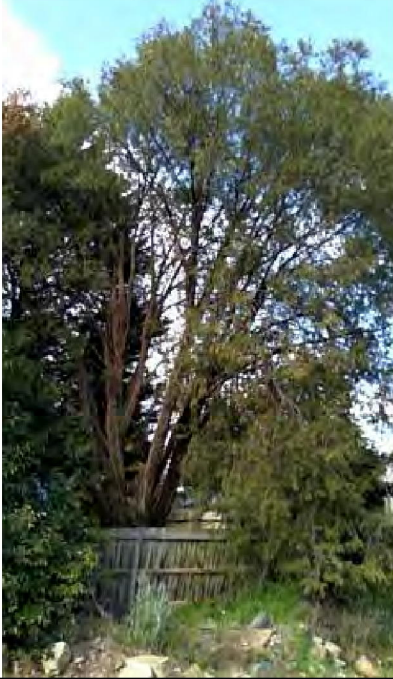
Tree No: 5 Rose She-oak
(*Allocasuarina torulosa*) Over-mature,
Australian native. DBH: 47,40,40
(est.)cm. Height x Width: 14 x 14m.
Arb. Rating: Moderate C. TPZ: 8.8m rad.

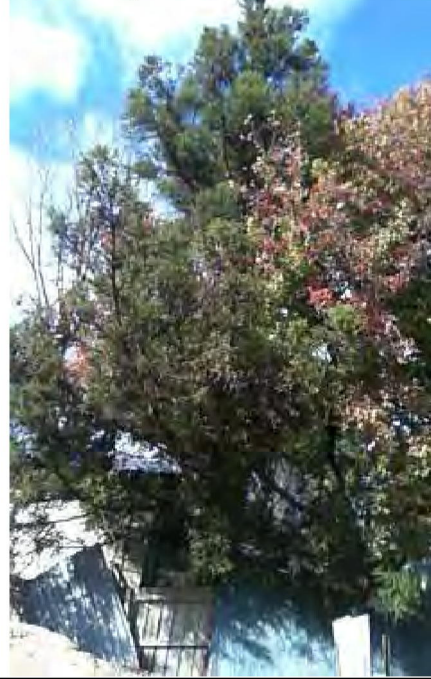
Tree No: 7. Japanese Cedar
(*Cryptomeria japonica*) Early-mature,
Exotic conifer. DBH: 37(est.)cm.
Height x Width: 14 x 8m.
Arb. Rating: Moderate B. TPZ: 4.4m rad.

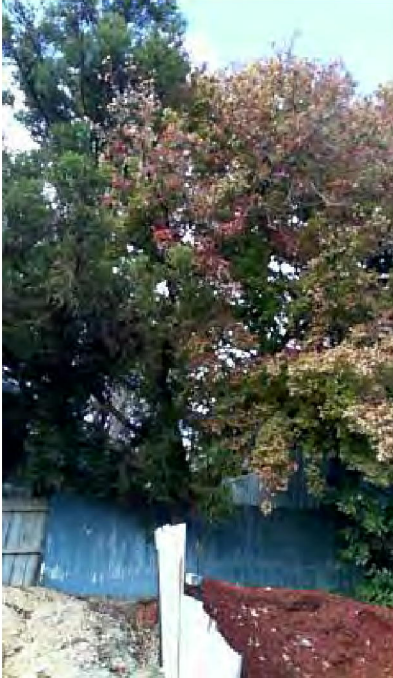
Tree No: 6. Formosan Evergreen Liquidamber
(*Liquidambar formosana*) Maturing, Exotic
deciduous. DBH: 70 (est.)cm. Height x Width:
13 x 14m. Arb. Rating: Moderate B. TPZ: 8.4m
rad.

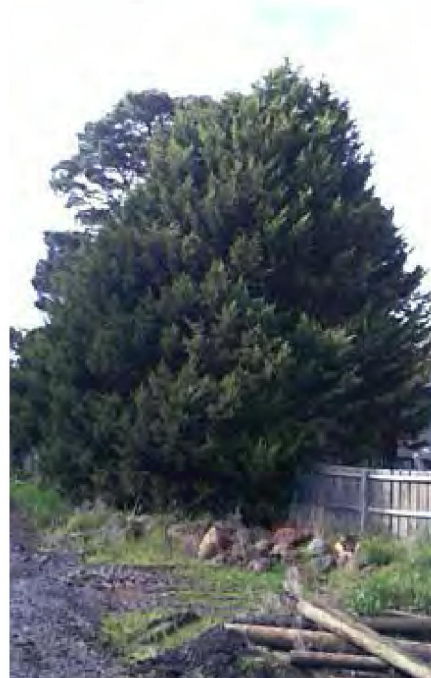
Tree No: 8. Leyland Cypress
(*XCupressocyparis leylandii*)
Maturing, Exotic conifer DBH: 50,40 (est.)cm.
Height x Width: 14 x 14m.
Arb. Rating: Moderate C. TPZ: 7.7m rad.

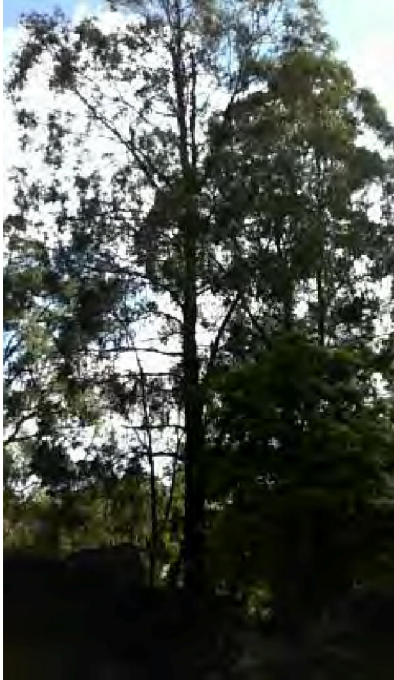
Tree No: 9. Manna Gum
(*Eucalyptus viminalis*) Early-mature,
Indigenous DBH: 55 (est.)cm.
Height x Width: 23 x 13m.
Arb. Rating: Moderate B. TPZ: 6.6m rad.

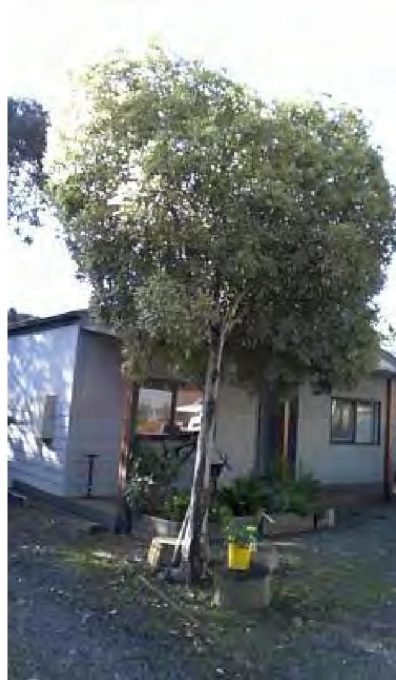
Tree No: 11. Variegated Tarata
(*Pittosporum eugenioides 'Variegatum'*)
Early-mature, Exotic evergreen
DBH: 14cm. Height x Width: 4 x 4m.
Arb. Rating: Low. TPZ: 2.0m rad.

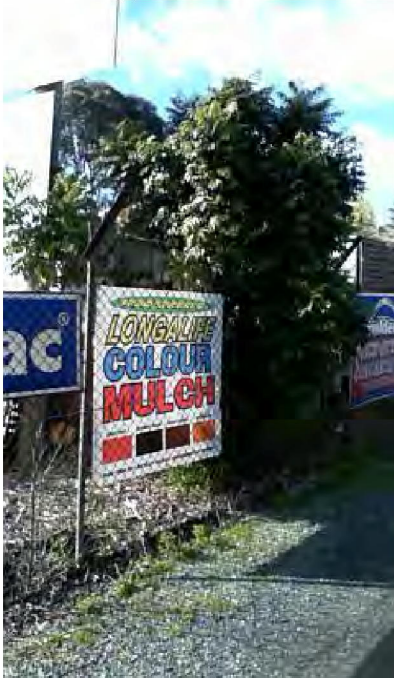
Tree No: 10. Black Bean
(*Castanospermum australe*) Early-mature,
Australian native. DBH: 12,4,4,3cm.
Height x Width: 3 x 3m.
Arb. Rating: Low. TPZ: 2.0m rad.

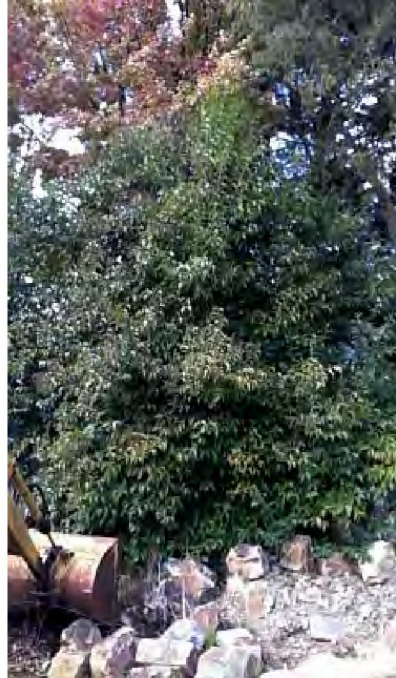
Tree No: 12. Shining Privet
(*Ligustrum lucidum*) Early-mature,
Exotic evergreen. DBH: 10,9,9,9,8cm.
Height x Width: 5 x 5m.
Arb. Rating: Very Low. TPZ: 2.0m rad.

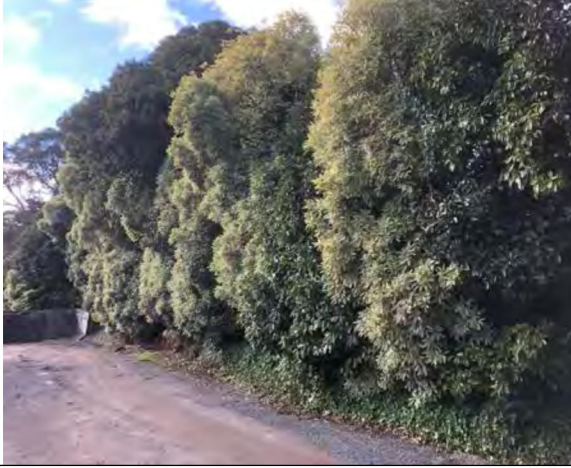
Tree No: Group 1. Chinese Hawthorn,
Variegated Tarata, Sweet Pittosporum
(*Photinia serratifolia*; *Pittosporum eugenioides*
'*Variegatum*'; *Pittosporum undulatum*) Early-
mature, Exotic evergreen & Victorian native
DBH: ~20,18,17,14,10cm.
Height x Width: ~7 x 7m.
Arb. Rating: Moderate C. TPZ: 4.3m rad.

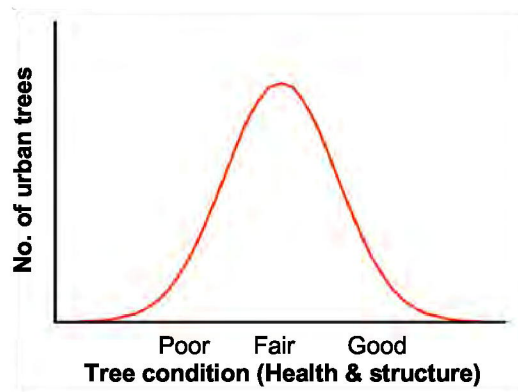
Diagram 1: Indicative normal distribution curve for tree condition

Diagram 1, provides an indicative distribution curve for tree condition to illustrate that within a normal tree population the majority of specimens are centrally located within the condition range (normal distribution curve). Furthermore, that those individual trees with an assessed condition approaching the outer ends of the spectrum occur less often.

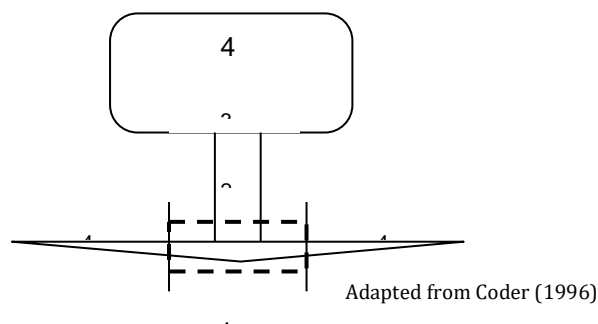
1. Root plate & lower stem
2. Trunk
3. Primary branch support
4. Outer crown & roots

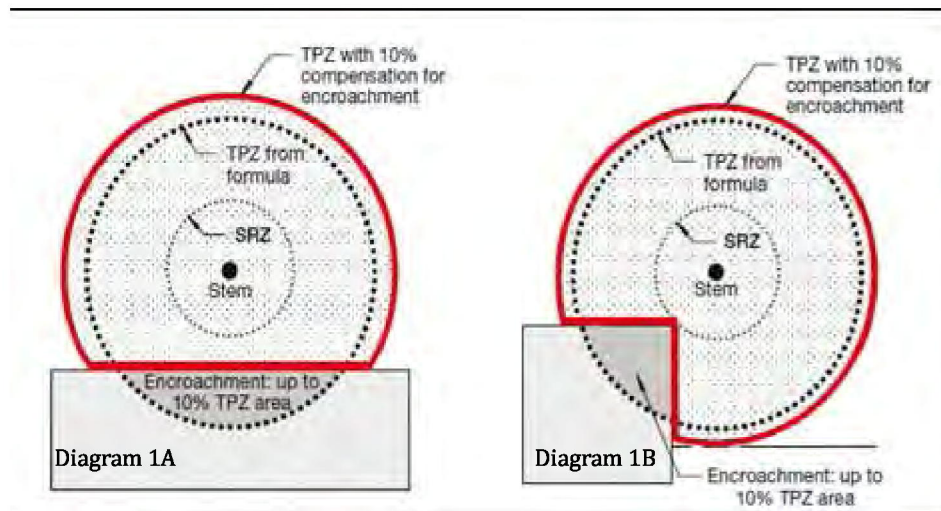
Diagram 1: Examples of minor encroachment into a TPZ.

(Extract from: AS4970-2009, Appendix D, p30 of 32)

The 10% encroachment on one side equates to approximately $\frac{1}{3}$ radial distance. Tree root growth is opportunistic and occurs where the essentials to life (primarily air and water) are present. Heterogeneous soil conditions, existing barriers, hard surfaces and buildings may have inhibited the development of a symmetrically radiating root system.

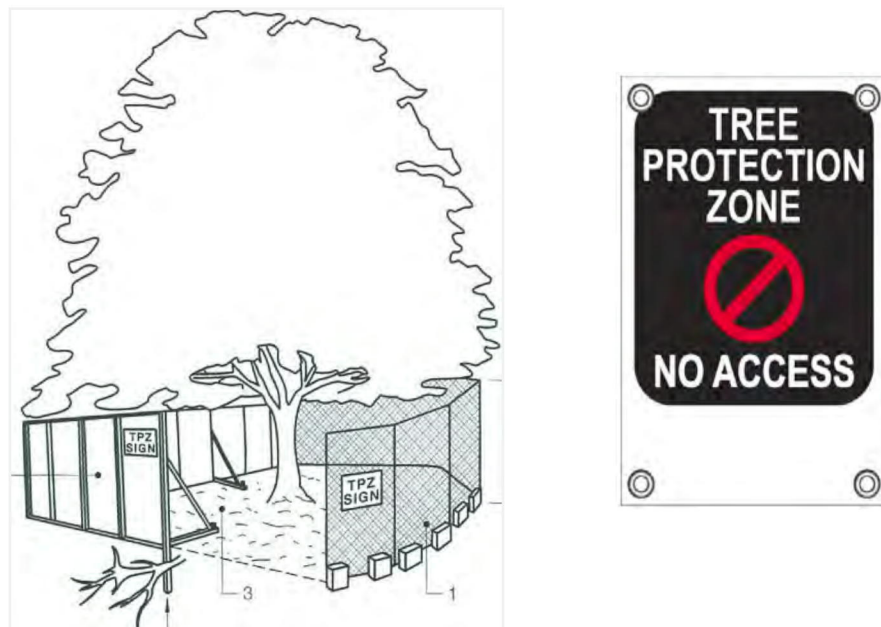
Figure 1. Above left - Example of TPZ fencing above right -Example of TPZ signage.

Refer to Figure 1 for fencing example.

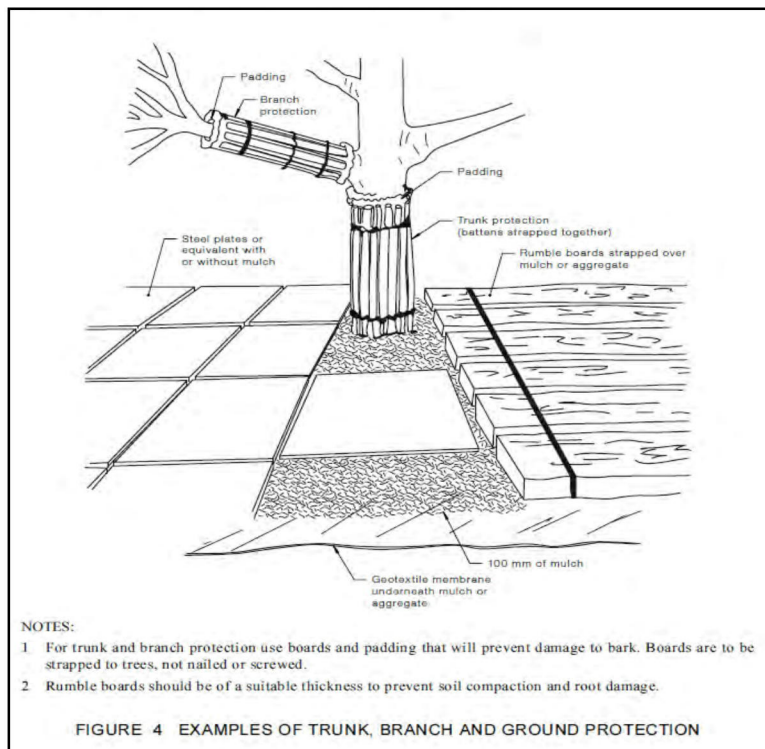
Diagram 2: Examples of ground buffering and trunk and limb protection.

(Extract from: AS4970-2009, Appendix D, pg17)
