Arboricultural Construction Impact Assessment

**5 Seymour Street,
Seville**

Location: 5 Seymour Street, Seville

Date: 13th March 2023

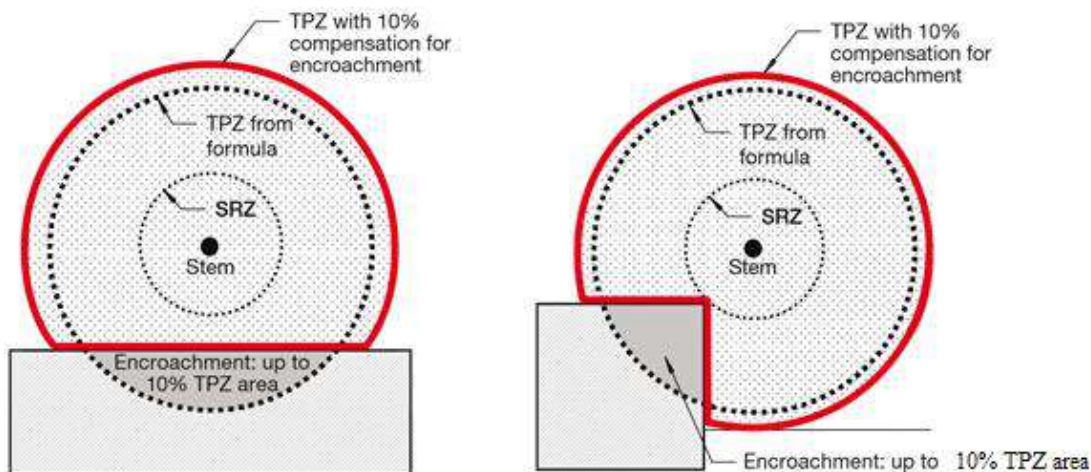
Examples of minor encroachment into Tree Protection Zones and outside Structural Root Zones

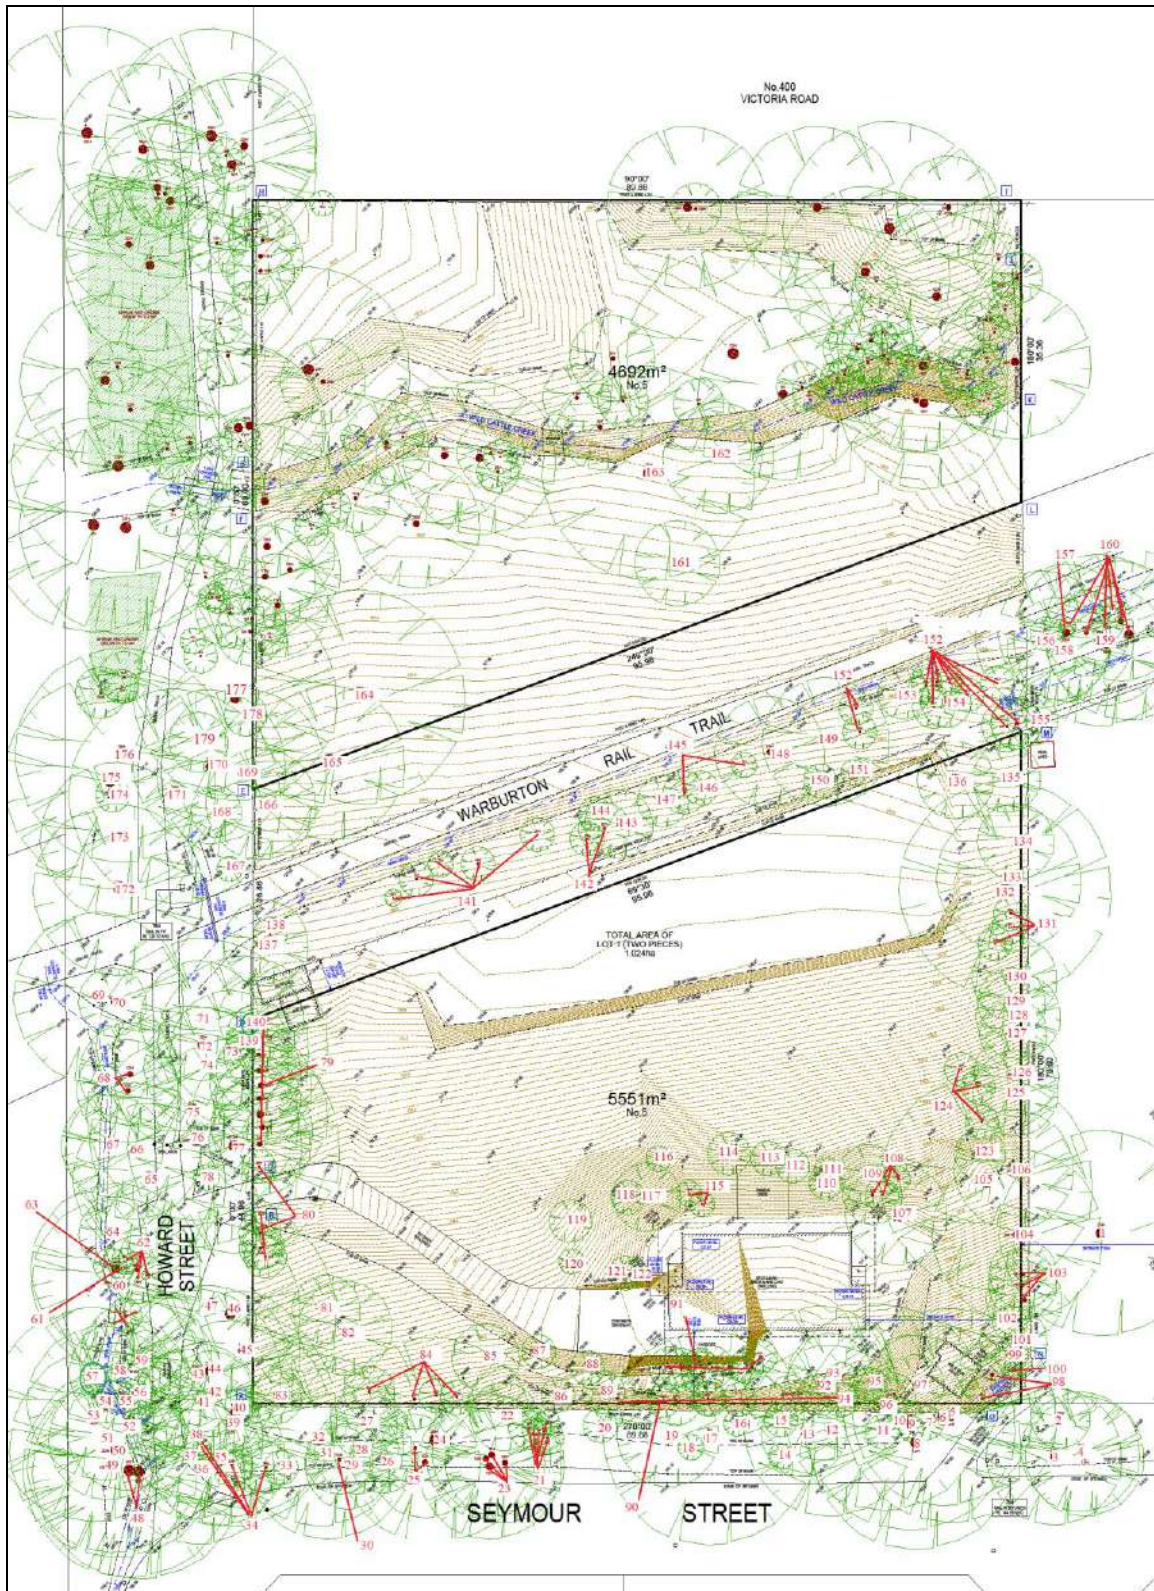
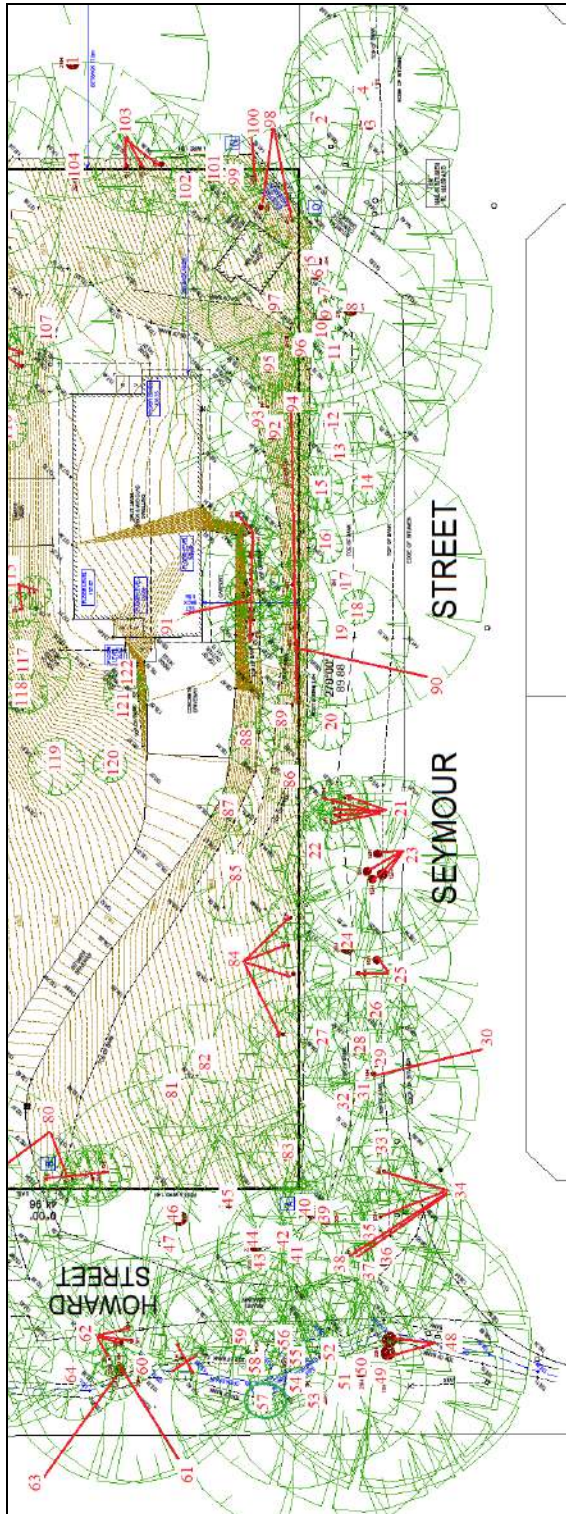
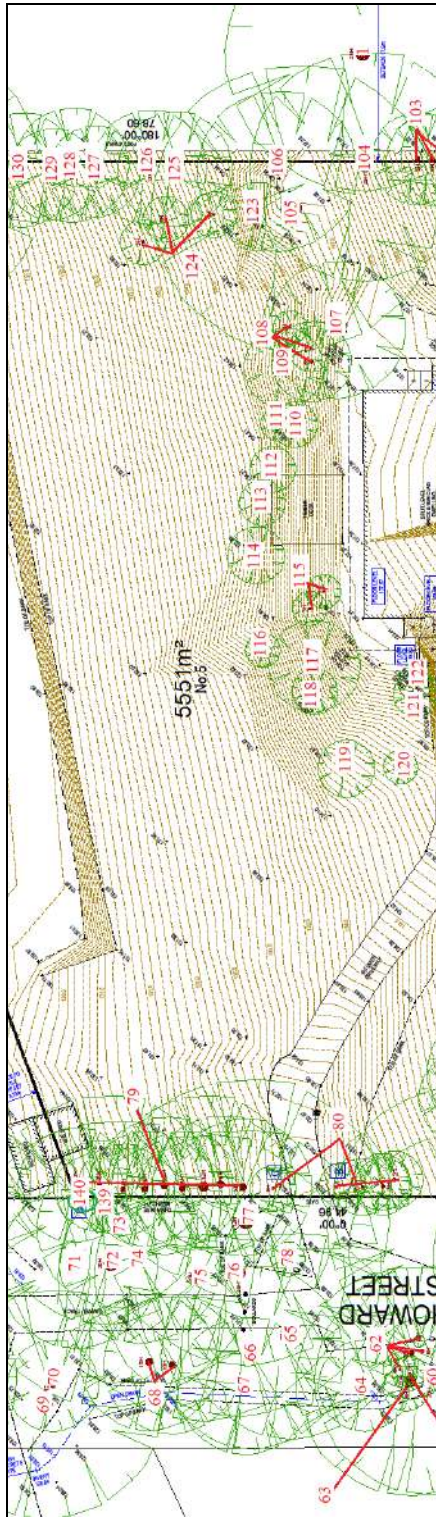
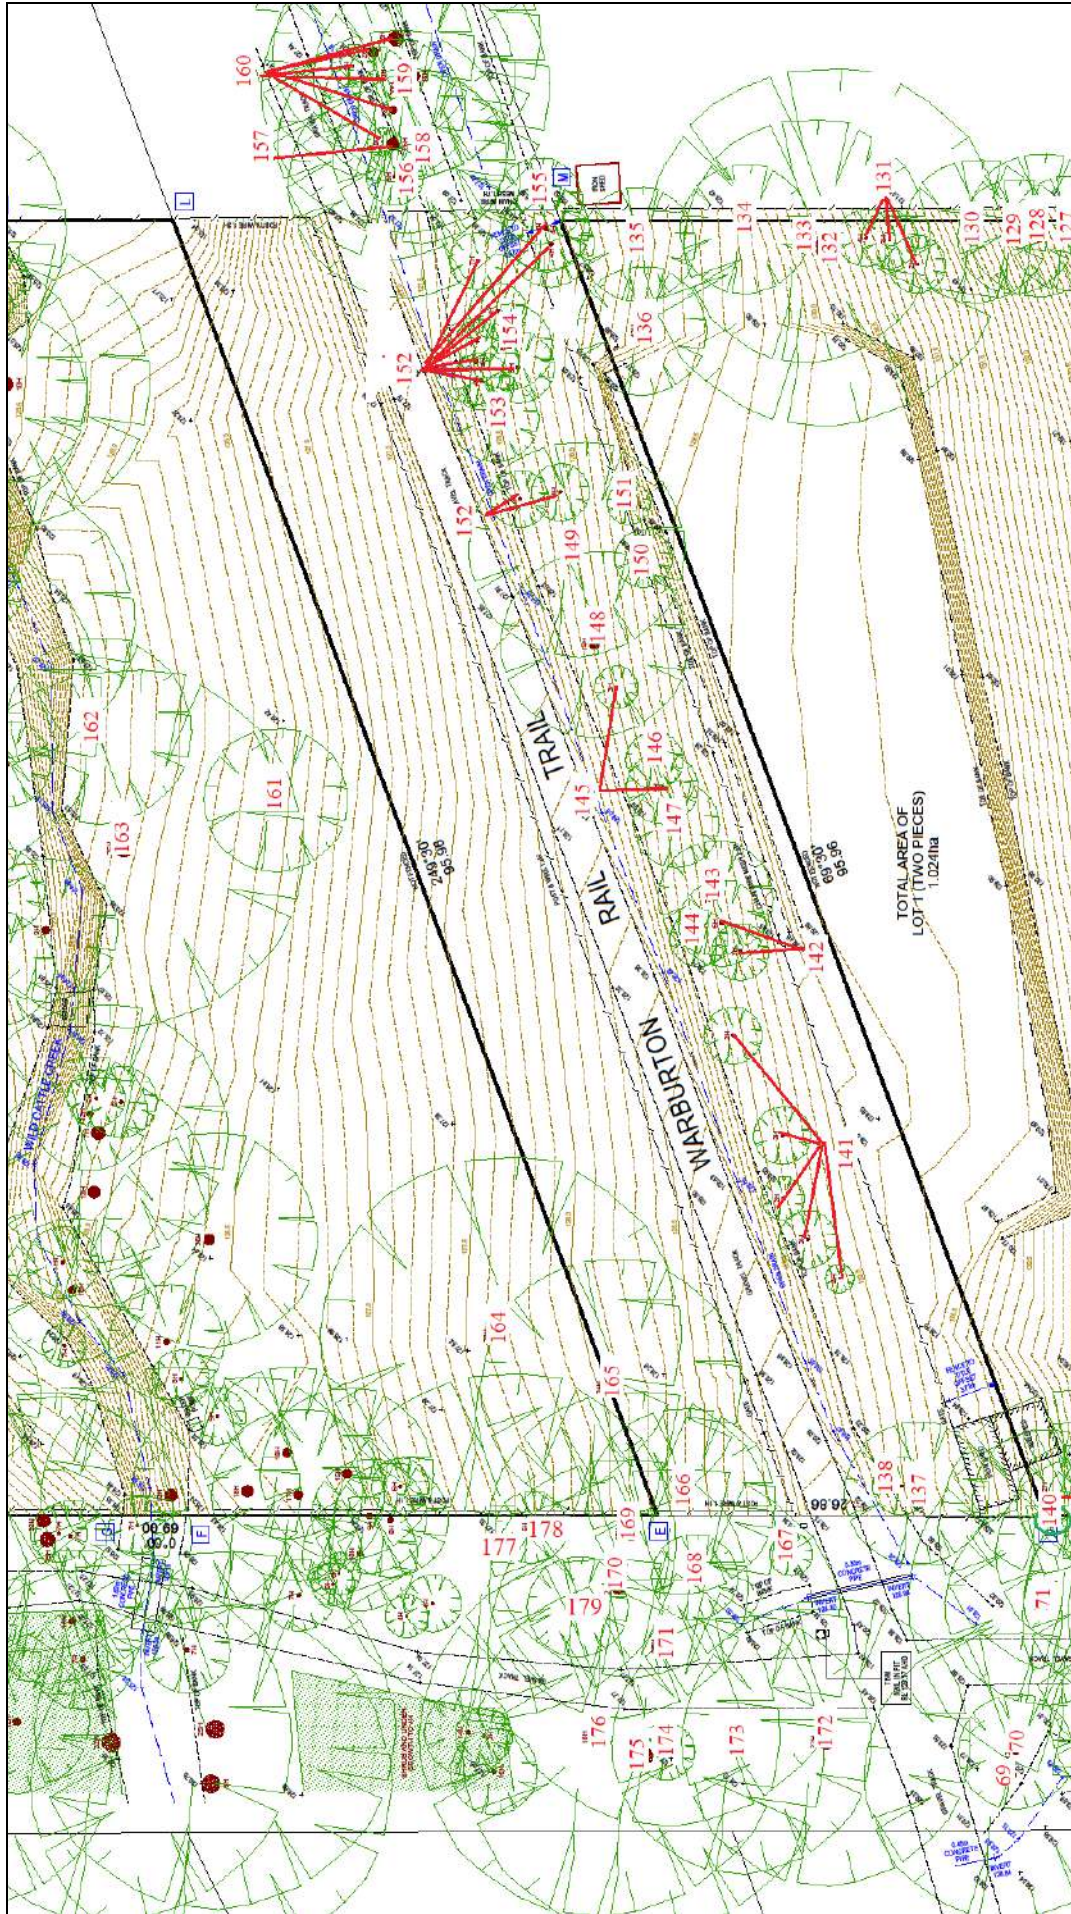
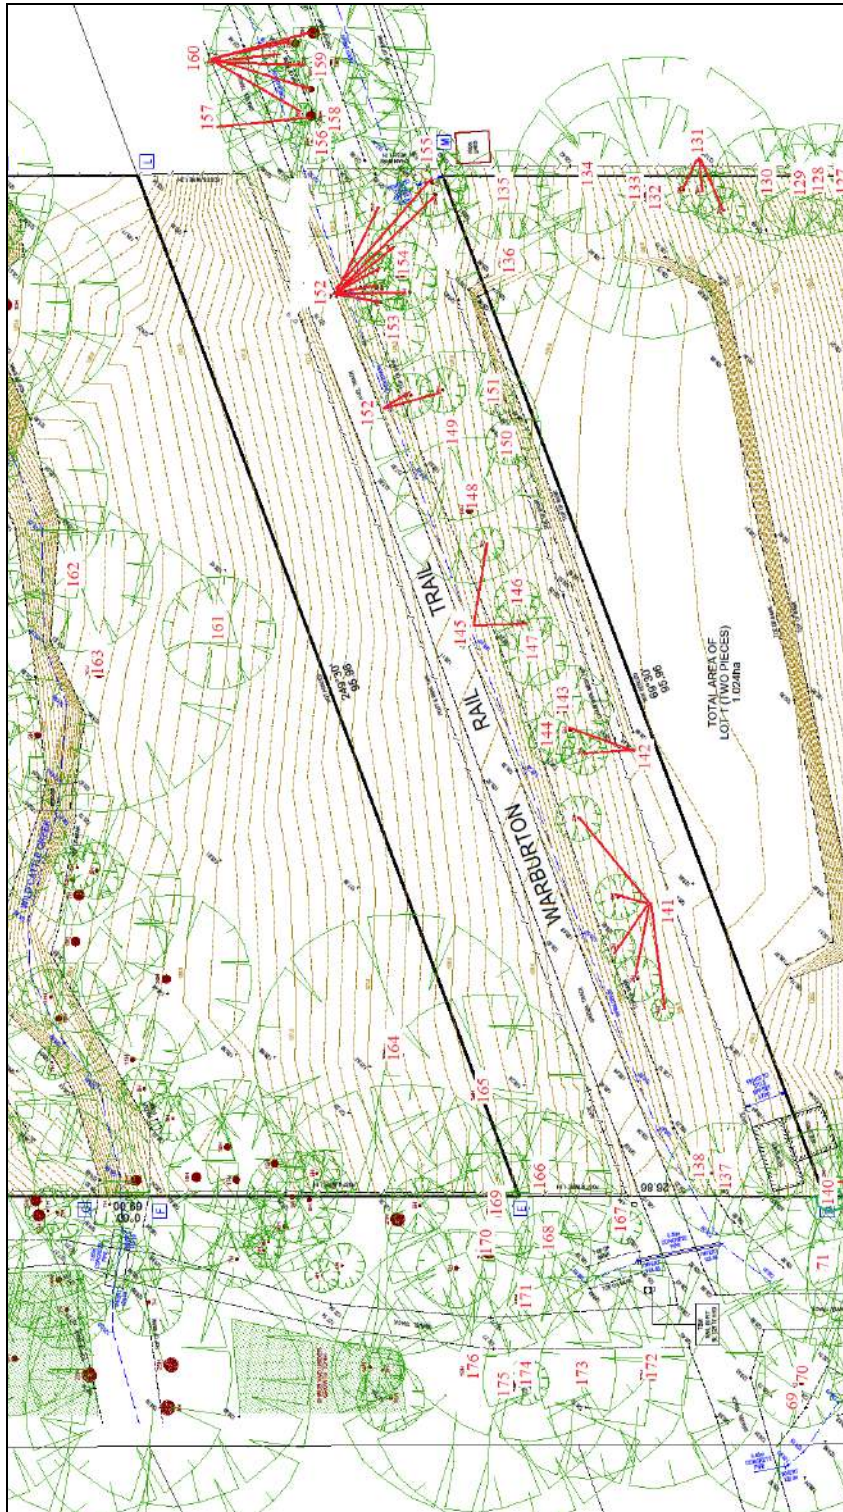
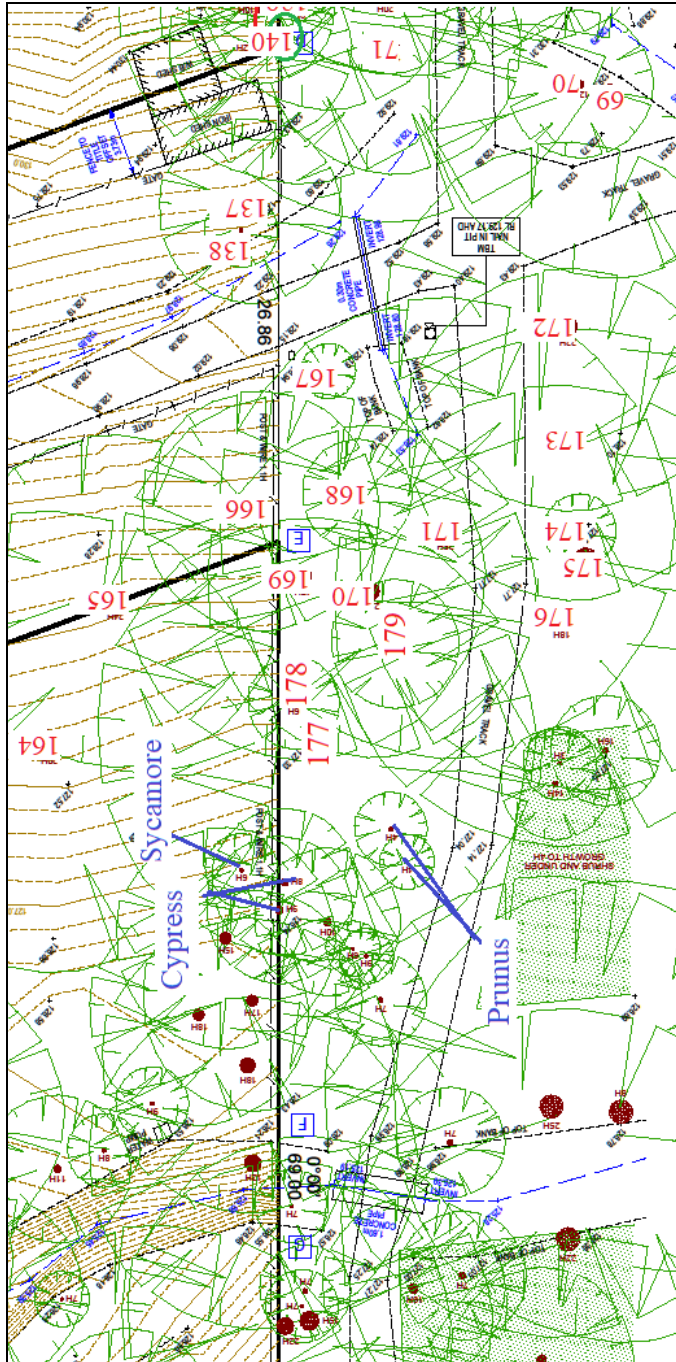
6. Tree location Plan:

The TPZ and SRZ of the Sycamore, Cypress and Prunus will not be impacted by the proposed cross over
