## Arboricultural Assessment and Report

375 Swansea Rd, Lilydale

Prepared for      Lilydale Development Pty.  
Ltd

29 August 2022

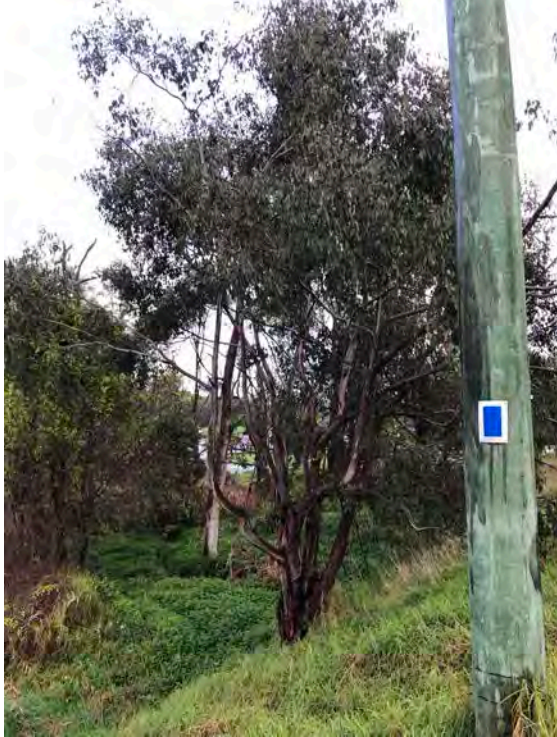
Tree id: 1. *Eucalyptus ovata* (Swamp Gum)  
 Semi-mature, Indigenous Arb rating. Mod.C  
 DBH: 26,24,22,18 (est.) cm TPZ: 5.4 m rad. Comments:  
 Included bark forks, multi-stemmed, past powerline  
 clearance.  
 Impact: None. TPZ encroachment 0.0%
