ARBORICULTURAL REPORT

20 DAVID HILL ROAD, MONBULK

May 2022

October 2022

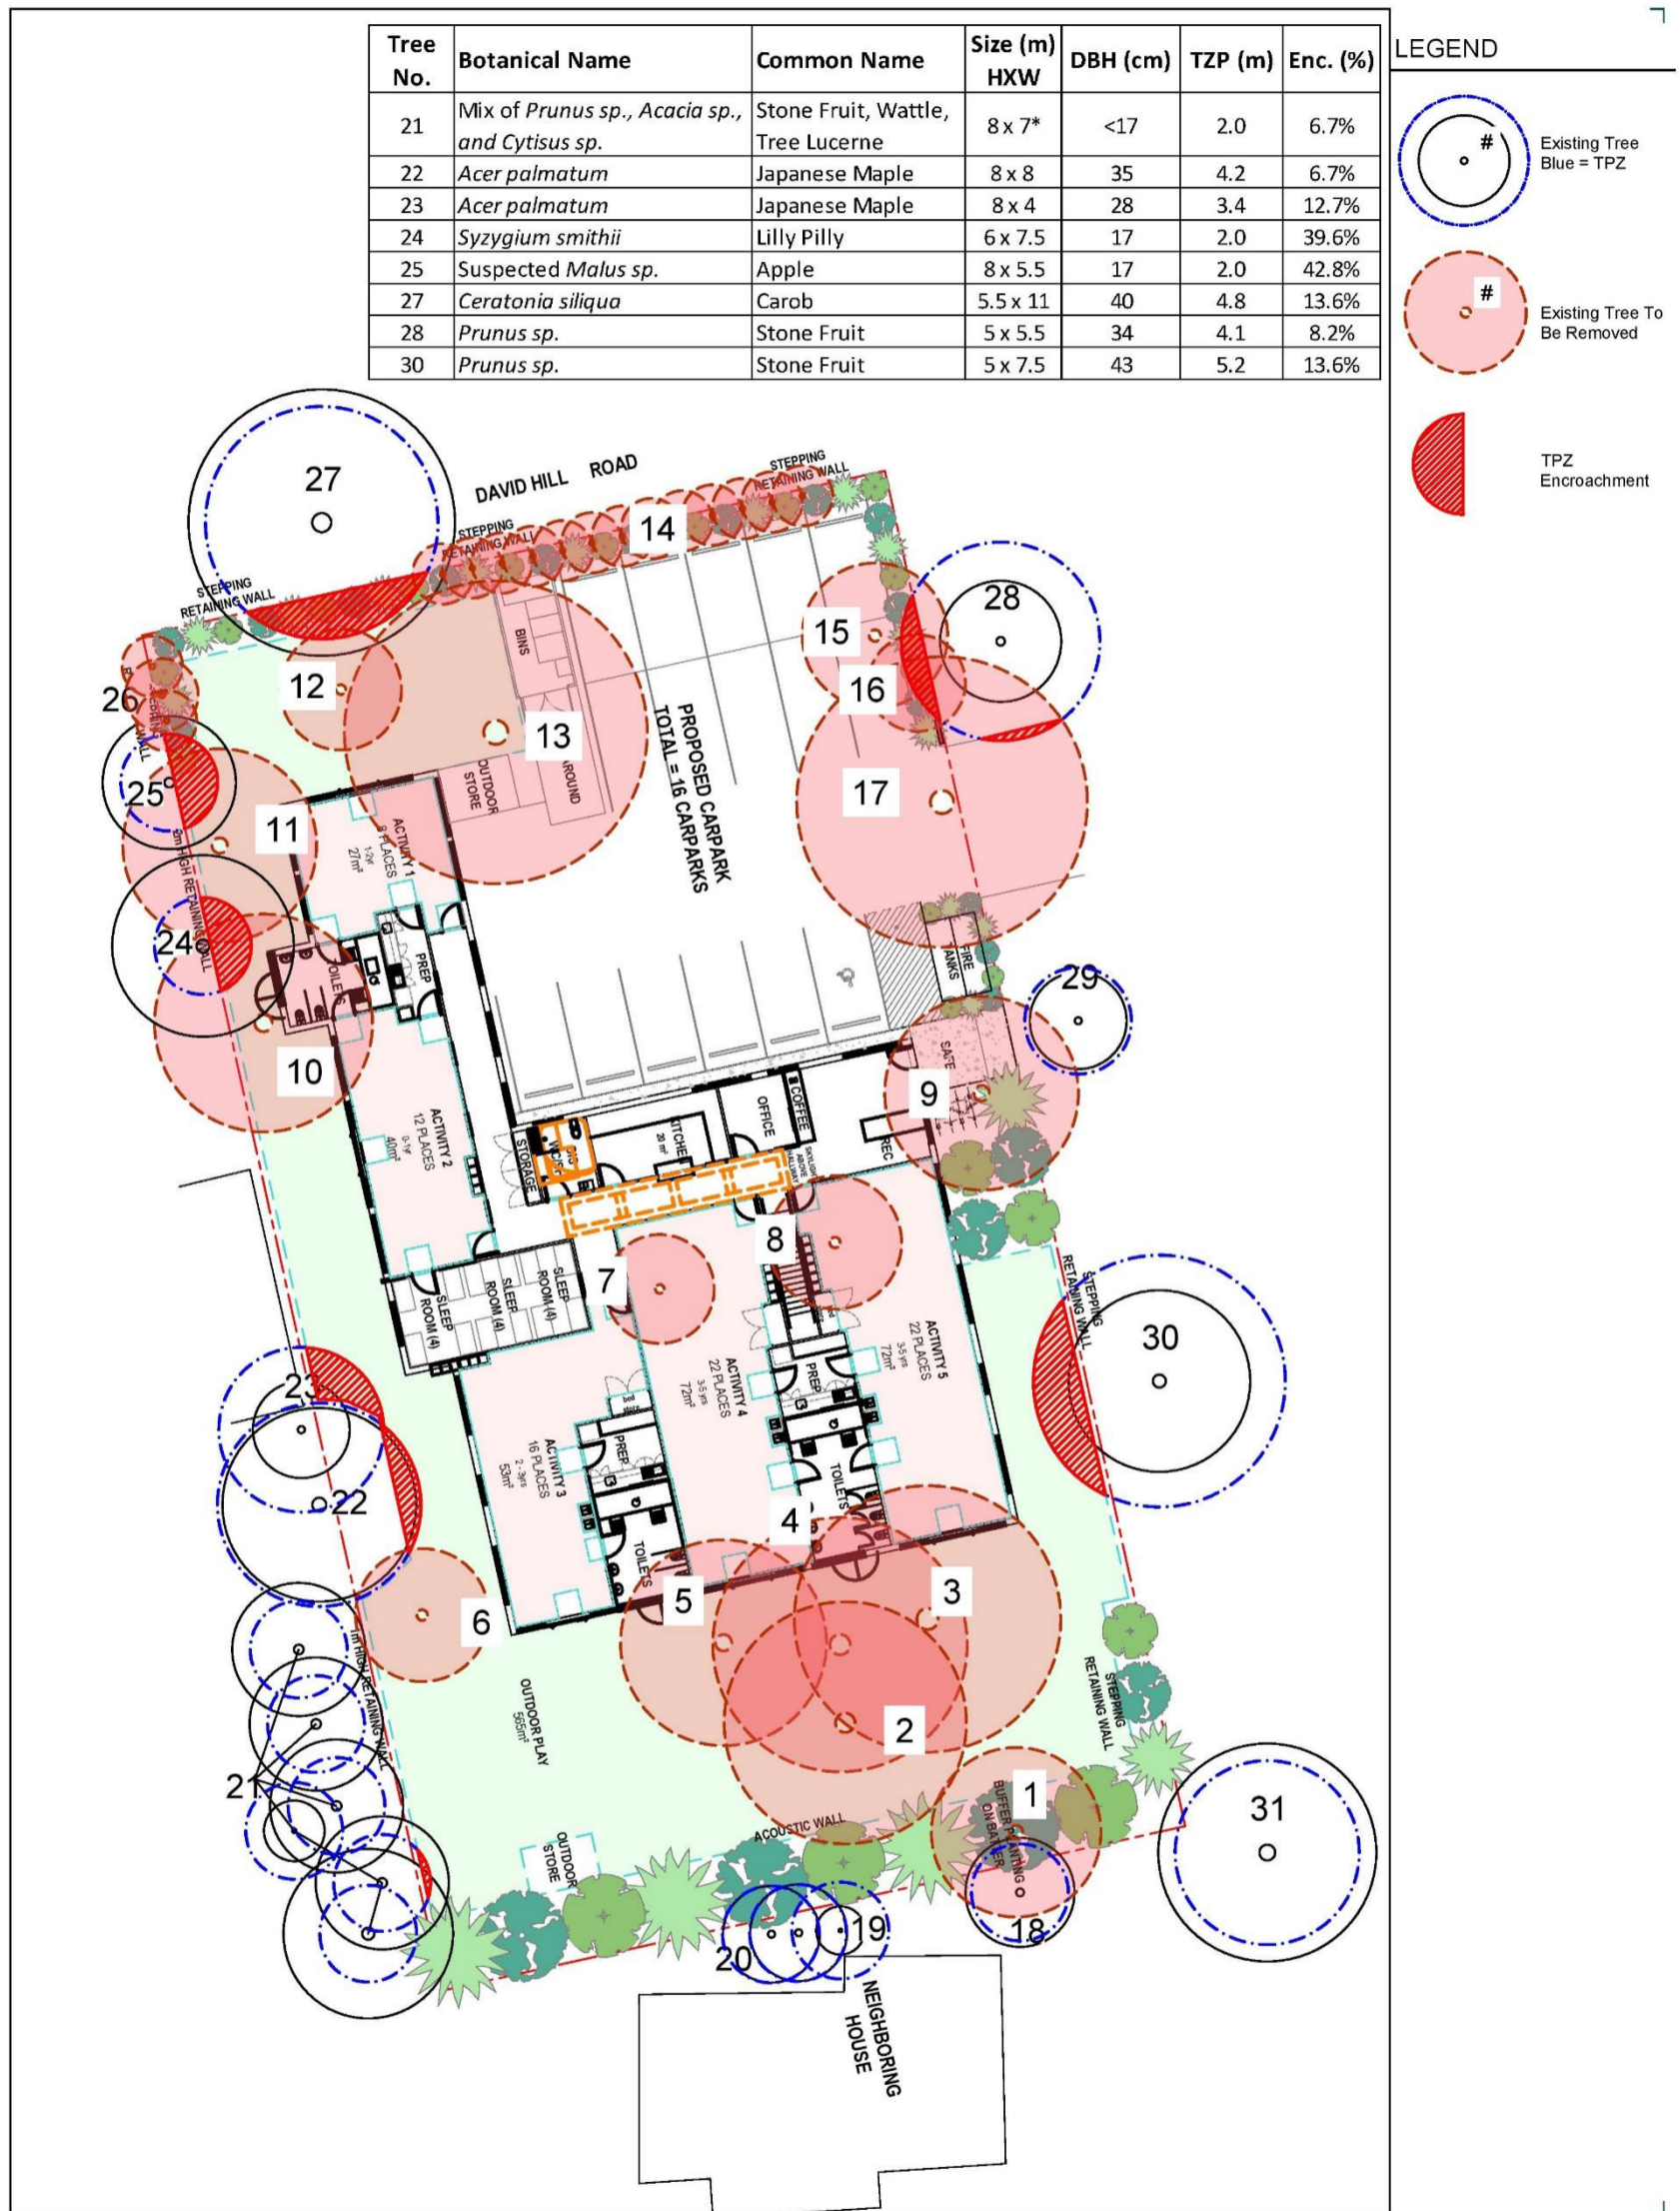
TPZ IMPACT ASSESSMENT PLAN

- 5.19 Tree Group 21 is a mix of *Prunus sp.* (Stone Fruit), *Acacia sp.* (Wattle), and *Cytisus sp.* (Tree Lucerne) located in the neighbouring yard along the western boundary towards the south of the site. One of these trees' TPZ is encroached by 6.7% caused by the proposed retaining wall. This is considered a minor encroachment (<10%) under AS4970 and is not expected to impact the long-term health of the tree. The rest of the trees within this group are not encroached and are not expected to be impacted.

- 5.20 Trees 22 and 23 are both *Acer palmatum* (Japanese Maple) located in the neighbouring yard along the western boundary of the site. Tree 22's TPZ is encroached by 6.7% caused by the proposed retaining wall. This is considered a minor encroachment (<10%) under AS4970 and is not expected to impact the long-term health of the tree. Tree 23's TPZ is encroached by 12.7% caused by the proposed retaining wall, considered a major encroachment (>10%) under AS4970. The retaining wall is proposed to be constructed of post and rail with no strip-footing. If pads for the posts are located to avoid any major roots (>40mm dia.) within the tree's TPZ, the long-term health of the tree is not expected to be impacted.

- 5.21 Trees 24 and 25 are a *Syzygium smithii* (Lilly Pilly) and a suspected *Malus sp.* (Apple) located within the neighbouring property along the western boundary of the site. Their TPZs are encroached by 39.6% and 42.8% respectively caused by the proposed retaining wall, considered a major encroachment (>10%) under AS4970. The retaining wall is proposed to be constructed of post and rail with no strip-footing. If pads for the posts are located to avoid any major roots (>40mm dia.) within the trees' TPZ, the long-term health of the trees are not expected to be impacted.

- 5.22 Tree 27 is a *Ceratonia siliqua* (Carob) located in the nature strip along David Hill Road to the north of the subject site. Its TPZ is encroached by 13.6% caused by the proposed stepping retaining wall. This is considered a major encroachment (>10%) under AS4970. If any major root located within the site are cleanly severed by hand the tree is not expected to suffer any long-term health effects due to the development.

- 5.23 Tree 28 is a *Prunus sp.* (Stone Fruit) located in the nature strip along Victoria Avenue towards the northwest corner of the site. Its TPZ is encroached by 8.2% caused by the proposed stepping retaining wall and new crossover. This is considered a minor encroachment under AS4970 and is not expected to significantly impact the long-term health of the tree.

- 5.25 Tree 30 is a *Prunus sp.* (Stone Fruit) located in the nature strip along Victoria Avenue to the east of the subject site. Its TPZ is encroached by 13.6% caused by the proposed retaining wall, considered to be a major encroachment (>10%) under AS4970. The retaining wall is proposed to be constructed of post and rail with no

- 5.26 If any boundary fences are to be replaced, it is recommended that any section of the new fences that pass through the TPZ of trees to be retained be of light-weight construction with post holes hand dug and relocated if necessary to avoid major roots. It is also recommended that all landscape areas within the TPZ of trees to be retained be maintained at existing grades.
