Review of Stage 1b Lilydale Heritage Review Gap Study Lilydale Heritage Study (Task 2)

Prepared for Yarra Ranges Council

November 2021—Final

| Project: | Lilydale Heritage Review |

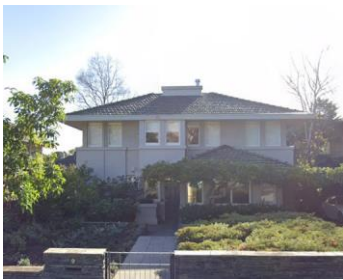
| Wiori (former Dora Mitchell House), 1/33-61 Edinburgh Road, Lilydale | | |
|--|---|--|
| | <p>Revell, 9 Toorak Avenue, Toorak (HO342 City of Stonnington)</p> <p>This 1920 Edward F. Bilson designed house is analogous to Wiori in terms of form and style. Although it is a more articulated example of Prairie-style architecture, its defining features are similarly observable at Wiori through the shallow pitched hipped roof with</p> | <p>Figure 7. Revell (source: Google Streetview, 2019)</p> |

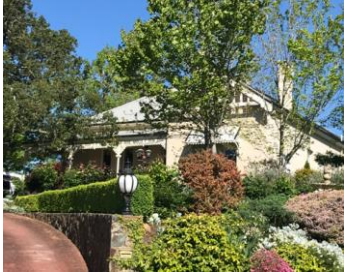
| Willowbank, 16 Crestway, Lilydale | | |

| Willowbank, 16 Crestway, Lilydale | | |
|---|--|---|
| Place type | Residential buildings (private) | <p>Figure 11. Willowbank (source: Extent Heritage, 2021).</p> |
| Part 1B Lilydale Heritage Review Gap Study 2019 comments | <p>Trevor Westmore: <i>This is a considerably extended Edwardian hip and gable brick dwelling with a corrugated iron roof, the street elevation of which is essentially intact. It may have been over-rendered, but this probably would not disqualify it from significance at the local level.</i></p> <p><u>Recommendation:</u> Include in Stage 2 Review.</p> | |
| Research findings | <ul style="list-style-type: none"> ▪ Construction date(s): 1912 ▪ Architect: unknown ▪ Builder: unknown ▪ Erected on a large estate for couple Joseph Moore Poyner and Elizabeth Ada Poyner in 1912. Estate formerly belonged to Joseph Poyner’s father, Edward Moore Poyner. ▪ Edward Moore Poyner was a baker and one of the early pioneers of the district. ▪ Estate was put up for auction in 1951 as a 10-roomed residence with extensive outbuildings set on 71 acres of land. Was subsequently purchased by the Maughans. ▪ Antique homewares and art belonging to Willowbank were put up for auction in 2014. | |

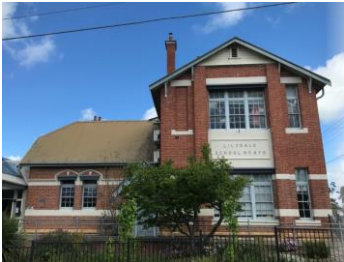
| Lilydale Primary School, No. 876, 63-66 Castella Street, Lilydale | | |

| Lilydale Primary School, No. 876, 63-66 Castella Street, Lilydale | | |
|--|--|--|
| Part 1B Lilydale Heritage Review Gap Study 2019 comments | Trevor Westmore: <i>This building has obvious social, historic and architectural significance.</i> <u>Recommendation:</u> Include in Stage 2 Review. | <p>Figure 15. Lilydale Primary School (source: Extent Heritage, 2021).</p> |
| Research findings | <ul style="list-style-type: none"> Construction date(s): 1876 (main building), 1924 (building enlarged and second storey added), 1966 (new wing added), 1995 (contemporary section). Architect: original main building- Public Works Department, potentially Henry Robert Bastow. 1924 alterations and additions – Public Works Department. Builder: 1924 alterations and additions – Mr. Soutar. Previously known as Lilydale State School. Public Works Department calls for tenders for the re-modelling of the building in 1922. A second storey added in 1924 resulting in extensive alterations and enlargement of main building, although the projecting entrance gable bay is retained. Fire in 1991 destroyed the wing addition that was constructed in 1966. | |

Recommended for the Heritage Overlay as an individual place.
